**PROJECT NAME: DESIGN SERVICES FOR THE NEW CITY HALL COUNCIL CHAMBERS ADDITION
5555 Perimeter Drive
City of Dublin, Ohio**

At the request of the City of Dublin, Osborn Engineering Company (OEC) in conjunction with our architectural sub-consultant (m+a architects) conducted a facility condition assessment at the existing building and parking lot located at 5555 Perimeter Drive, Dublin, Ohio formerly owned by Delta Energy. The assessment included Architectural (provided by m+a architects), Civil/Site, Mechanical, Electrical, and Plumbing systems. The objectives within this assignment include performing a survey of the existing building and its systems and providing recommendations for the facility including a summary rough order-of-magnitude costs for equipment replacement and repair within the next 20 years for major systems.

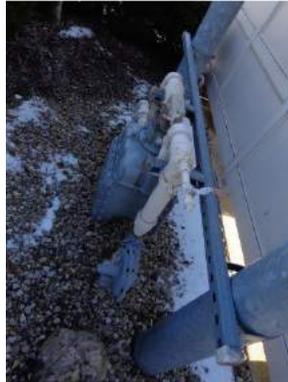
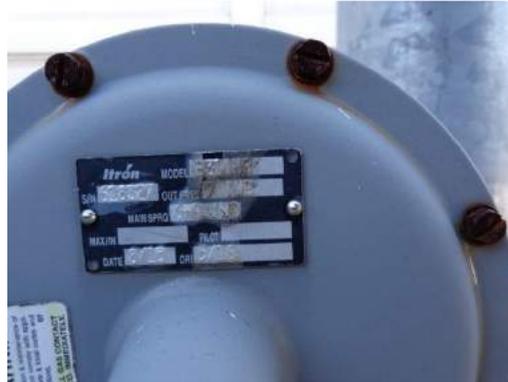
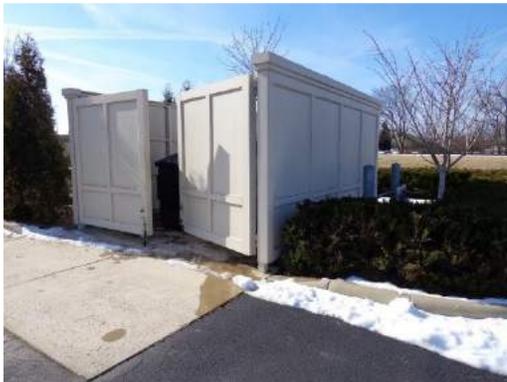
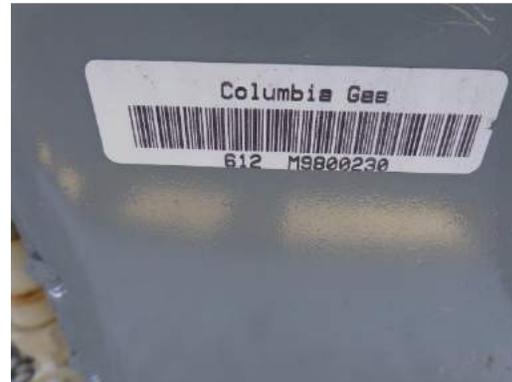
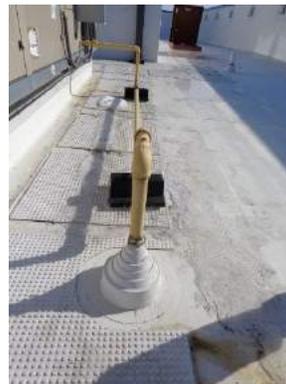
- Natural gas service and distribution—A Columbia Gas meter installation is located near the emergency generator and dumpster enclosure. A line is routed to and serves the generator. A two-inch plastic line is routed from the gas meter into the building at the west wall. A one-inch gas line is routed to the four gas lights located at the main entry. A two-inch gas line serving the rooftop units is routed within the building from where the gas line enters the building up to above the roof and then is routed on pipe supports to RTU-1 and RTU-2. The system is in good condition. Typical service life for natural gas systems is 50 years.

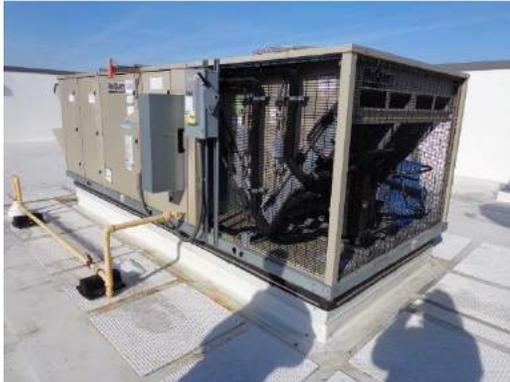
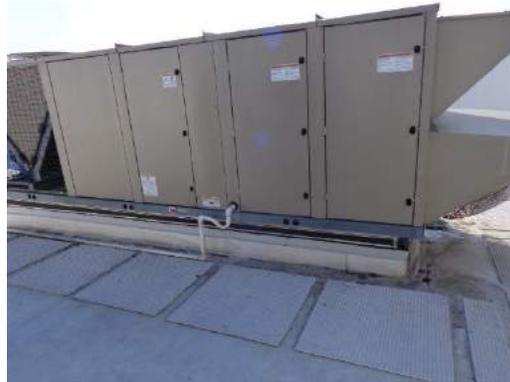
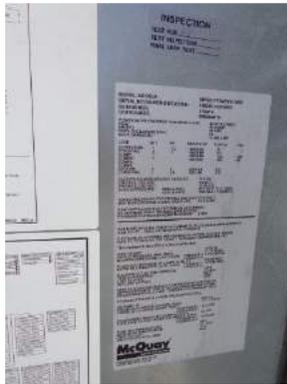
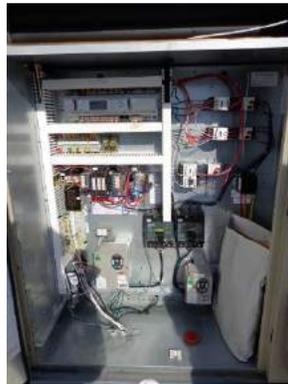
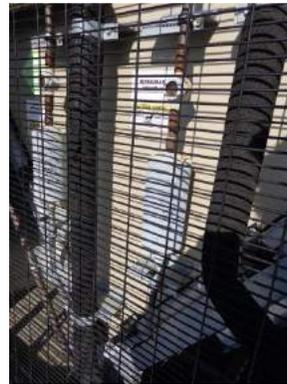
- Roof-mounted Packaged Variable Air Volume (VAV) Gas-Fired Rooftop Units with DX Cooling. There are two (2) McQuay Model MPS packaged gas-fired, DX, rooftop units designed for VAV applications. A 17-ton unit serves both floors of the east portion of the building, except for the Board Room area which is served by AH-2. The units are in good condition. The beginnings of aging of the elastomeric insulation around the refrigerant piping in the condenser section was observed. Typical service life for packaged RTUs is 20 to 25 years, and having had 8 years of service to date, replacement can be anticipated within the next 20 years.

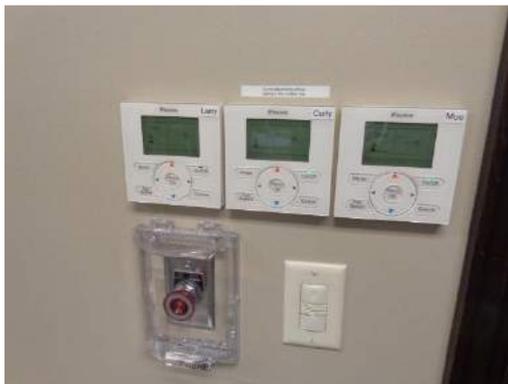
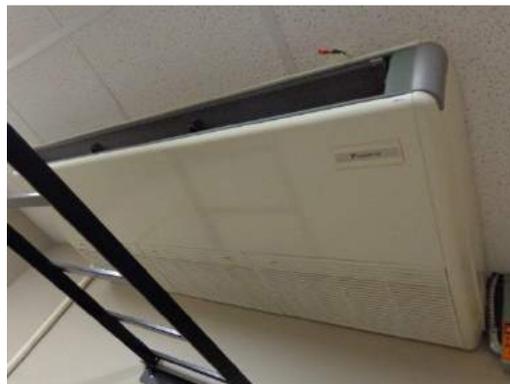
- AH-1s—Three (3) 40,500 Btuh cooling, ceiling suspended Daikin units (all tagged AH-1) provide cooling and heating for the Server Room (Rm 111) for which the condensing units (three CU-1s) are located on the roof. The server room units operate independently of the building HVAC systems. Commercial split systems have a typical service life of 20 years.
- AH-2 serves the board room and ancillary offices/spaces (not pictured here). The 2,000 CFM air handler AH-2 suspended above the ceiling is connected to the emergency power system. A 10 kW duct heater is interlocked with the operation of the unit. Condensing unit CU-2 is located on the roof.

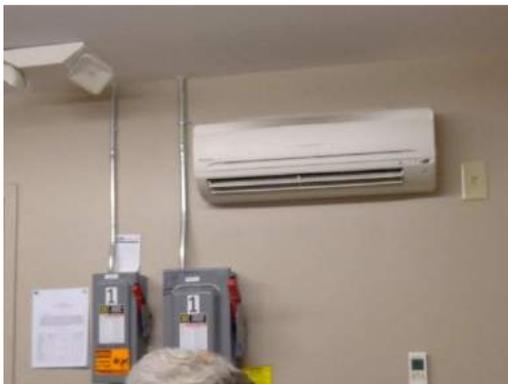
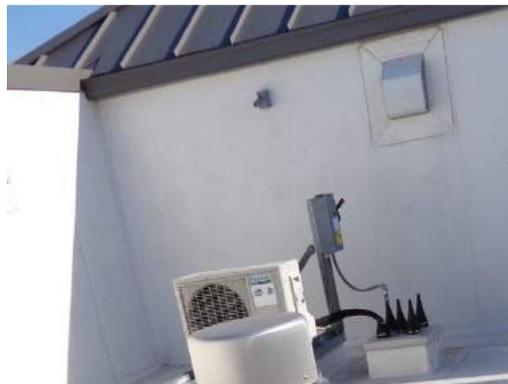
- AH-3, a one-ton cooling only unit serves the elevator equipment room. Its condensing unit is located on the roof. The typical service life for commercial split systems is 20 years. Replacement is expected within a 10 to 20 year period.

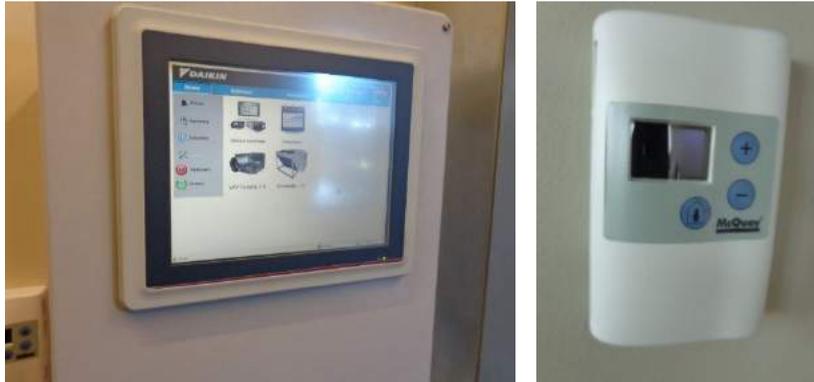
- The Building Automation System (BAS) is McQuay based and provides control for the main HVAC equipment in the building. Temperature control systems have typical service lives of 20 years.

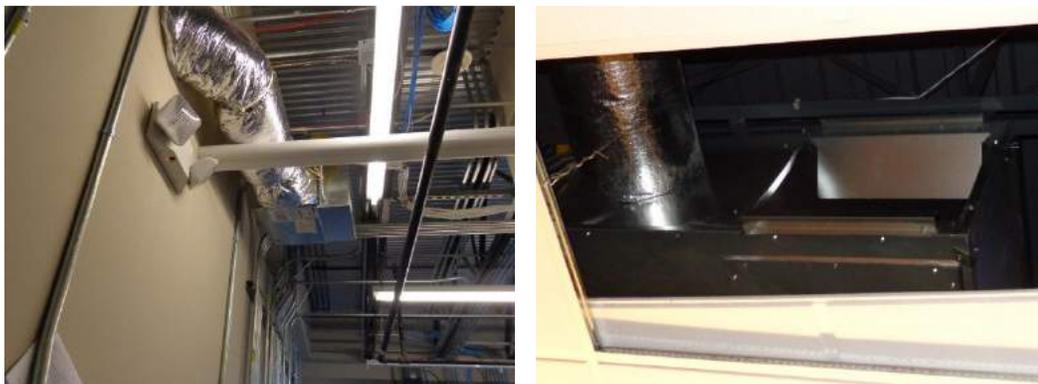
- Supply air distribution is through insulated galvanized ducts to fan-powered electric reheat VAV boxes which vary flow to spaces and provide heating of the supply air when needed. Corridors are served by cooling-only VAV boxes. Tables on the approved construction drawings indicate compliance with ASHRAE 62.1 2004 ventilation requirements. A zoned plenum return air system is used for the HVAC units serving the spaces. This equipment has typical service lives of 30 years.

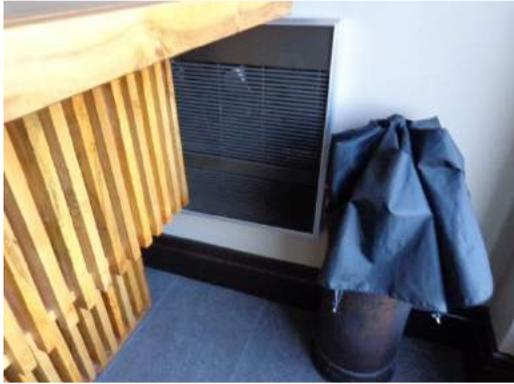
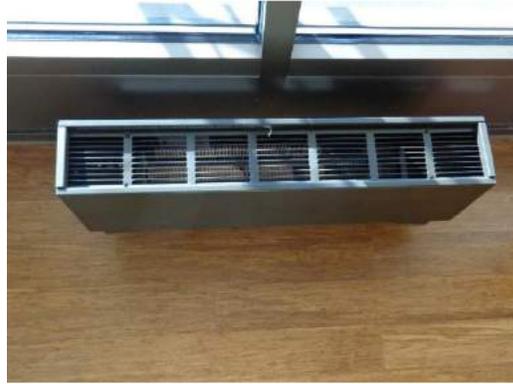
- Electric unit heaters—two (2) recessed, wall mounted, 3 kW recessed heaters (EH-1) are installed near the main entrance. Two (2) pedestal-mounted 1.5 kW electric heaters (EH-2) supply heat to the south entrance. EH-3 is a wall mounted heater serving the Water Room (Rm 131).

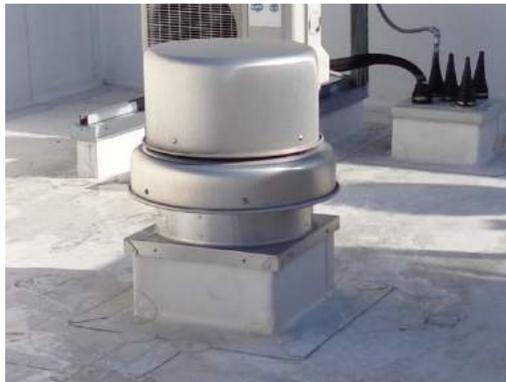
- Exhaust fans: one rooftop curb mounted exhaust fan (EF-1; 1,170 CFM, ¼ HP) serves the public restrooms and the locker/shower area in the west portion of the building. An inline fan (EF-3; Greenheck CSP Inline, 75 CFM) located above the first floor ceiling serves the small restroom in the east portion of the building in the Board Room area. [Note: there is no EF-3.]

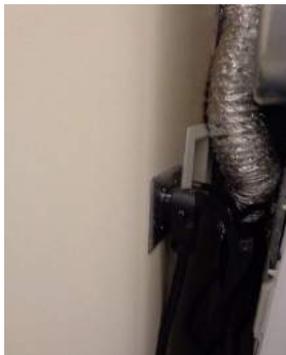
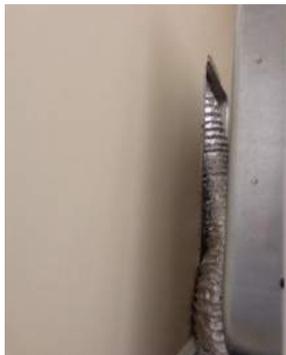
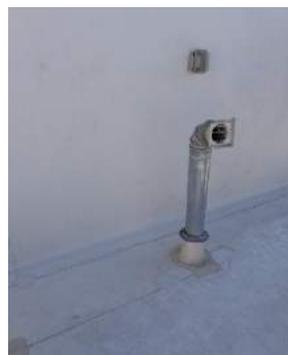
- A 100-CFM booster fan, BF-1, serves the clothes dryer near the Fitness Area in Room 123). The typical service life for an exhaust fan for this application is judged to be no more than 20 years. The replacement of the fan can be expected within a 20 year period. It is recommended that 4 inch flexible duct be replaced with hard duct (and a minimum of flexible duct used) within the near future. Hard duct connections at dryers are standard installation. Deformation of the flexible duct is observable behind the washer/dryer unit. The dryer vent duct termination is above the roof near CU-3.

- Mechanical Systems
 - In general, many mechanical systems have typical service lives between 15 and 30 years. With systems having been in operation for eight years, it can be expected that there will be replacements needed in the 10 to 20 year time frame of the following systems:
 - RTUs.
 - Split systems; both indoor and outdoor components.
 - Electric duct furnace.
 - Electric unit heaters.
 - Exhaust fans including the dryer exhaust booster fan.
 - The building temperature controls, BAS.

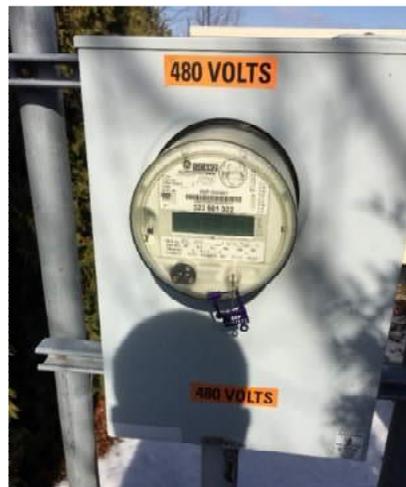
- The existing facility electrical service is provided by AEP Ohio. It is served by an oil-filled pad mount 500kVA, 13.2kV-480/277V utility transformer is owned and maintained AEP Ohio. The electrical service is a 480/277V, 3-phase, 4-wire, 800A service. The main service disconnect switch is the 800A main circuit breaker located in distribution panelboard HDP within the main electrical room adjacent to the elevator.

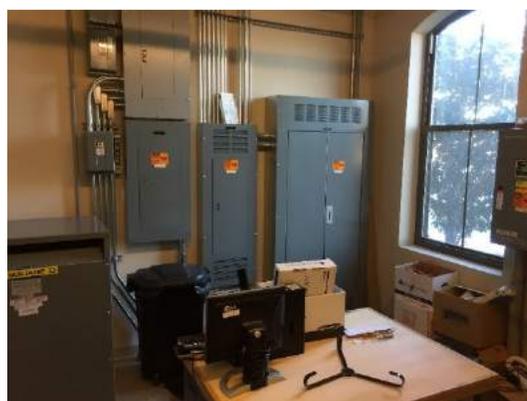
- The main distribution panel HDP within the main electrical room is a Square D, I-Line series distribution panelboard. It is 480/277V, 3-phase, 4-wire, 800A distribution panelboard with an 800A main circuit breaker. The equipment is in good condition and was installed in approximately 2010. According to the past 18 months of electrical utility bills, the peak on the building is approximately 190A and was seen in February of 2017. There is adequate space and ampacity within the panelboard to add additional circuit breakers for serving additional loads in the future. The equipment is approximately 8 years old and has an expected life of 30 years. It is not expected that the electrical distribution equipment will need to be replaced within the next 20 year period.

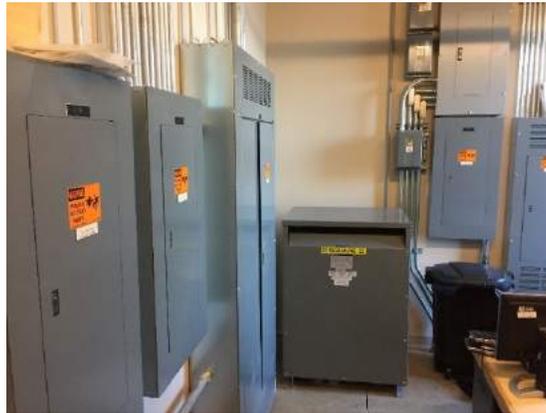
- There are two transformers within the facility for stepping down the 480V service to 208/120V. Both transformers are manufactured by Square D and are in good condition. The transformers are approximately 8 years old and have an expected life of 30 years. It is not expected that the electrical transformers will need to be replaced within the next 20 year period. Below is a summary of the transformers within the facility.

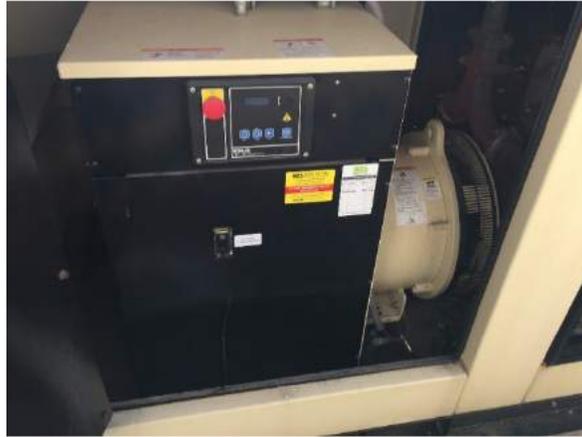
- The generator is a Kohler 100kW, 480/277V natural gas generator with a 150A output circuit breaker. The generator feeds the single ATS within the building. The generator does not serve life safety (NEC 700) or legally required standby (NEC 701) loads. It serves general area lighting, receptacles, IT equipment, security equipment and HVAC loads in critical spaces within the facility. The generator has 212.7 hours of runtime and is in good condition. The generator is approximately 8 years old and has a typical life expectancy of 25 years. Due to reaching the end of its life expectancy within the next 20 years, it should be planned to replace the generator set within the long-term plan (10-20 years).

- Electrical Systems
 - In the long-term (10-20 years), it should be planned to replace the generator and the associated ATS as they will be meeting their typical life cycle. Although not required, it would also be recommended to begin investigating the replacement of the existing fluorescent and metal halide based light fixtures with new LED light fixtures to provide energy savings and minimize required re-lampings and maintenance. This would also require the replacement of the lighting controls within the facility to meet the current ASHRAE 90.1 energy code requirements.

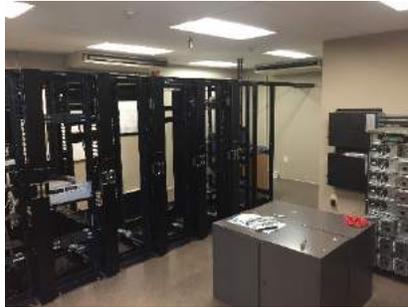
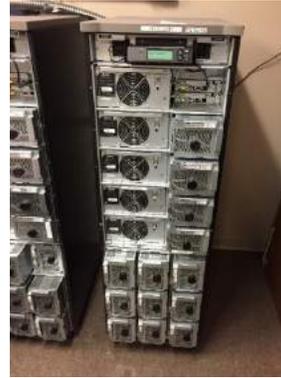
- The existing IT room has two 16kVA, 240/120V, 1-phase, APC (Schneider Electric) Uninterruptible Power Supplies (UPS). The UPS's are modular style units with modular power units and modular battery units installed within the UPS rack. Each UPS was equipped with a maintenance bypass cabinet and then serves a dedicated panel. Since the system was not in use, the batteries had been disconnected, but the building owner had reported that the system was functional and operational. The typical life expectancy for a UPS is 15-20 years. The UPS's should be considered for replacement within the intermediate plan (5-10 years). The expected life of the batteries is dependent upon use of the system, but typically have a life expectancy of 5-7 years. It should be expected to replace batteries within the first 5 years of using the system and then approximately every 5-7 years the system is operational.

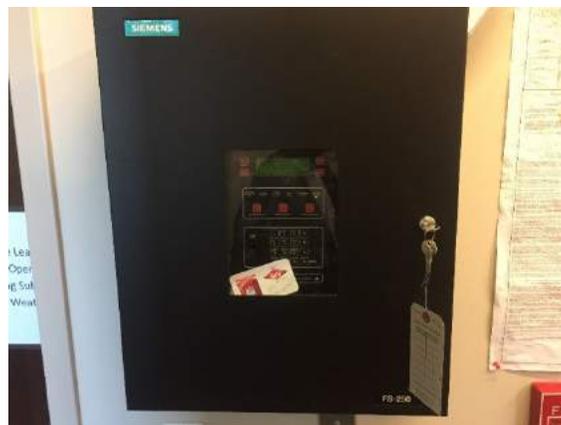
- The fire alarm system within the building is a Siemens FS-250 addressable fire alarm system and is set up to dial out to a fire alarm monitoring company. The fire alarm system is installed to integrate with the elevator, fire suppression system, IT room Novec fire suppression system, and HVAC units. The existing system does not provide manual pull stations throughout the facility and does not have complete notification coverage throughout the facility. According to the Ohio Building Code section 907.2.2 (2), if the building has an occupancy load greater than 100 people above the lowest level of egress, then a full manual fire alarm system must be provided. The original permit of occupancy shows an occupancy load of 107 on the second floor. Therefore, per the Ohio Building Code, a full notification ADA compliant fire alarm system should be provided within the facility. The existing system itself appears to be in good operational condition and has a typical life expectancy of 15 years. It is recommended to either expand upon the existing fire alarm system or provide a new fire alarm system to provide a complete ADA compliant fire alarm system with manual pull stations and notification devices throughout the facility in order to meet Ohio Building Code requirements (0-5 years).

- **Electrical Systems**
 - In the immediate term (0-5 years), the fire alarm system should be expanded upon or replaced in order to provide complete building notification to be in compliance with the OBC. It is also expected to need to replace the batteries on the UPS systems serving the IT room. The lighting control panel should also be considered for relocation to provide adequate working access for programming purposes. The flagpole flood light that has been damaged should also be replaced.

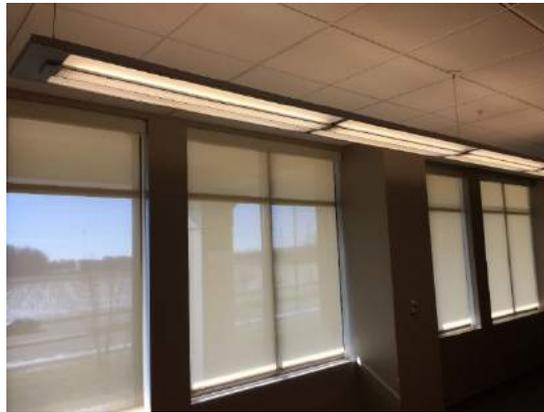
- The majority of the light fixtures within the facility are 2'x4' recessed acrylic lens volumetric style troffers in the general conference rooms, corridors, and common spaces. The open office areas have direct/indirect linear suspended pendant lighting fixtures installed. Most of the lighting consists of 32W, T8 linear fluorescent lamps. In the lobbies, the atrium, and the board room, there are a number of recessed downlights and other decorative lighting fixtures. The downlights all

appear to be compact fluorescent lamps. The light fixtures appear to be in good condition. There are approximately 5 locations that will need new lamps or ballasts as the fixtures did not appear to be working. All of the light fixtures were installed during the original building construction and are approximately 8 years old. Typically the light fixtures within a facility will last 25-30 years if well maintained. Although not required, with new LED technologies available, it would be recommended to replace the lighting within the space with LED lighting plan to begin taking advantage of energy saving options and to minimize fixture maintenance. This estimate of cost has been included in the long-term plan (10-20 years) for evaluation purposes. If the lighting fixtures are replaced, typically lighting control upgrades will be required to provide dimming controls and daylight harvesting controls to meet the current ASHRAE 90.1 energy code requirements.

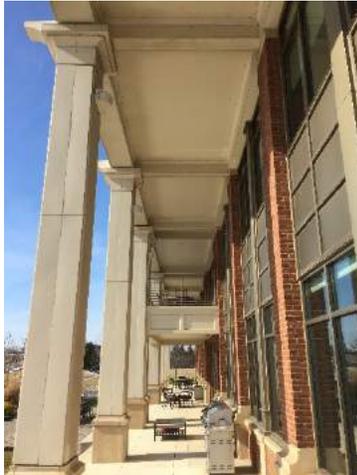
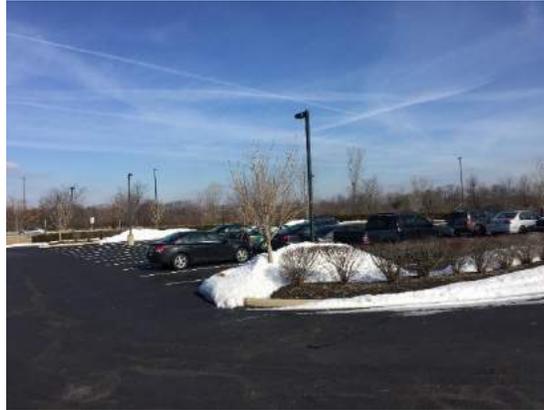
- The existing site lighting at the facility consists of pole mounted 175W metal halide light fixtures. There are also half-cylinder metal halide wall mounted fixtures that are mounted to the columns on the exterior of the building. The canopies around the building have wet-listed compact fluorescent downlights installed. The exterior fixtures appear to be in good condition and have a typical life expectancy of 25 years. With new LED technology options available, it would be recommended to upgrade the exterior fixtures to LED to provide energy savings within the long

term plan. It would also be recommended to perform a general cleaning of the building mounted light fixtures to remove debris from the lenses.

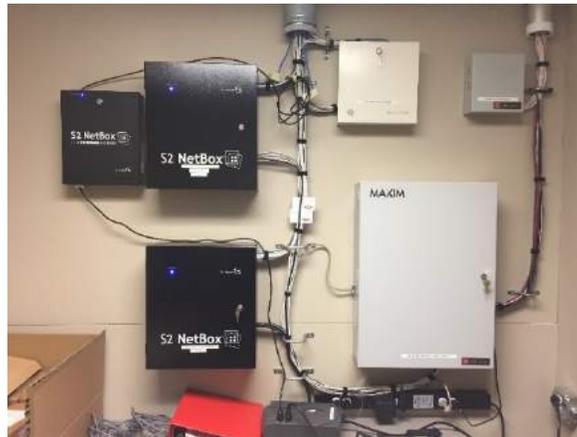
- The facility is equipped with an S2 Systems access control system. The head end equipment is located in the electrical room adjacent to the IT room. The system consists of access control locks, card readers, and keypads at all exterior doors and approximately four interior doors. The system is approximately 8 years old and is in good condition. Replacement parts are still readily available. According to the manufacturer, these systems have a typical life expectancy of 10-15 years. It is recommended to plan for replacement of the system in the intermediate plan (5-10 years).
