Memo

To: Members of Community Development Committee
From: Dana L. McDaniel, City Manager
Initiated By: Robert Taylor, PE, Director of Asset Management & Support Services
Jennifer Rauch, AICP, Director of Planning
J.M. Rayburn, Planner I
Date: March 18, 2021
Re: Maintenance of Historically Significant Stone Walls

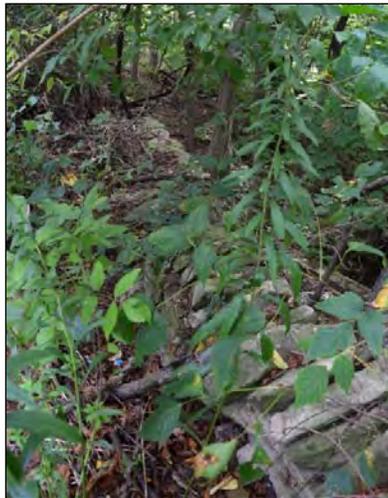
Condition: Fair, Ruinous, Overgrown

Overview of wall, looking south

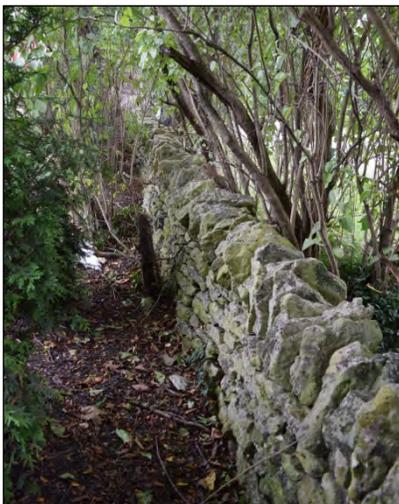
Condition: Good, Repaired

Overview of wall, looking south

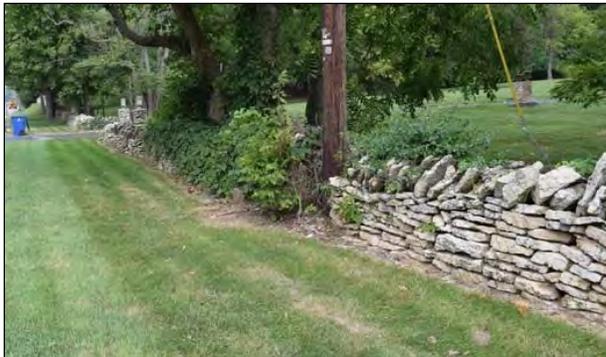
Condition: Good, Fair, Deteriorated/Poor, Ruinous, Overgrown

Overview of wall, looking north-northeast

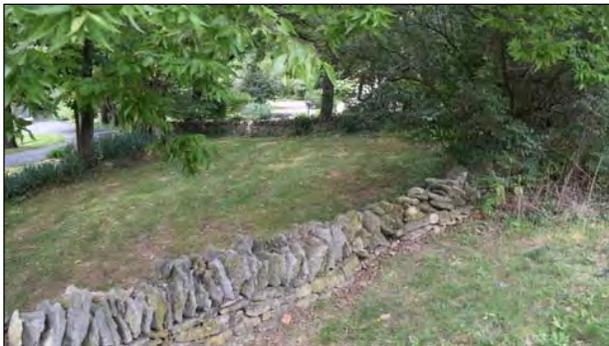
Overview of wall, looking northwest

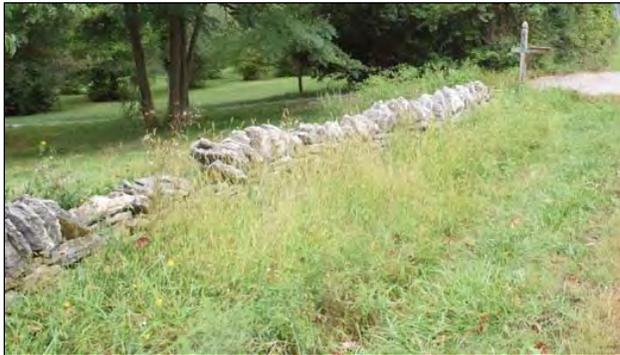
Historical Significance: This wall may have originally dated to the pre-1900 period, but has likely been repaired in the twentieth century. This wall appears to have historical significance as part of Dublin’s agricultural past and as part of Dublin’s 20th century suburban growth.

Overview of wall, looking north

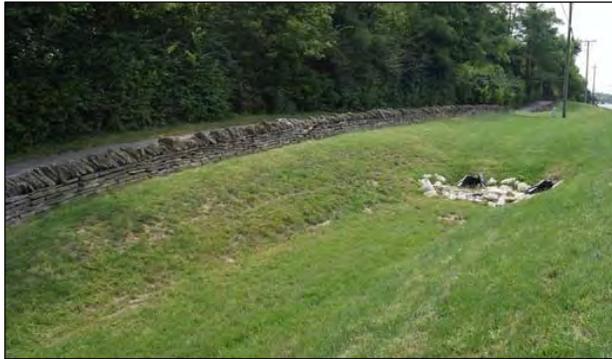
Overview of wall, looking south

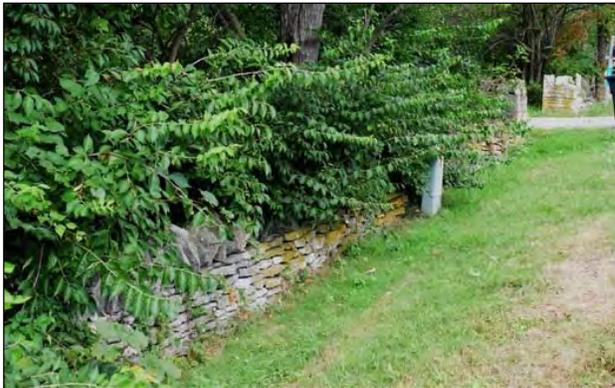
Overview of wall, looking north-northwest

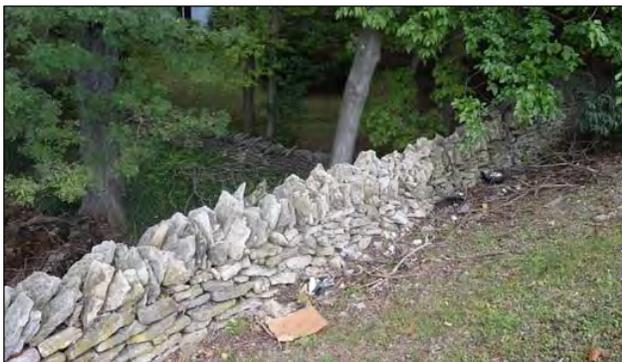
Overview of wall, looking north-northwest

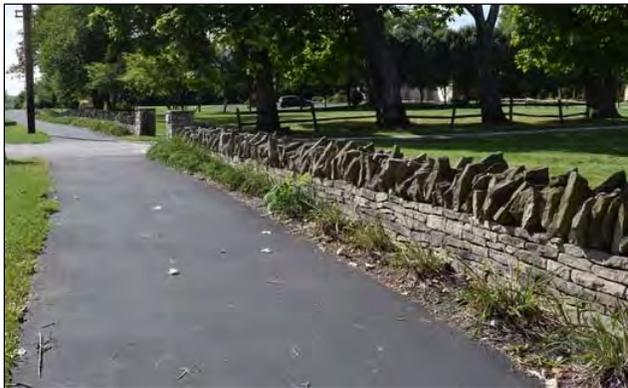
Overview of wall, looking south

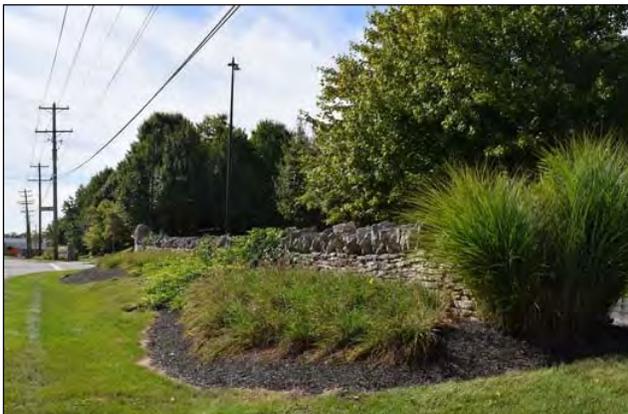
Overview of wall, looking south

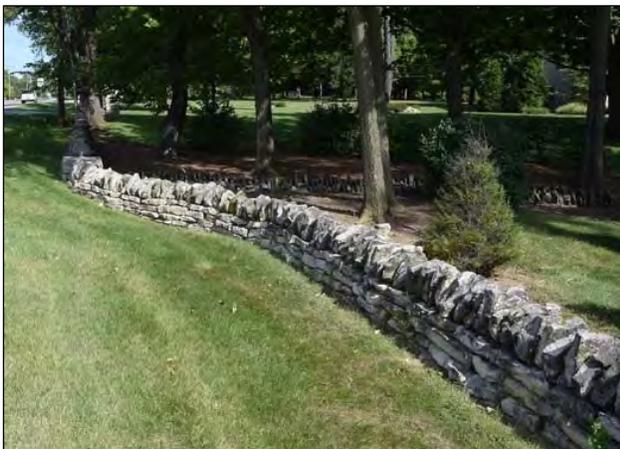
Overview of wall, looking north

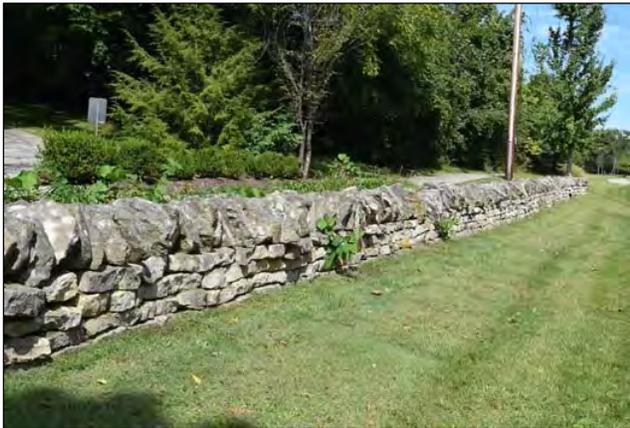
Overview of wall, looking north

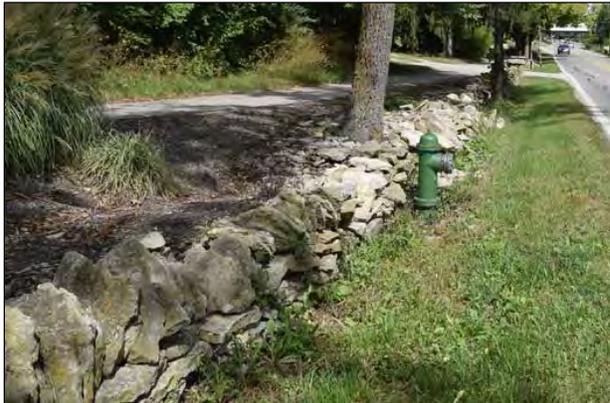
Historical Significance: This wall most likely dates to the pre-1900 period based on smaller stone size, location, and poor condition, and, as such, has historical significance as part of Dublin's agricultural past.

Overview of wall, looking north

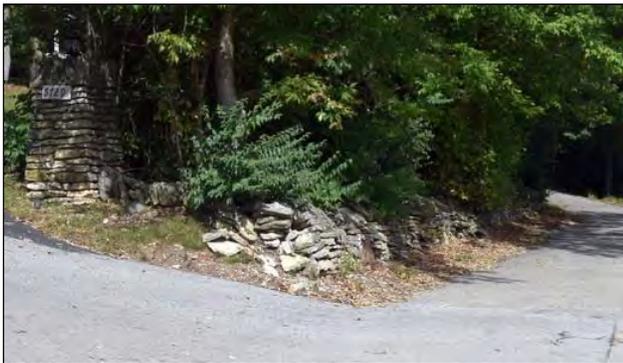
Historical Significance: This wall most likely dates to the pre-1900 period based on location, design and association with two pre-1900 homes, and, as such, has historical significance as part of Dublin's agricultural past.

Overview of wall, looking north

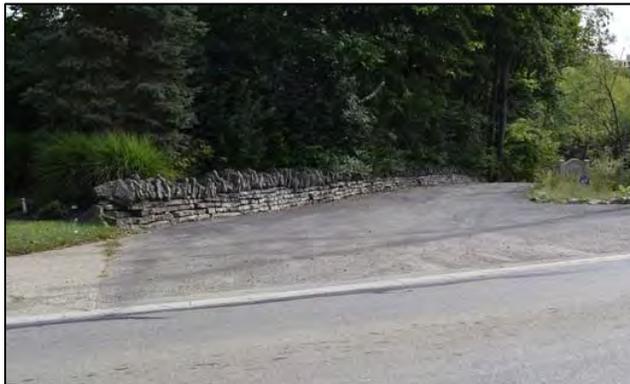
Historical Significance: This wall likely dates to between ca. 1900 and ca. 1970 based on larger stone size, location, and condition, and, as such, has historical significance as part of Dublin’s 20th century suburban growth.

Overview of wall, looking east

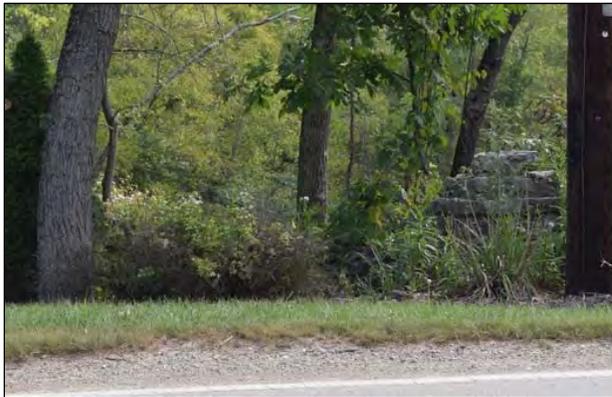
Overview of wall, looking east

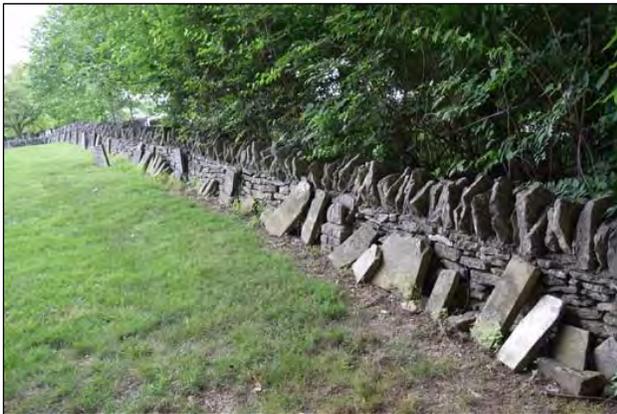
Overview of wall, looking southwest

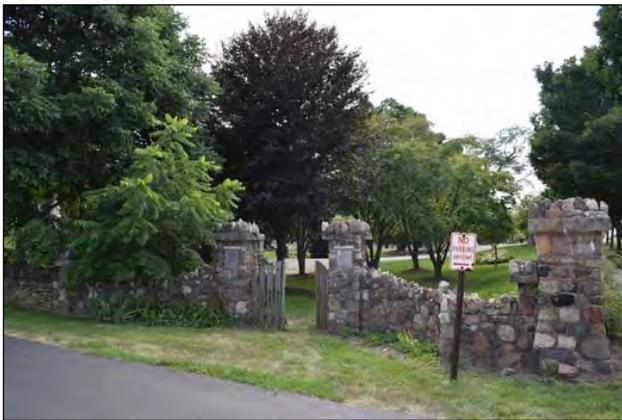
Overview of wall, looking southwest

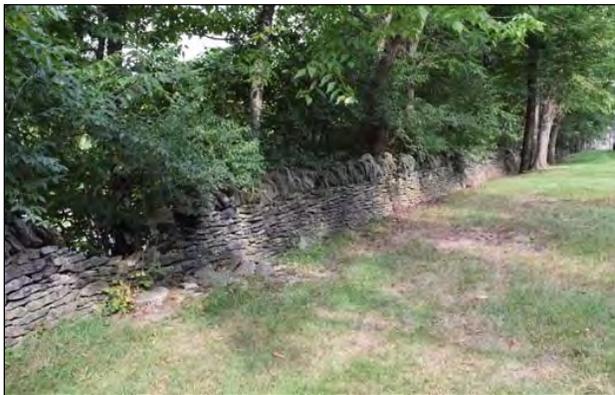
Overview of wall, looking north-northwest

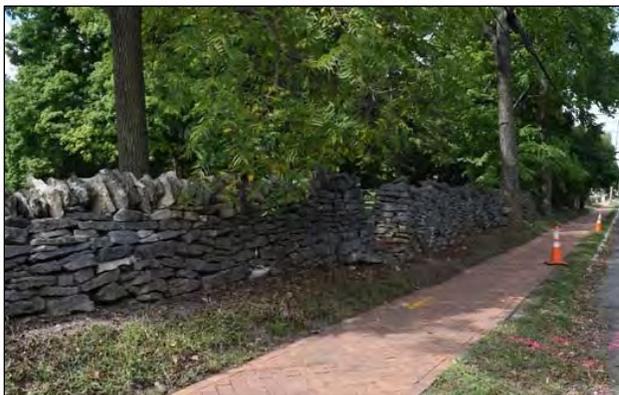
Overview of wall, looking North

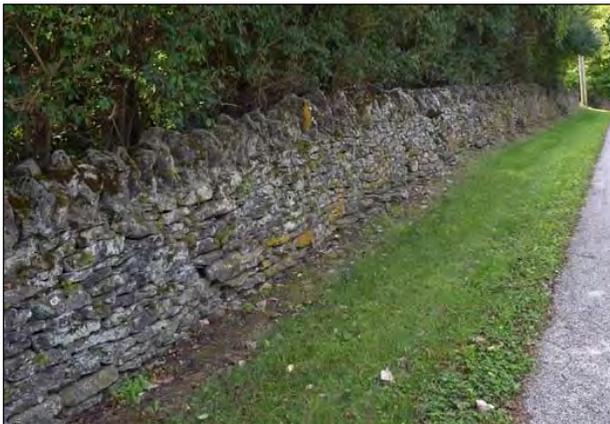
Overview of wall, looking west

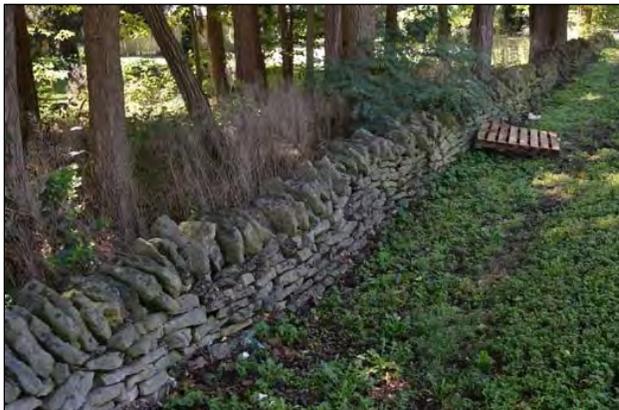
Overview of wall, looking south

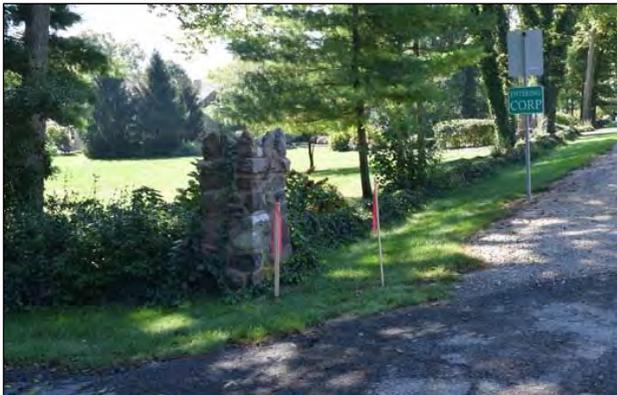
Overview of wall, looking south

Condition: Good, Fair, Deteriorated/Poor, Ruinous, Repaired, Overgrown, Unknown/Private

Integrity Notes: Wall has fair to poor integrity. The location, design, and materials appear to be original to the period of construction but the wall is in poor condition in some sections.

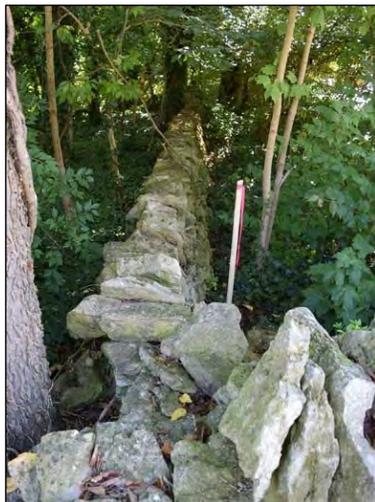
Overview of wall, looking east

Condition: Good, Repaired, Unknown/Private

Integrity Notes: Wall has good to fair integrity. The wall has integrity of location and design but some repairs have been made.

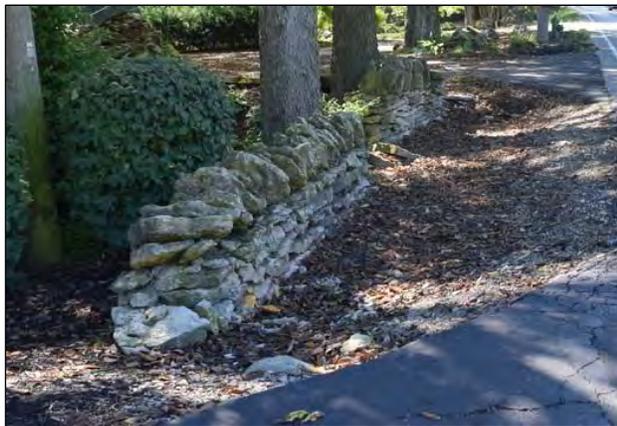
Overview of wall, looking south

Condition: Good

Historical Significance: This wall most likely dates to the ca. 1900 and ca. 1970 based on larger stone size, location, condition, and association with a home built ca. 1955, although it may be on the location of an older wall or be rebuilt in the 1950s. If constructed in the period 1900-ca.1970 then the wall has historical significance as part of Dublin's 20th century suburban growth.

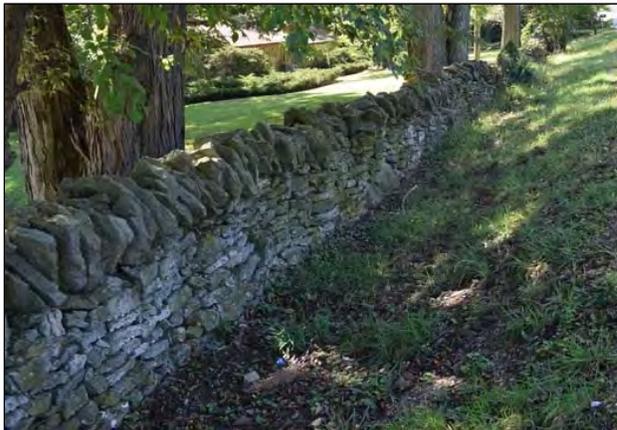
Overview of wall, looking south

Condition: Good, Repaired, Overgrown

Integrity Notes: Wall has good/fair to poor integrity because it appears to be located on the original alignment of a pre-1900 wall but has been repaired and may have been rebuilt at some point in the twentieth century in association with road work and construction of houses.

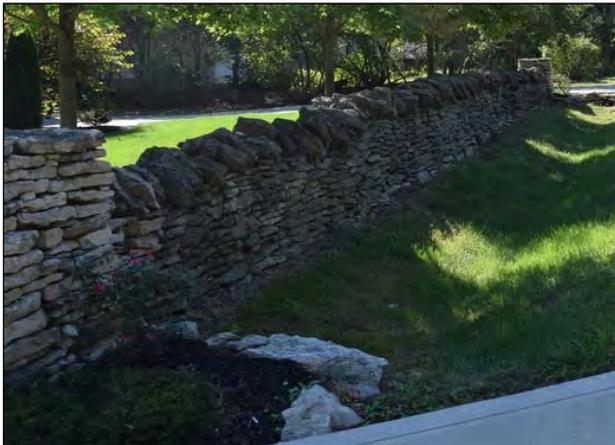
Overview of wall, looking south

Condition: Good, Repaired

Integrity Notes: Wall has good/fair to poor integrity because it appears to be located on the original alignment of a pre-1900 wall but has been repaired and may have been rebuilt at some point in the twentieth century in association with road work and construction of houses.

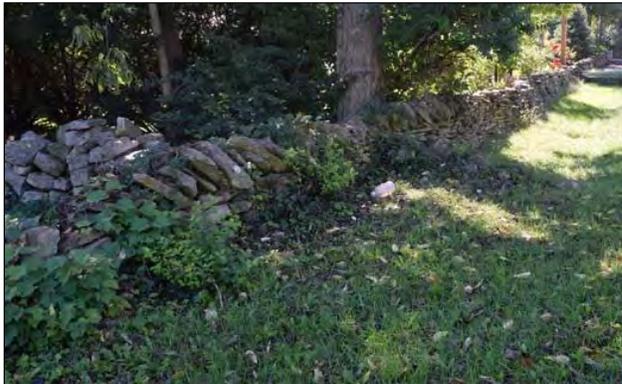
Overview of wall, looking south

Condition: Good, Deteriorated/Poor, Repaired, Overgrown

Integrity Notes: Wall has good/fair to poor integrity because it appears to be located on the original alignment of a pre-1900 wall but has been repaired and may have been rebuilt at some point in the twentieth century in association with road work, utility installation, and construction of houses.

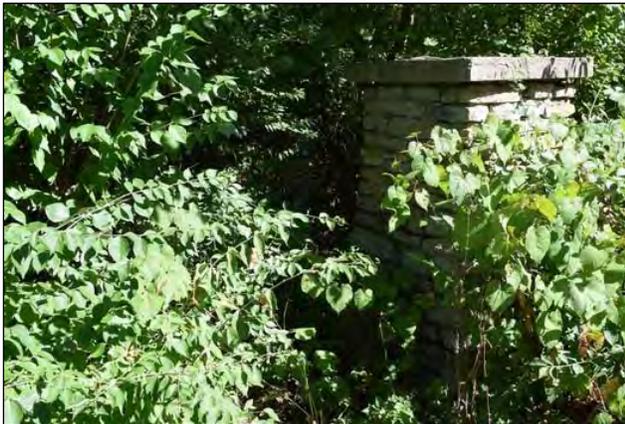
Overview of wall, looking northeast

Condition: Ruinous, Overgrown

Integrity Notes: Wall has poor integrity because of the ruinous condition and probable later addition of the pillar.

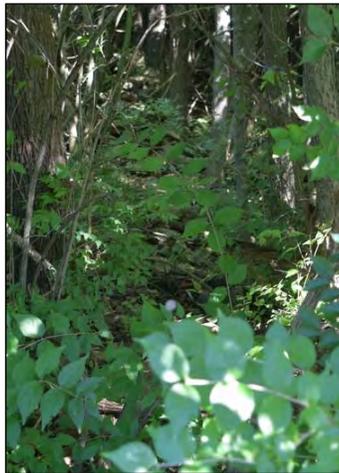
Overview of wall, looking north

Condition: Ruinous, Overgrown

Integrity Notes: Wall has poor integrity because of its ruinous condition.

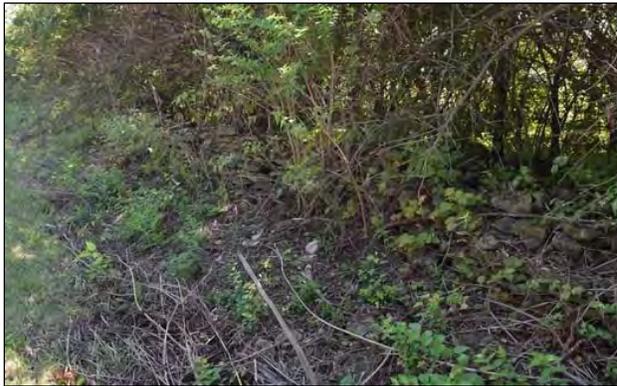
Overview of wall, looking east-southeast

Condition: Ruinous, Overgrown

Integrity Notes: This wall has poor integrity although the materials, and location appear original the condition is ruinous and the setting has been altered.

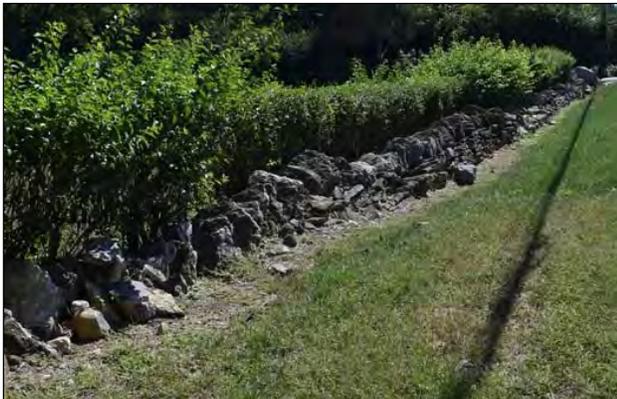
Overview of wall, looking south

Condition: Good, Ruinous

Integrity Notes: Wall has fair to poor integrity. The main body of the wall appears to have integrity of location, design, and materials, but the wall is in poor conditions in certain sections and in others appears to have been altered by construction of twentieth-century homes.

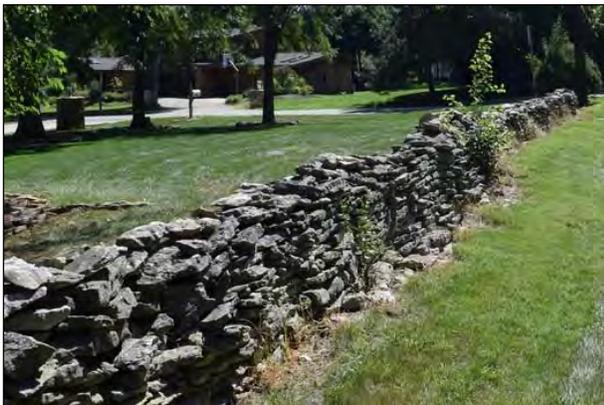
Overview of wall, looking south

Condition: Fair, Deteriorated/Poor, Unknown/Private

Integrity Notes: Wall has fair to poor integrity on the basis of its condition and possible missing top vertical stone course.

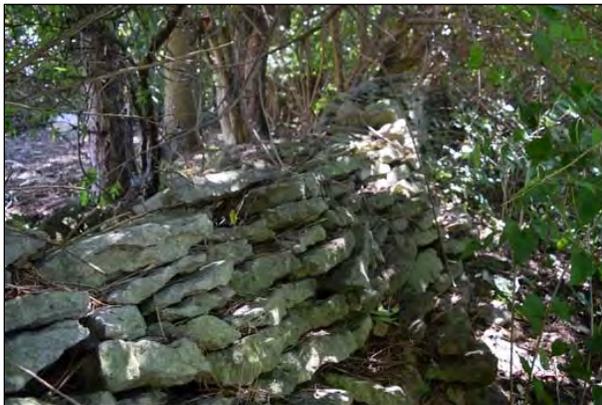
Overview of wall, looking south

Today, the northern terminus of this atypical limestone wall is on the southeastern corner of the intersection of Locust Hill Lane and Dublin Road. The wall ranges in height from 0.5 ft to 2.5 ft, and has been impacted considerably by overgrowth. The wall terminates approximately 200 ft south of the intersection of Monahan Lane and Dublin Road. Based on the construction technique this wall appears to be a traditional dry-laid stone wall that is missing the top vertically set stones.

Condition: Deteriorated/Poor, Ruinous, Overgrown

Integrity Notes: Wall has poor integrity as a result of its condition.

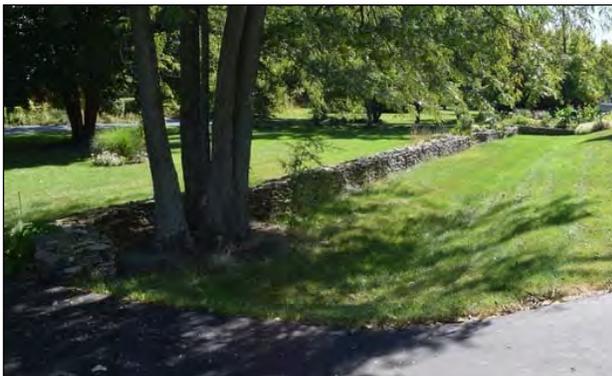
Overview of wall, looking south

Condition: Good, Deteriorated/Poor

Integrity Notes: Wall has good to poor integrity. The wall appears to have integrity of location and design for the periods in which it was built but the older section is deteriorated.

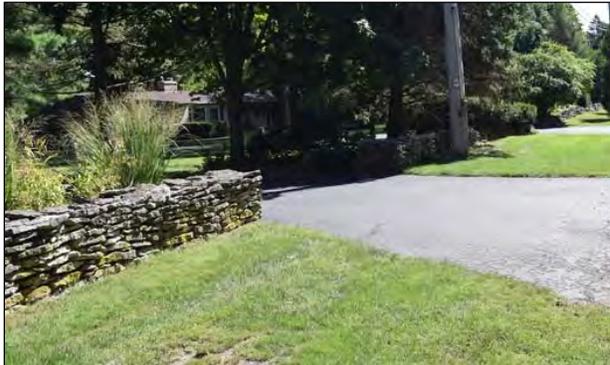
Overview of wall, looking south

Condition: Good, Deteriorated/Poor, Ruinous, Overgrown

Integrity Notes: Wall has good to poor integrity. The wall appears to have integrity of location and design for the periods in which it was built but the older section is deteriorated.

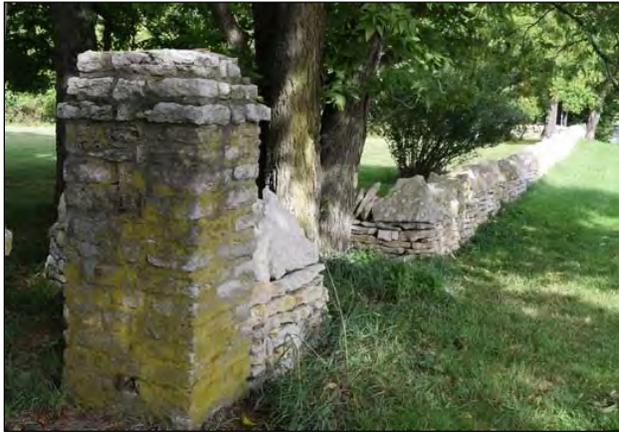
Overview of wall, looking north-northwest

Condition: Good

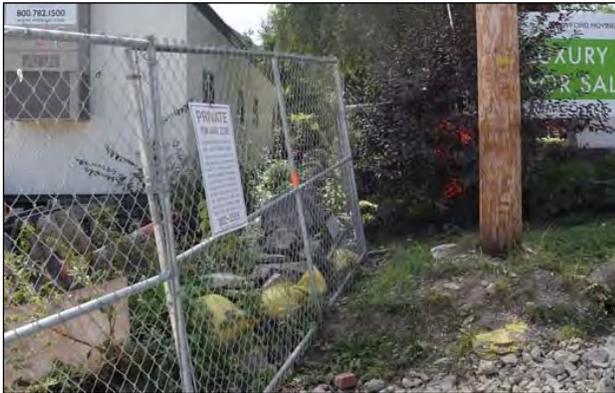
Overview of wall, looking south

Condition: Good

Historical Significance: This wall most likely dates to between ca. 1900 and ca. 1970 based on larger stone size, location, condition, and association with a home built ca. 1930, although it could be on the alignment of an older wall. The wall has historical significance as part of Dublin's 20th century suburban growth.

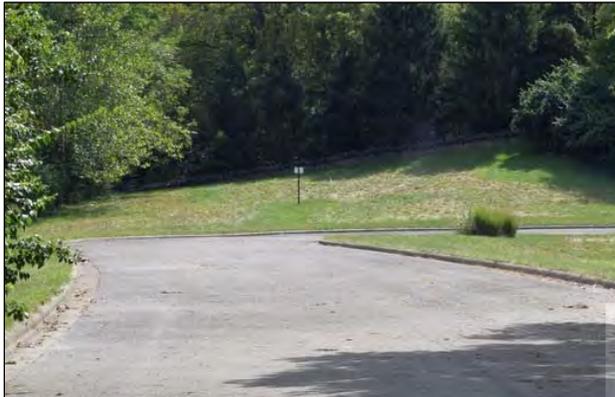
Overview of wall, looking south

Condition: Unknown/Private

Historical Significance: This wall most likely dates to the pre-1900 period based on smaller stone size, location, condition, and association with a ca. 1900 barn, and, as such, has historical significance as part of Dublin's agricultural past.

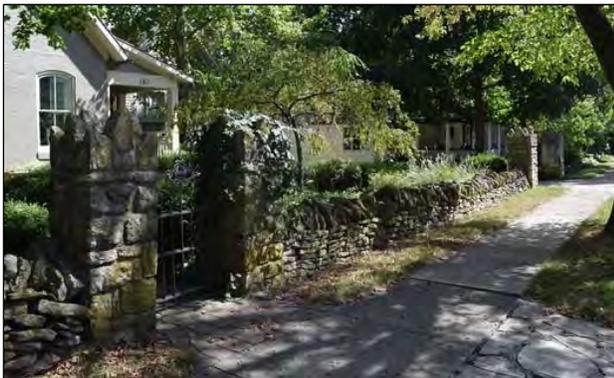
Overview of wall, looking south-southeast

Description / Location / Setting: Wall W065 was located during the 2016 survey. This traditional dry-laid limestone wall begins 210 ft north of the intersection of Waterford Drive and South High Street. The wall, ranging between 1 ft and 2 ft in height, runs parallel with High Street and Wall W031. The wall breaks twice for the walkway and the driveway of 182 South High Street, which are both flanked by sets of mortared limestone pillars with vertical limestone pieces set in the top. The wall continues south until it is broken twice again for the driveway and walkway of 190 South High Street, both of which are flanked by sets of dry-laid limestone pillars. The wall ends east of the intersection of Waterford Drive and South High Street where it shares a common corner with Wall W065A and Wall W066.

Condition: Good

Integrity Notes: Wall has good to fair integrity. The wall has retained integrity of location and design although it may have been repaired with non-original materials.

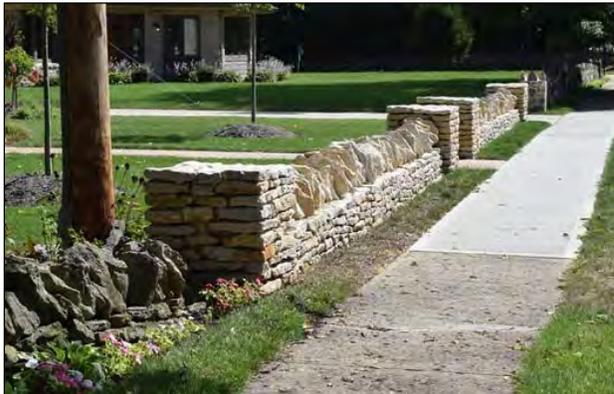
Condition: Good

Overview of wall (new section in foreground, old section at far upper right of photo), looking south-southeast

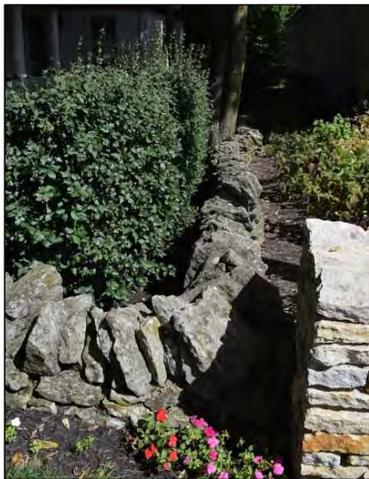
Overview of wall, looking east

Condition: Good, Unknown/Private

Integrity Notes: Wall has good to fair integrity. The wall has retained integrity of location and design although it may have been rebuilt or repaired with non-original materials.

Historical Significance: This wall may have originally dated to the pre-1900 period, but has likely been repaired in the twentieth century. This wall appears to have historical significance as part of Dublin’s agricultural past and as part of Dublin’s 20th century suburban growth.

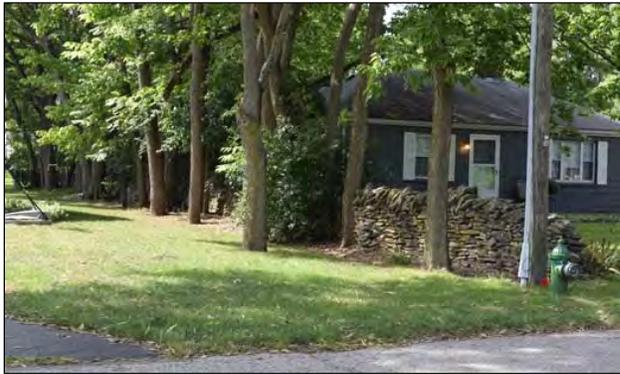
Overview of wall, looking northwest

Condition: Good, Unknown/Private

Integrity Notes: The wall has good to fair integrity. The wall has retained integrity of location and design although it may have been rebuilt or repaired with non-original materials.

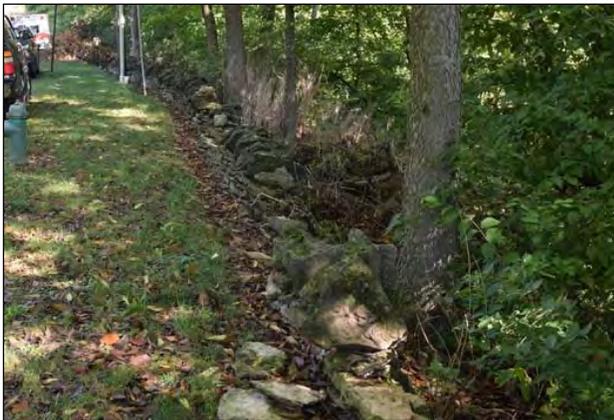
Overview of wall, looking north

Description / Location / Setting: Wall W068 was documented during the 2016 survey. The southern extent of this wall is located 30 ft north of the Bridge Street bridge. The traditional dry-laid limestone wall runs along the east side and parallel to North Riverview Street. The wall varies in height from 0.5 ft to approximately 2 feet and is broken in several places due to deterioration, slumping, and/or drainage. There is also a break for the entrance to 62 North Riverview. The wall terminates east of the intersection of North and Riverview Streets.

Condition: Good, Fair, Deteriorated/Poor, Ruinous

Historical Significance: This wall most likely dates to the pre-1900 period based on smaller stone size, location, and condition, and, as such, has historical significance as part of Dublin's agricultural past. However, it is possible that it also dates to the early part of the 1900s as a result of its association with homes of varying ages.

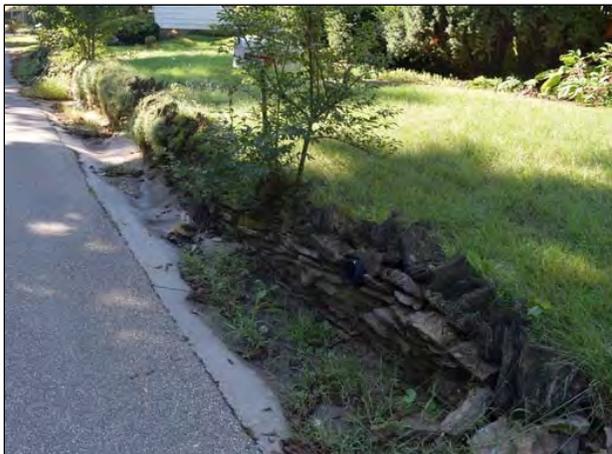
Overview of wall, looking south

Description / Location / Setting: Wall W069 was documented during the 2016 survey. The northern end of this wall begins on the southwest corner of the intersection of North and North Riverview Streets. The 0.5-ft to 2-ft high, traditional dry-laid limestone style wall has concrete block under some portions. The wall is broken for the steps of 53 North Riverview Street and terminates at 45 North Riverview Street, 117 ft north of the intersection of Wing Hill Lane and N Riverview Street.

Condition: Good, Fair, Repaired

Integrity Notes: Wall has fair integrity because it appears to retain integrity of location and design, but has been repaired with some non original materials.

Historical Significance: This wall most likely dates to the pre-1900 period, but has been repaired during the twentieth century, and, as such, may have historical significance as a reflection of Dublin’s original settlement and as part of Dublin’s 20th century suburban growth.

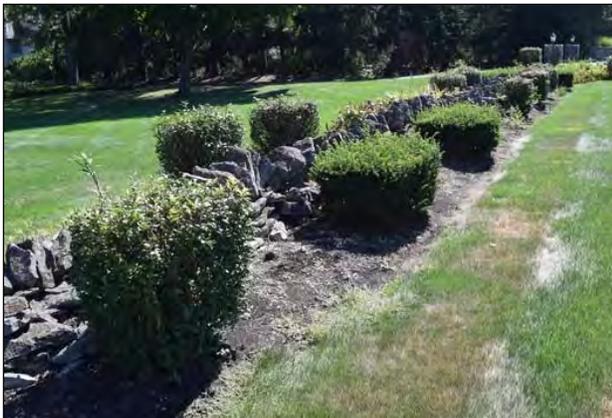
Overview of wall, looking south

Condition: Good

Historical Significance: This wall most likely dates to the pre-1900 period based on condition, but it may have been rebuilt or repaired in the twentieth century, and, as such, may have historical significance as a reflection of Dublin’s agricultural past and as part of Dublin’s 20th century suburban growth.

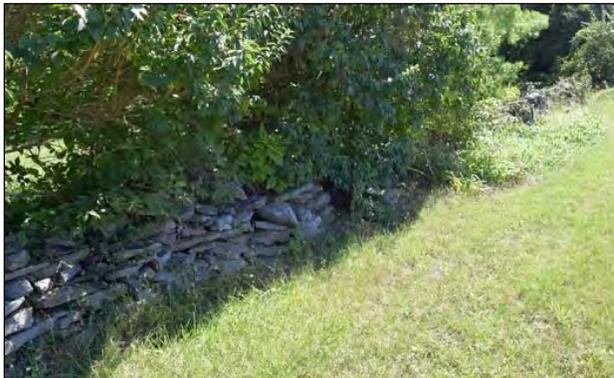
Overview of wall, looking south

Condition: Deteriorated/Poor, Ruinous, Overgrown

Historical Significance: This wall most likely dates to the period between ca. 1900 and ca. 1970 based on larger stone size, atypical design (missing vertical limestone slabs as top course), and association with a home built ca. 1955, and, as such, has historical significance as part of Dublin's 20th century suburban growth.

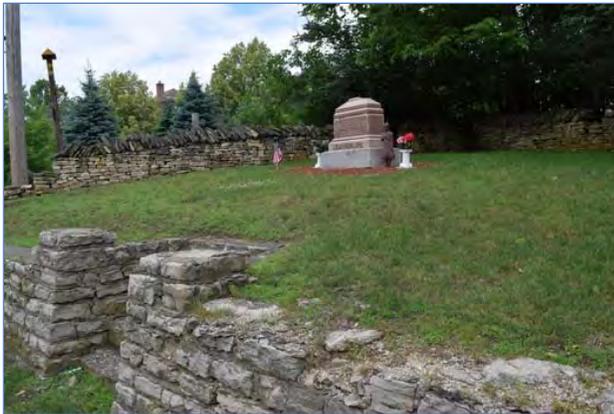
Overview of wall, looking north

Wall Identifier	W072	Map No.	044
Parcel(s)	273008791	Address	Around Leatherlips Memorial, Riverside Dr.
Photo No:	0462-0464 (6/16/16)	Associated Walls:	N/A
Theme:	Agriculture	Historic Use:	Agriculture
Orientation:	North-South and East-West	Wall Length:	200.78 ft / 61.21 m
		Likely period of construction:	Pre-1900 + ca. 1900 – ca. 1970
		Present Use:	Decorative
		Style:	Traditional Dry-Laid; Atypical, Limestone

Condition: Good

Integrity Notes: The wall has good to fair integrity. The location and design appear to be original but some materials may be replacements.

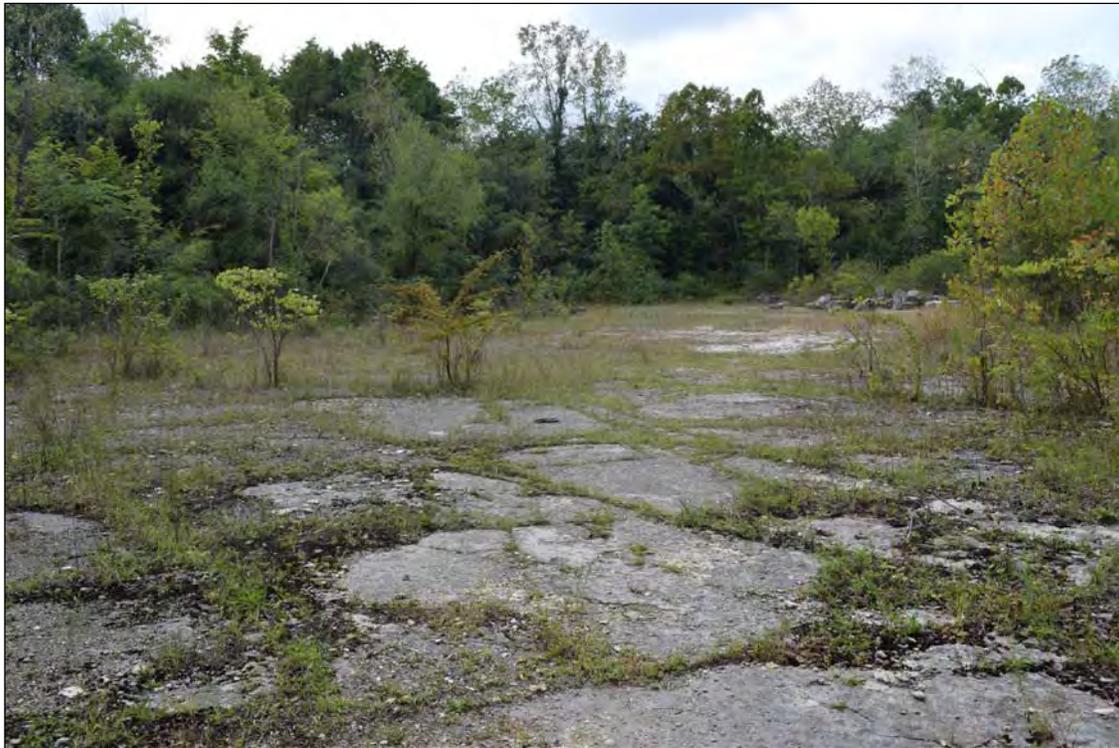
Snouffer Quarry #3, located in Donegal Cliffs Park, was the only quarry that the field team could conclusively verify. A picture of the quarry is shown in Figure 87. Snouffer Quarry #1 is reportedly still extant but located on inaccessible private property. The entrance to the quarry is shown in Figure 88.

Figure 87. Snouffer Quarry #3 at Donegal Cliffs Park, looking west

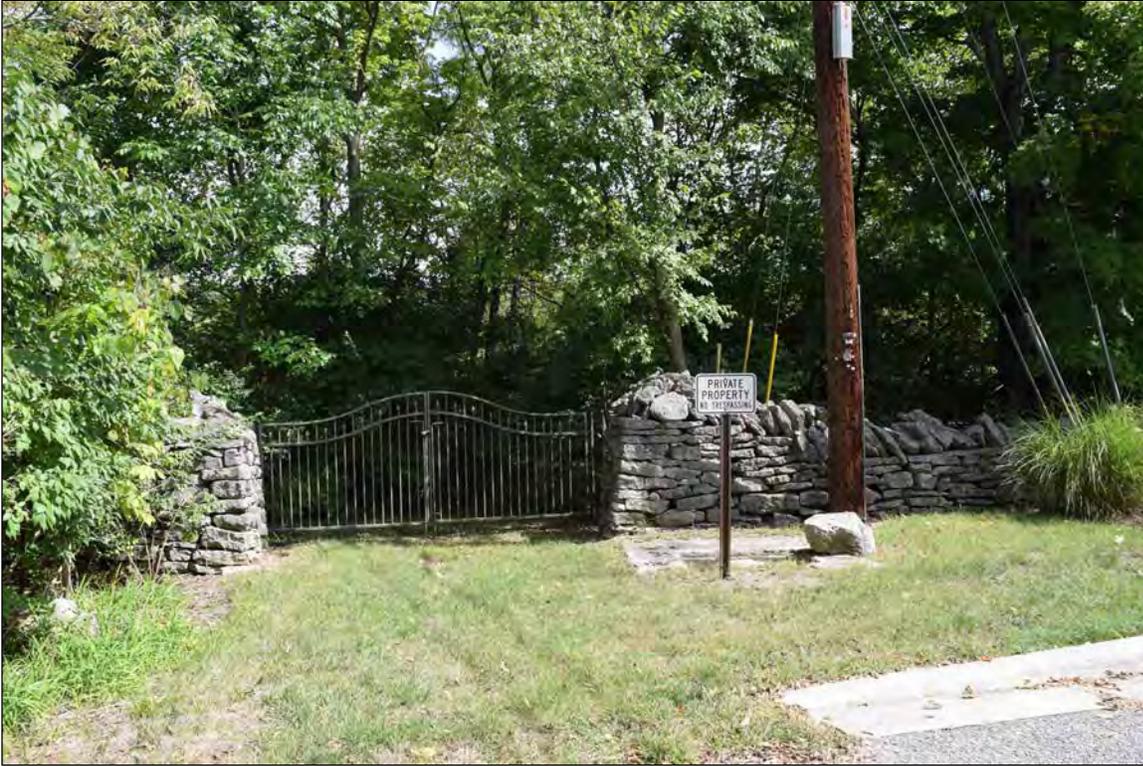
Figure 88. Entrance to Snouffer Quarry #1, looking east

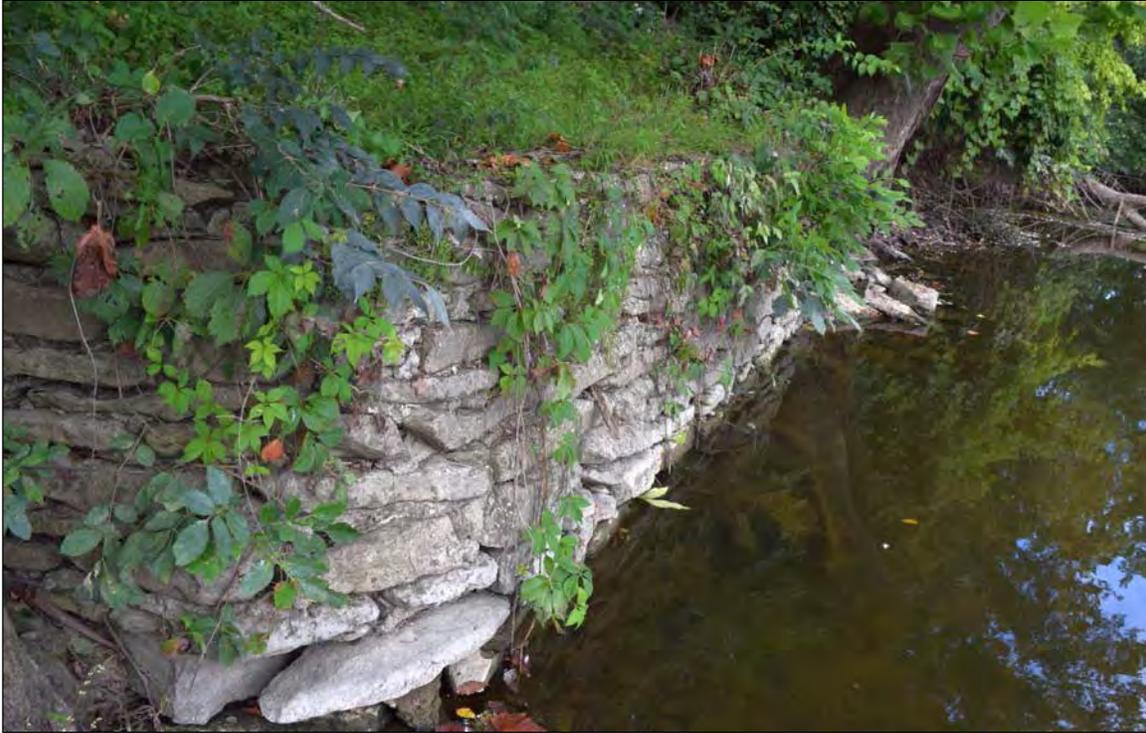
The only mill location that the field team was able to verify is the probable location of the Joseph Corbin Stone Mill, located along the Scioto River near the intersection of Short and Riverview. This mill was reportedly built ca. 1855 and demolished sometime in the 1890s. The adjacent property owners (Mr. Dyas and Mr. Easterday) allowed access to the river bank through their property and indicated the general location of where the mill remnants could be found. The field crew documented a stone wall (possibly a structural foundation) on the edge of the river that may be associated with the Corbin Stone Mill (Figure 89 and Figure 90). A possible mill stone and wood beam, both submerged in the river, were also observed.

Figure 89. Dry-laid stone wall in general vicinity of the Joseph Corbin Stone Mill, looking northwest

Commonwealth recommends that a more complete survey of the potential quarry and mill locations on private property, in conjunction with property owner interviews and a detailed examination of primary sources, is warranted for planning purposes.

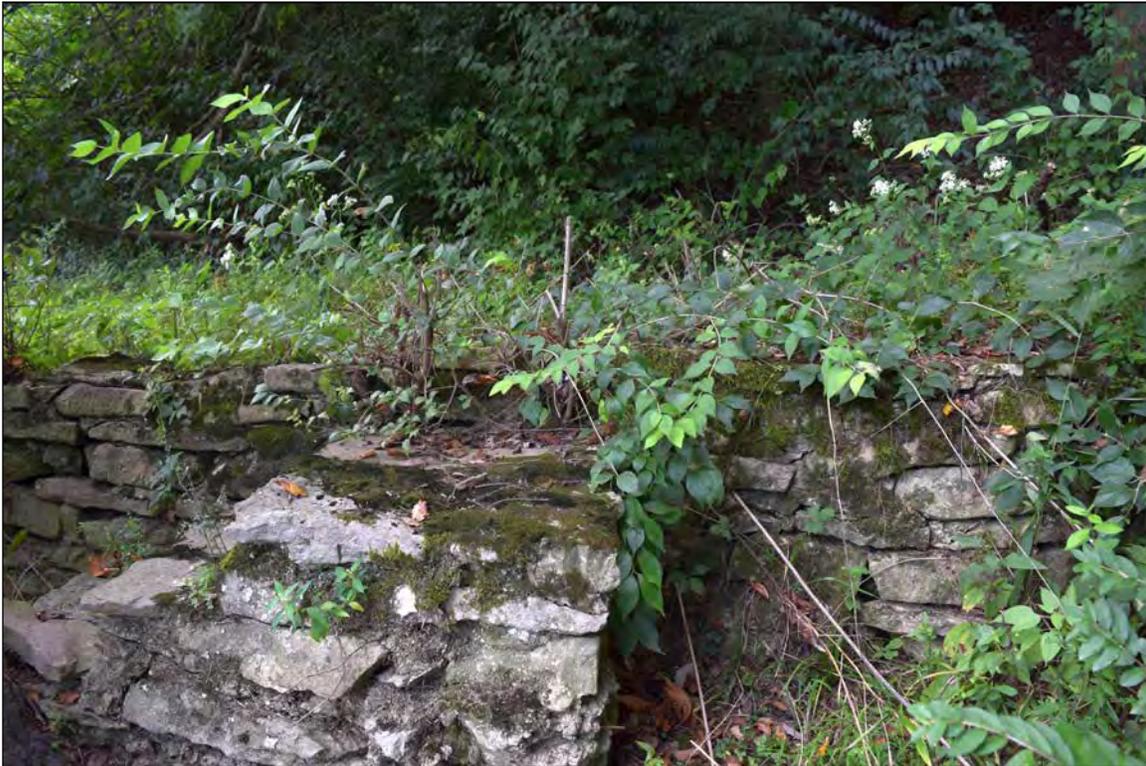
Figure 90. Dry-laid stone wall in general vicinity of the Joseph Corbin Stone Mill, looking south
