MEMO

Date: May 17, 2021

Re: 110-112 S. Riverview Street, First Demolition Review and Second New Construction Review

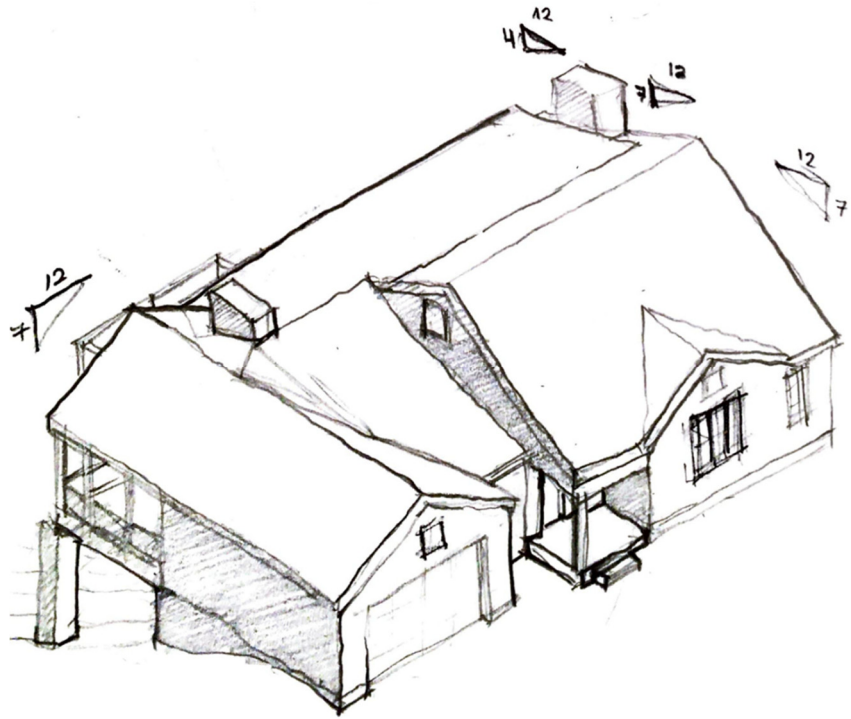
One option to resolve some of the massing and composition issues with the rear of the structure is to view the building as if it grew over time. The main portion of the house could be considered the “original building” while a “hyphen” (the powder room and mud room) connects it to the garage outbuilding. The kitchen, dining and great room areas could be a later “addition.” This alternative massing option separates out an “addition” and a “connector” from the “original” house and garage, thereby containing elements of a “later date.” For example, the “original” house would have older elements, such as having a stone foundation around the entire lower level. Any “addition” to this building could have a later element, such as reducing the stone foundation to allow more horizontal siding on this lower level (see sketches below). The roofline of the whole structure should follow this pattern as well, with the roof of the main building being predominate and the others appearing as shed-roof additions (see sketches below).

Diagrammatic sketch of north and west elevations.

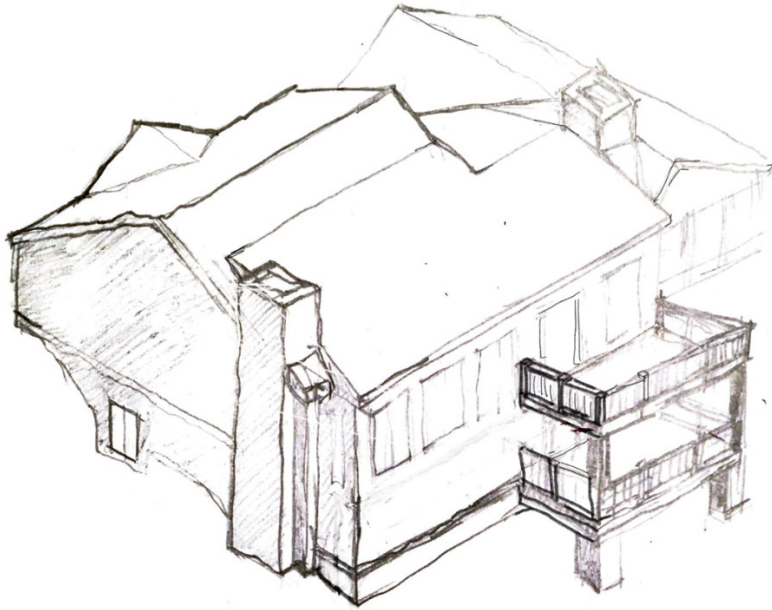
Diagrammatic sketch of south and east elevations. Note the rear “addition” is a separate architectural entity from the “original” house.

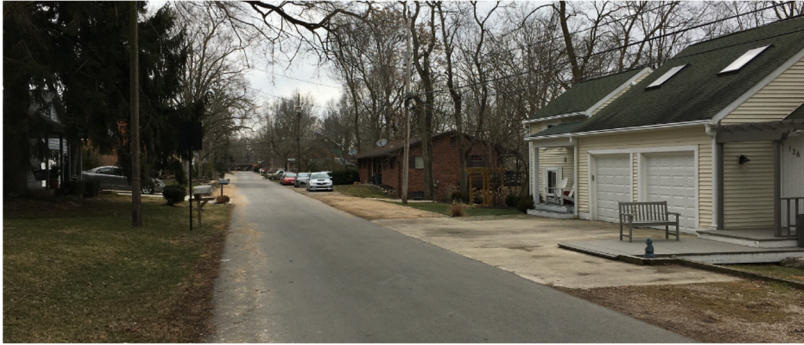
Figure 4. 110-112 S. Riverview Street is located at right of center, looking northward as taken in front of 137 S. Riverview St. (Preservation Designs, March 2021)

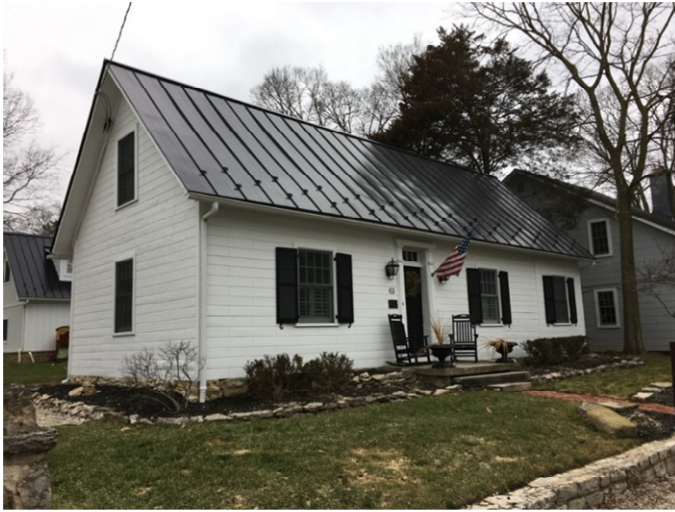
Figure 7. 63 S Riverview St. This house is an example of a one-and-a-half house. Note the horizontal siding and sash windows. (Preservation Designs, March 2021)

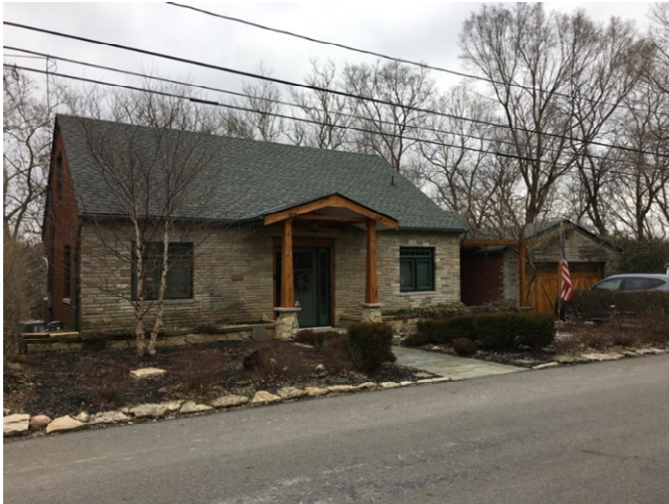
Figure 8. 84 S Riverview St. This house is another example of a one-and-a-half-story dwelling. Note the front-loaded garage is set slightly back from the main house and is separate from the main house. (Preservation Designs, March 2021)

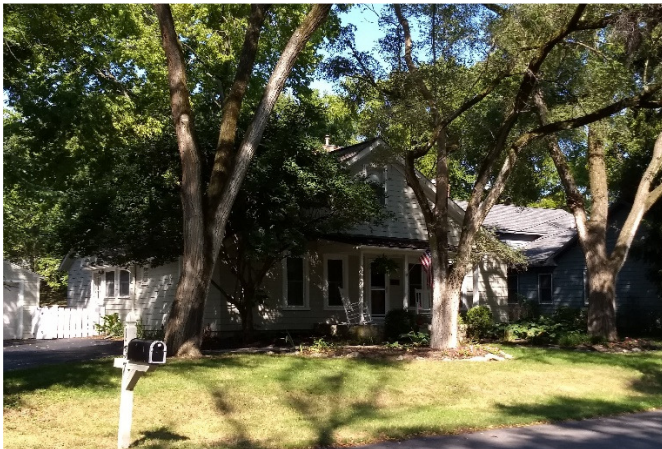
Figure 9. 137 S. Riverview St. Like 84 S. Riverview, this is another example of a one-and-a-half-story dwelling with a detached garage set back from the main house. Note the sash windows.
