Memo

Re: Community Development Committee Recommendations - Maintenance of Historically Significant Stone Walls

Stone Wall Inventory

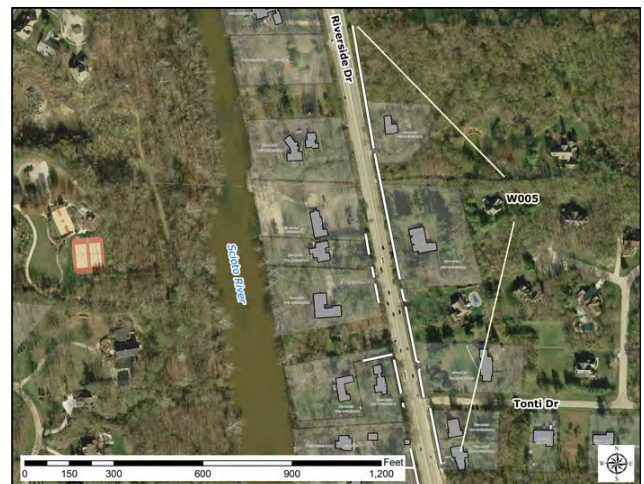
Overview of wall, looking north-northeast

Condition: Good, Fair, Overgrown

Integrity Notes: Wall has fair integrity. The location and design is similar to the older stone walls, but the wall may have been repaired or rebuilt during the twentieth century.

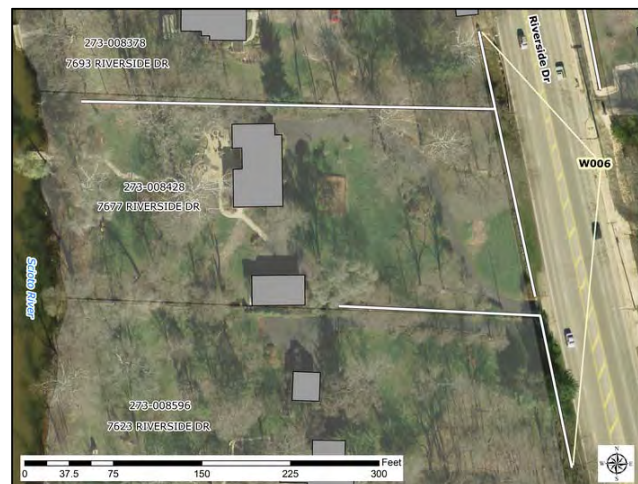
Overview of wall, looking northwest

Today, this traditional dry-laid limestone wall is located on the west side of Riverside Drive and runs parallel to Riverside Drive. The wall starts west of the Riverside Drive/ Hard Road intersection and runs south for 129 ft where it is broken by the driveway for 7675 Riverside Drive. It continues southward an additional 77 ft where it terminates with dual limestone mortared pillars delineating the parcels and the terminus of Wall 009. The wall varies between 1 and 2 ft in height.

Condition: Good, Fair, Overgrown

Integrity Notes: Wall has fair integrity. The location and design are similar to the older stone walls, but the wall may have been repaired with non-original materials.

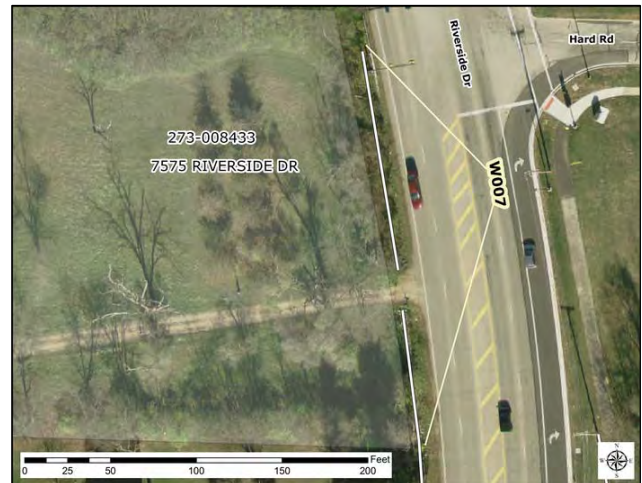
Overview of wall, looking north

Condition: Good

Historical Significance: This wall may have been moved back from the road edge when the new drainage features were installed. This wall appears to be a later twentieth reconstruction along the same alignment as a former historical wall using older materials. Although the wall has no historical significance it reflects a distinctive feature of the Dublin landscape.

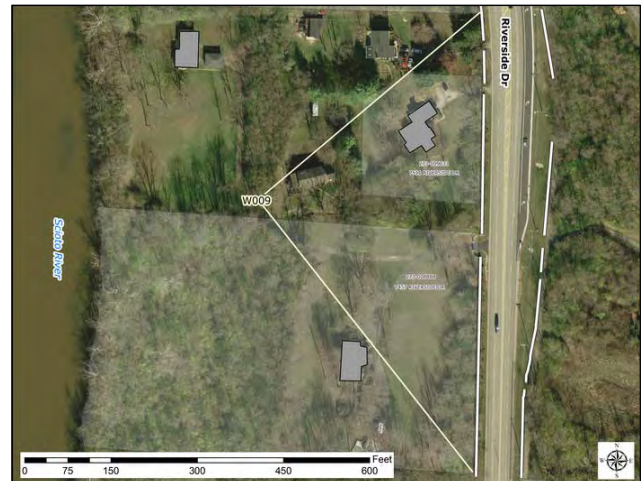
Overview of wall, looking north-northwest

Today, this wall is located on the west side of Riverside Drive and runs parallel to Riverside Drive with three perpendicular spurs running west. The northernmost corner is located on the southwest corner of the Riverside Drive and Orchard Crest Court intersection and is marked by a large boulder. From this corner, the wall travels both west and south. The western spur is a traditional dry-laid wall approximately 2 ft in height. It runs along the southern side of Orchard Crest Court for 40 ft, is broken by the driveway for 3961 Orchard Crest, runs west for an additional 153 ft, then turns south onto River Knolls Pl for 25 ft. The southern spur varies in height between 2 and 3 ft. The wall runs south for 114 ft where a western spur of unknown length delineates parcel boundaries. From this junction, the wall exhibits signs of having been repaired and continues south for approximately 168 ft to a square limestone pillar. This pillar delineates two different construction time periods. The wall is broken by the driveway for 7195 Riverside Drive which is embellished with an iron gate and flanked by two limestone pillars topped by light-fixtures. Just south of this driveway stands a mortared limestone pillar topped with a three-tiered stepped stone cap, which delineates two different construction types—the vertical limestone top includes concrete south of this pillar. The wall continues south, broken by the driveway for 7125 Riverside Drive, until the north side of 7049 Riverside Drive where a second three-tiered stepped stone capped pillar delineates a western spur. This final spur lines the north side of the driveway for an indeterminate distance.

Condition: Good, Repaired**Integrity Notes:** Wall has/fair to poor integrity. Portions of the wall appear to have been moved back from the road and repaired with concrete.**Historical Significance:** Portions of this wall likely date to the pre-1900 period while others probably date to the period between 1900 and 1970. Thus, the wall has historical significance as part of Dublin's agricultural past and significance as part of Dublin's 20th century suburban growth.**District:** No**Distinctive Feature:** Yes**National Register:** Washington Township MRA**Associated OHI:** FRA-8853-2; FRA-8851-2

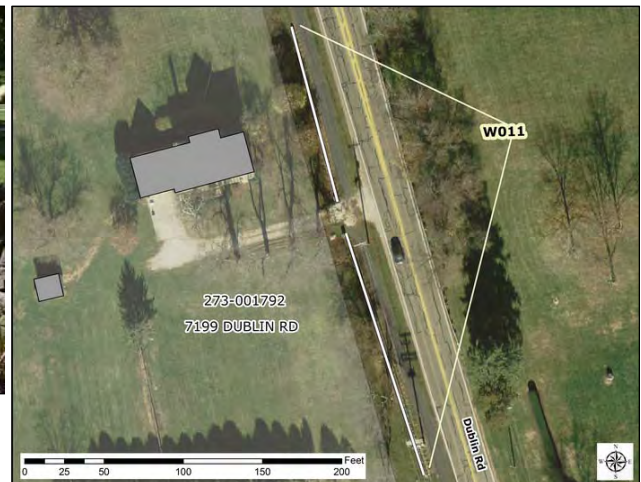
Overview of wall, looking south

Condition: Good, Repaired / Rebuilt

Historical Significance: The wall originally located in at this site may have once dated to the pre-1900 period but the current wall is likely modern, having been rebuilt when the subdivision was built and/or when the paved walking path was installed. This wall is a recent reconstruction along the same alignment as a former historical wall and although it has no historical significance it is a distinctive feature of the Dublin landscape.

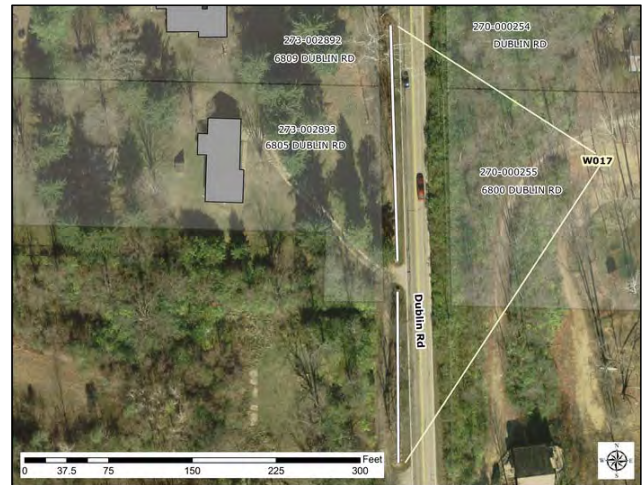
Overview of wall, looking north

Condition: Fair, Deteriorated/Poor, Repaired

Integrity Notes: This wall has poor integrity because it has been repaired with replacement materials and some sections are deteriorated.

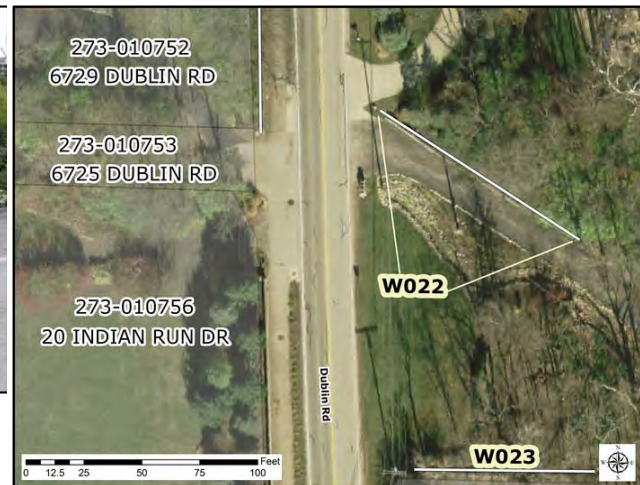
Overview of wall, looking east

Condition: Unknown/Private

Historical Significance: The visible portion of this wall likely dates to between ca. 1900 and ca. 1970 based on larger stone size, location, repairs, and association with a home built ca. 1953, and, as such, has historical significance as part of Dublin's 20th century suburban growth. It is possible the sections of the wall that could not be seen date to the pre-1900 period.

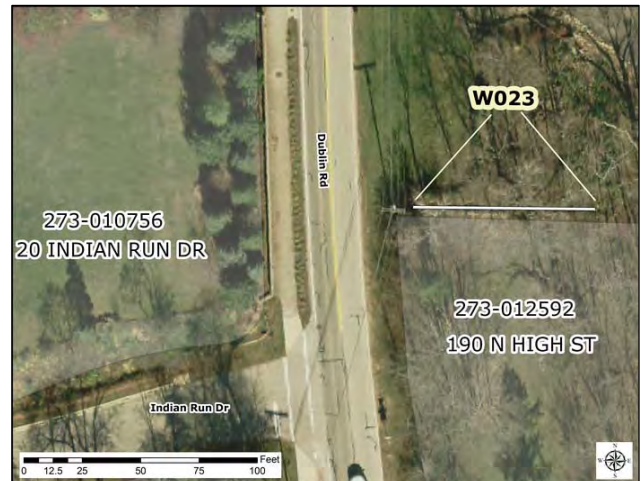
Overview of wall, looking east

Condition: Good, Repaired

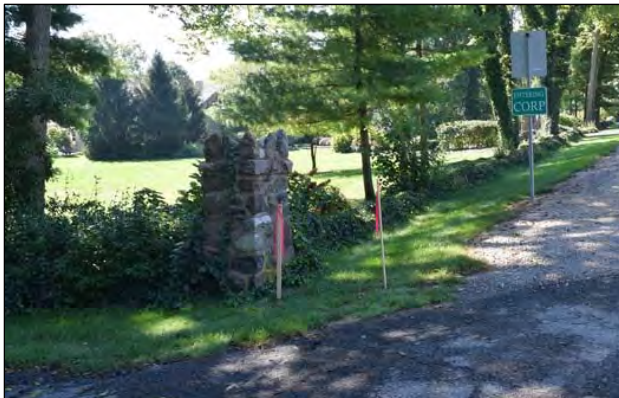
Today, this 1-ft to 3-ft high limestone wall varies in style and condition. It runs parallel to W033 along the driveway for 6036 Dublin Road—the eastern wall was not relocated. There is a break for the northern driveway of 6028 Dublin Road, which is flanked by two atypical mortared granite cobble pillars. Another atypical pillar, paired with the one described with W033 flanking the driveway for 6036 Dublin Road, is at the corner of the property. The wall then runs southwest parallel to Dublin Road and is broken again by the southern driveway for 6028 Dublin Road, which is also flanked by atypical pillars. There is another atypical pillar 134 ft south of this driveway where the wall jogs and changes style. The wall terminates approximately 165 ft south of the intersection of Grandview Drive and Dublin Road where it intersects W037.

Condition: Good, Fair, Deteriorated/Poor, Ruinous, Repaired, Overgrown, Unknown/Private

Integrity Notes: Wall has fair to poor integrity. The location, design, and materials appear to be original to the period of construction but the wall is in poor condition in some sections.

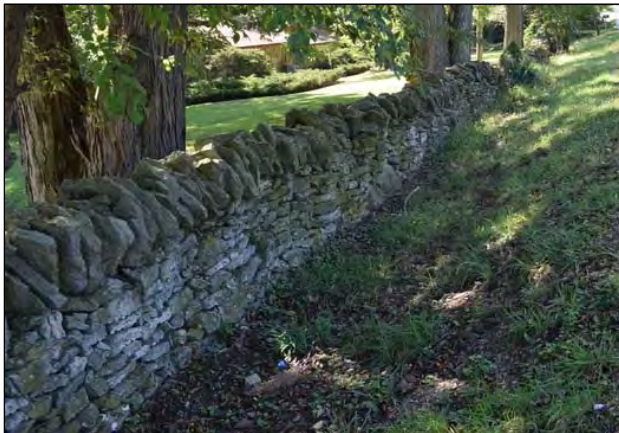
Condition: Good, Repaired, Overgrown

Integrity Notes: Wall has good/fair to poor integrity because it appears to be located on the original alignment of a pre-1900 wall but has been repaired and may have been rebuilt at some point in the twentieth century in association with road work and construction of houses.

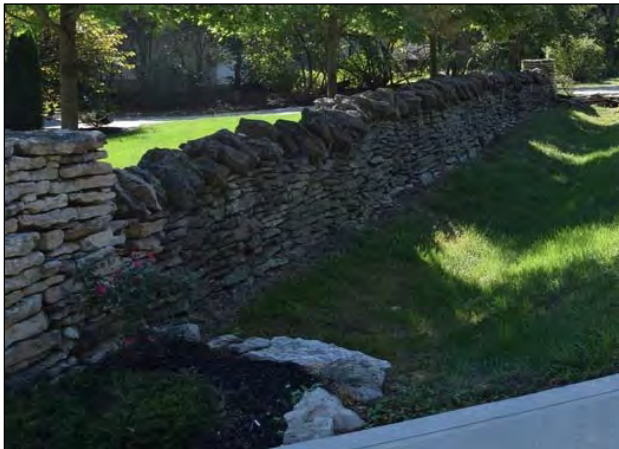
Condition: Good, Repaired

Integrity Notes: Wall has good/fair to poor integrity because it appears to be located on the original alignment of a pre-1900 wall but has been repaired and may have been rebuilt at some point in the twentieth century in association with road work and construction of houses.

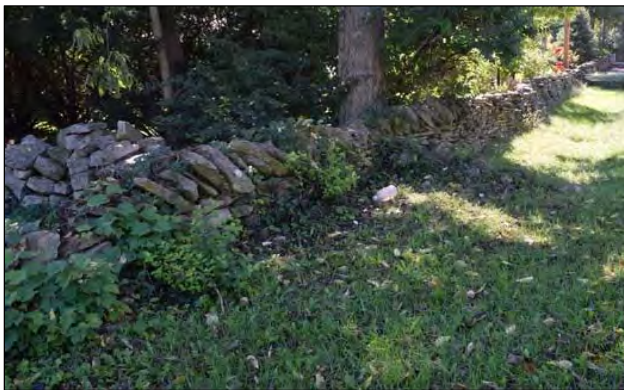
Condition: Good, Deteriorated/Poor, Repaired, Overgrown

Integrity Notes: Wall has good/fair to poor integrity because it appears to be located on the original alignment of a pre-1900 wall but has been repaired and may have been rebuilt at some point in the twentieth century in association with road work, utility installation, and construction of houses.

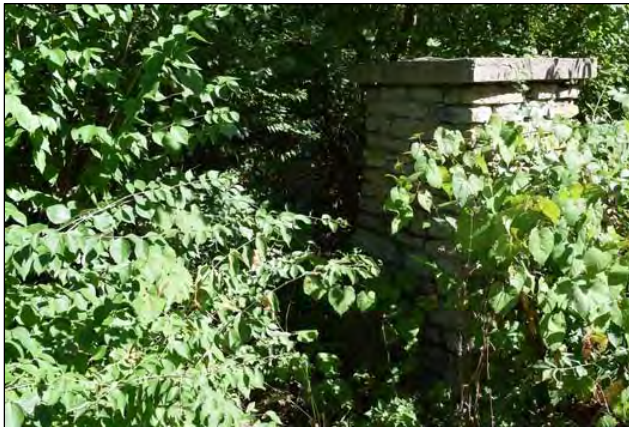
Condition: Ruinous, Overgrown**Integrity Notes:** Wall has poor integrity because of the ruinous condition and probable later addition of the pillar.

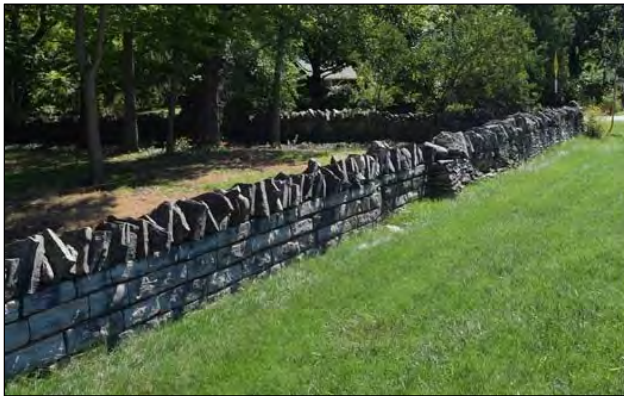
Condition: Good, Repaired, Unknown/Private**Integrity Notes:** Wall has poor integrity. The wall appears to have been rebuilt with machine-cut limestone blocks.

Historical Significance: This wall may be in the location of an earlier stone wall dating to the pre-1900 period but the non-traditional materials used to rebuild the body of the wall along with its association with a later home suggests a post-1900 date for the current wall. Because of the lack of integrity the wall has no historical significance, but it does mimic a distinctive feature of the Dublin landscape.

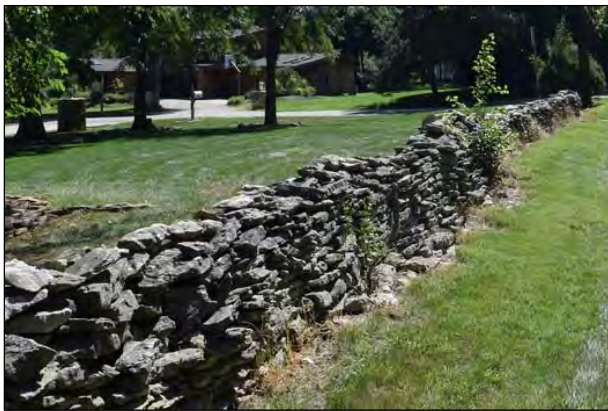
Condition: Fair, Deteriorated/Poor, Unknown/Private**Integrity Notes:** Wall has fair to poor integrity on the basis of its condition and possible missing top vertical stone course.

Historical Significance: This wall may date to the pre-1900 or 1900-ca. 1970 period. The lack of a top course or coping may have been intentional or the result of deterioration. The wall likely has historical significance to Dublin's agricultural past and Dublin's 20th century suburban growth.

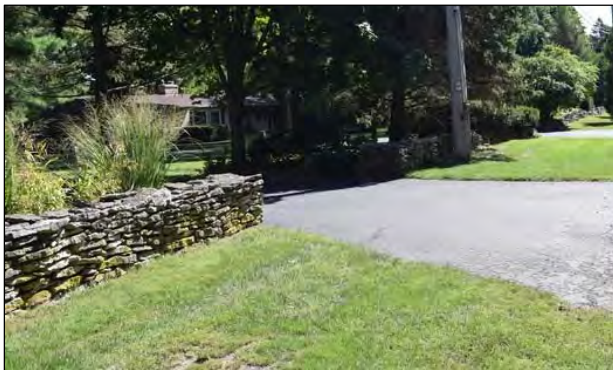
Today, the southern terminus of this atypical limestone wall is located north of the driveway for 5940 Dublin Road approximately 215 ft due north of the intersection of Hayden Run and Frantz Roads. The 0.5-ft to 2-ft high wall runs north along the former route of Dublin Road and varies in condition. The wall breaks without embellishment at the driveways for 4960, 4980, 5000, and 5020 Dublin Road and for a decorative split rail fence at the parcel boundary of 5020 Dublin, before ending 546 ft south of the intersection of Thornhill Drive and Dublin Road.

Condition: Good, Deteriorated/Poor, Ruinous, Overgrown

Integrity Notes: Wall has good to poor integrity. The wall appears to have integrity of location and design for the periods in which it was built but the older section is deteriorated.

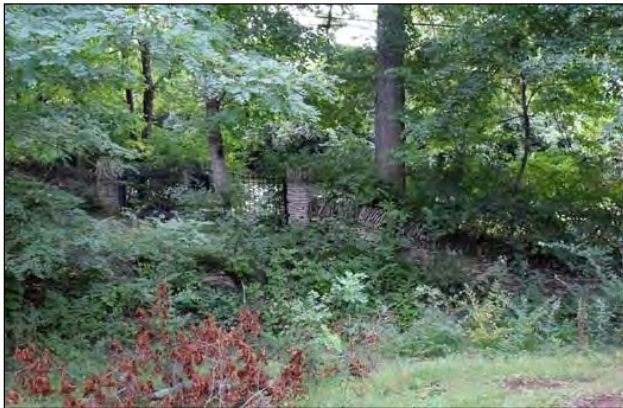
Condition: Good, Overgrown

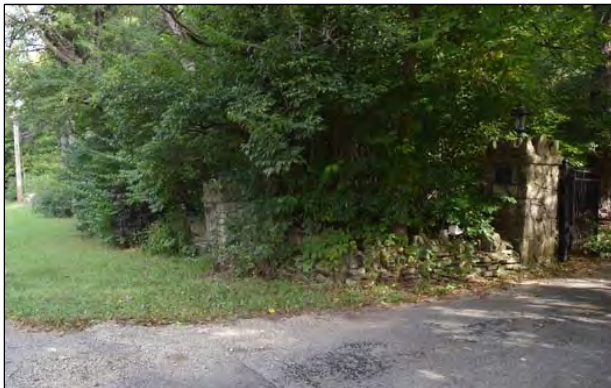
Condition: Good, Overgrown

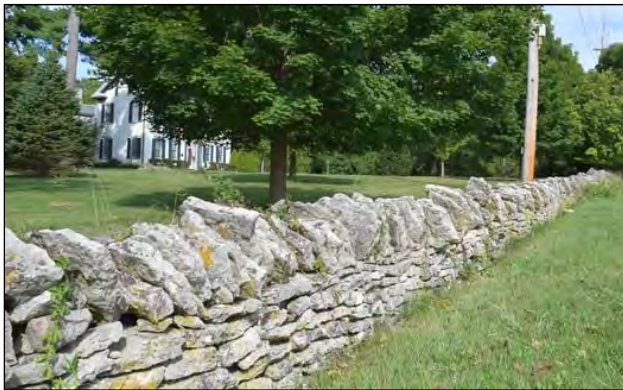
Condition: Good, Repaired

Integrity Notes: Wall has fair integrity. The wall appears to be in its original location and have integrity of design although it has been repaired or strengthened with non-original materials.

Historical Significance: This wall most likely dates to the pre-1900 period based on smaller stone size, location, condition, and association with a home built in 1855, and, as such, has historical significance as part of Dublin's agricultural past. However some portions of this wall appear to have been repaired during the twentieth century.

Overview of wall, looking north

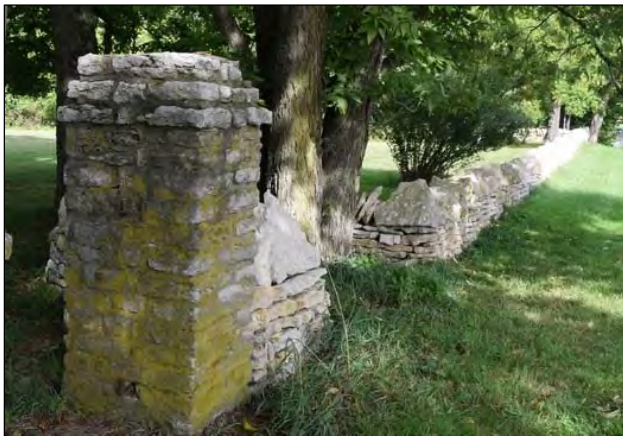
Condition: Good**Integrity Notes:** None; this is a recently built wall.

Historical Significance: This wall is a recent reconstruction along the same alignment as a former historical wall associated with an 1855 house and, although it has no historical significance, it mimics a distinctive feature of the Dublin landscape.

Overview of wall, looking north-northwest

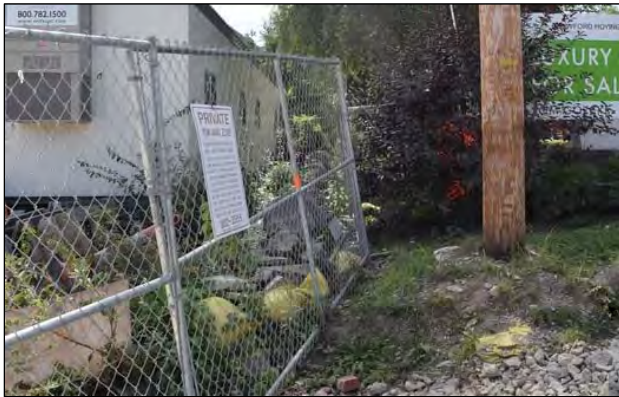
Condition: Good

Historical Significance: This wall most likely dates to between ca. 1900 and ca. 1970 based on larger stone size, location, condition, and association with a home built ca. 1930, although it could be on the alignment of an older wall. The wall has historical significance as part of Dublin's 20th century suburban growth.

Overview of wall, looking south

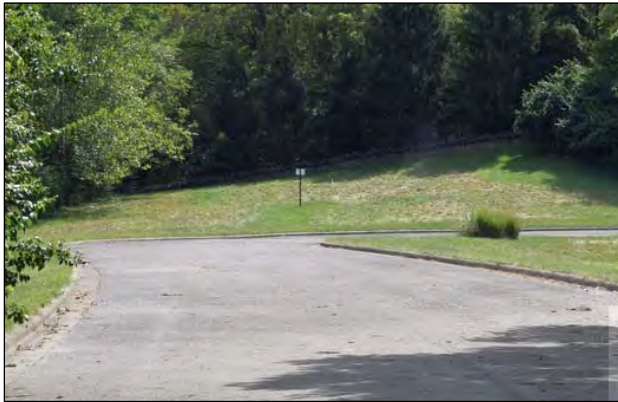
Condition: Unknown/Private**Integrity Notes:** The wall appears to have at least fair to good integrity, but was not able to be fully assessed.

Historical Significance: This wall most likely dates to the pre-1900 period based on smaller stone size, location, condition, and association with a ca. 1900 barn, and, as such, has historical significance as part of Dublin's agricultural past.

Overview of wall, looking south

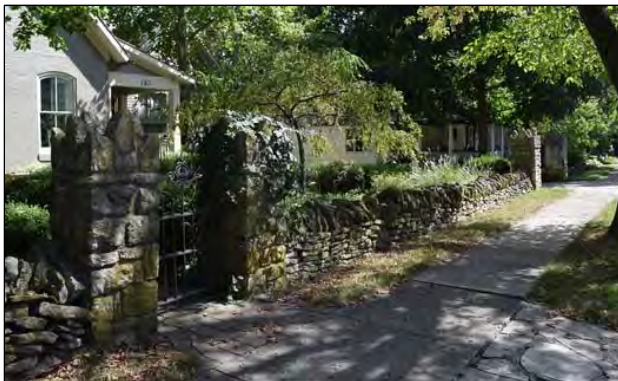
Condition: Good

Integrity Notes: Wall has good to fair integrity. The wall has retained integrity of location and design although it may have been repaired with non-original materials.

Overview of wall, looking south-southeast

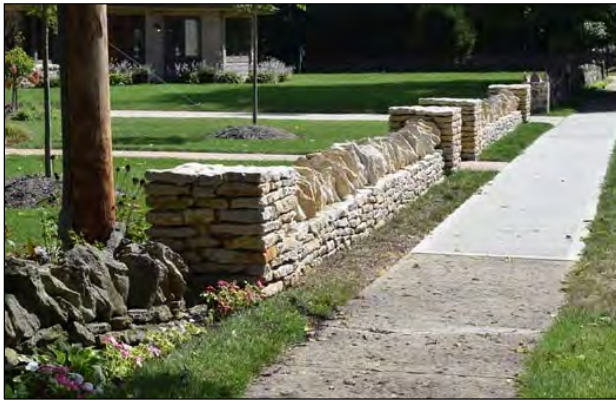
Condition: Good**Integrity Notes:** The older section of wall has good integrity while the new section of wall has poor integrity.

Historical Significance: The older portion of this wall likely dates to the pre-1900 period, and as such, has historical significance as part of Dublin's agricultural past. The new section of wall is a recent reconstruction along the same alignment as a former historical wall and although it has no historical significance, it reflects a distinctive character defining feature of the Dublin landscape.

Overview of wall (new section in foreground, old section at far upper right of photo), looking south-southeast

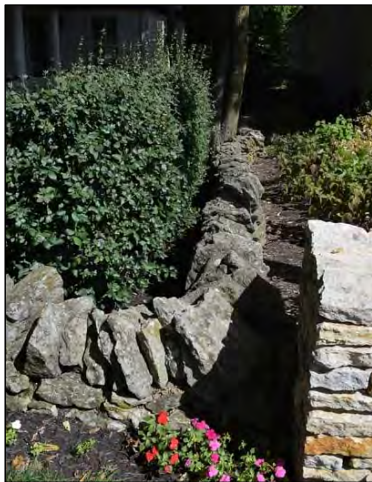
Condition: Good, Unknown/Private

Integrity Notes: Wall has good to fair integrity. The wall has retained integrity of location and design although it may have been rebuilt or repaired with non-original materials.

Historical Significance: This wall may have originally dated to the pre-1900 period, but has likely been repaired in the twentieth century. This wall appears to have historical significance as part of Dublin's agricultural past and as part of Dublin's 20th century suburban growth.

Overview of wall, looking east

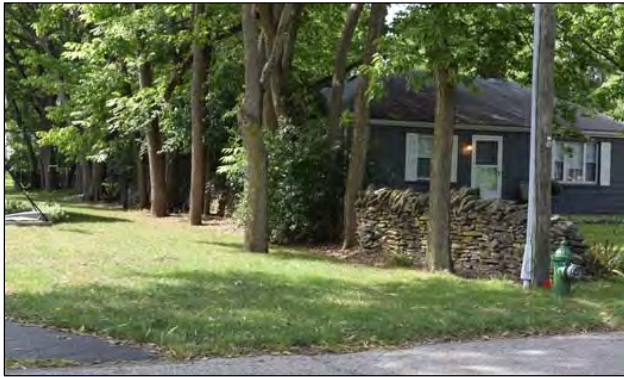
Condition: Good, Unknown/Private

Integrity Notes: The wall has good to fair integrity. The wall has retained integrity of location and design although it may have been rebuilt or repaired with non-original materials.

Historical Significance: This wall could date to either the pre-1900 or the post-1900 period based on location, condition, and association with homes of varying ages, and as such has historical significance as a reflection of Dublin's agricultural past and as part of Dublin's 20th century suburban growth.

Overview of wall, looking northwest

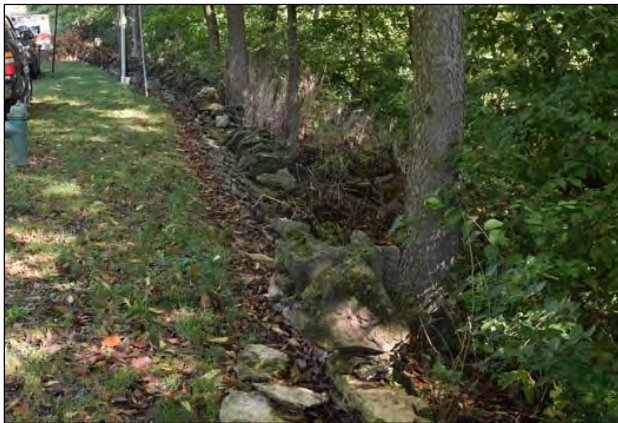
Condition: Good, Fair, Deteriorated/Poor, Ruinous

Historical Significance: This wall most likely dates to the pre-1900 period based on smaller stone size, location, and condition, and, as such, has historical significance as part of Dublin's agricultural past. However, it is possible that it also dates to the early part of the 1900s as a result of its association with homes of varying ages.

Overview of wall, looking north

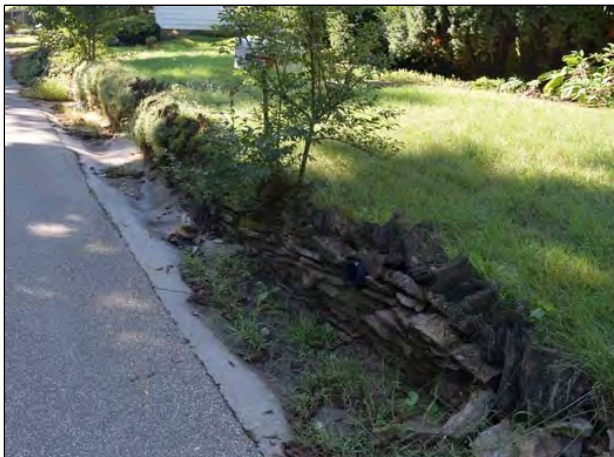
Condition: Good, Fair, Repaired

Integrity Notes: Wall has fair integrity because it appears to retain integrity of location and design, but has been repaired with some non original materials.

Historical Significance: This wall most likely dates to the pre-1900 period, but has been repaired during the twentieth century, and, as such, may have historical significance as a reflection of Dublin's original settlement and as part of Dublin's 20th century suburban growth.

Overview of wall, looking south

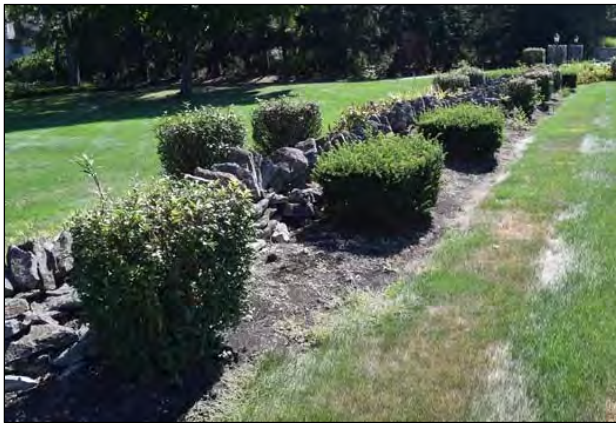
Condition: Good

Historical Significance: This wall most likely dates to the pre-1900 period based on condition, but it may have been rebuilt or repaired in the twentieth century, and, as such, may have historical significance as a reflection of Dublin's agricultural past and as part of Dublin's 20th century suburban growth.

Overview of wall, looking south

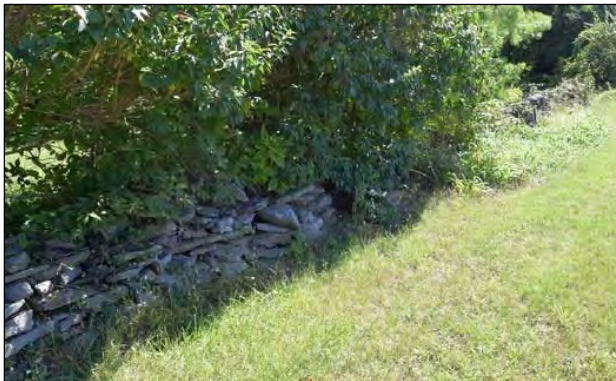
Condition: Deteriorated/Poor, Ruinous, Overgrown**Integrity Notes:** This wall has good integrity because it appears to have retained integrity of design and location.

Historical Significance: This wall most likely dates to the period between ca. 1900 and ca. 1970 based on larger stone size, atypical design (missing vertical limestone slabs as top course), and association with a home built ca. 1955, and, as such, has historical significance as part of Dublin's 20th century suburban growth.

Overview of wall, looking south

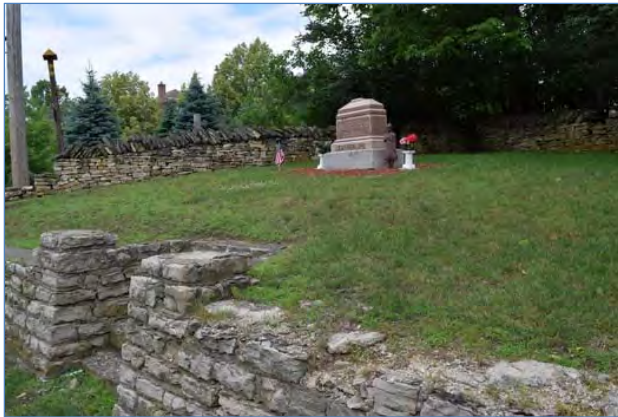
Condition: Good

Integrity Notes: The wall has good to fair integrity. The location and design appear to be original but some materials may be replacements.

Historical Significance: This wall most likely dates to the pre-1900 period based on the date the memorial was erected, although it may also date to the early 1900s. As part of the Leatherlips Memorial, the wall is a distinctive feature of the Dublin landscape.

Overview of wall, looking north
