Tuller Flats | Dublin, OH  
 Clubhouse  
 2-12-2015

Townhomes & Garden Apartments

Garden Units

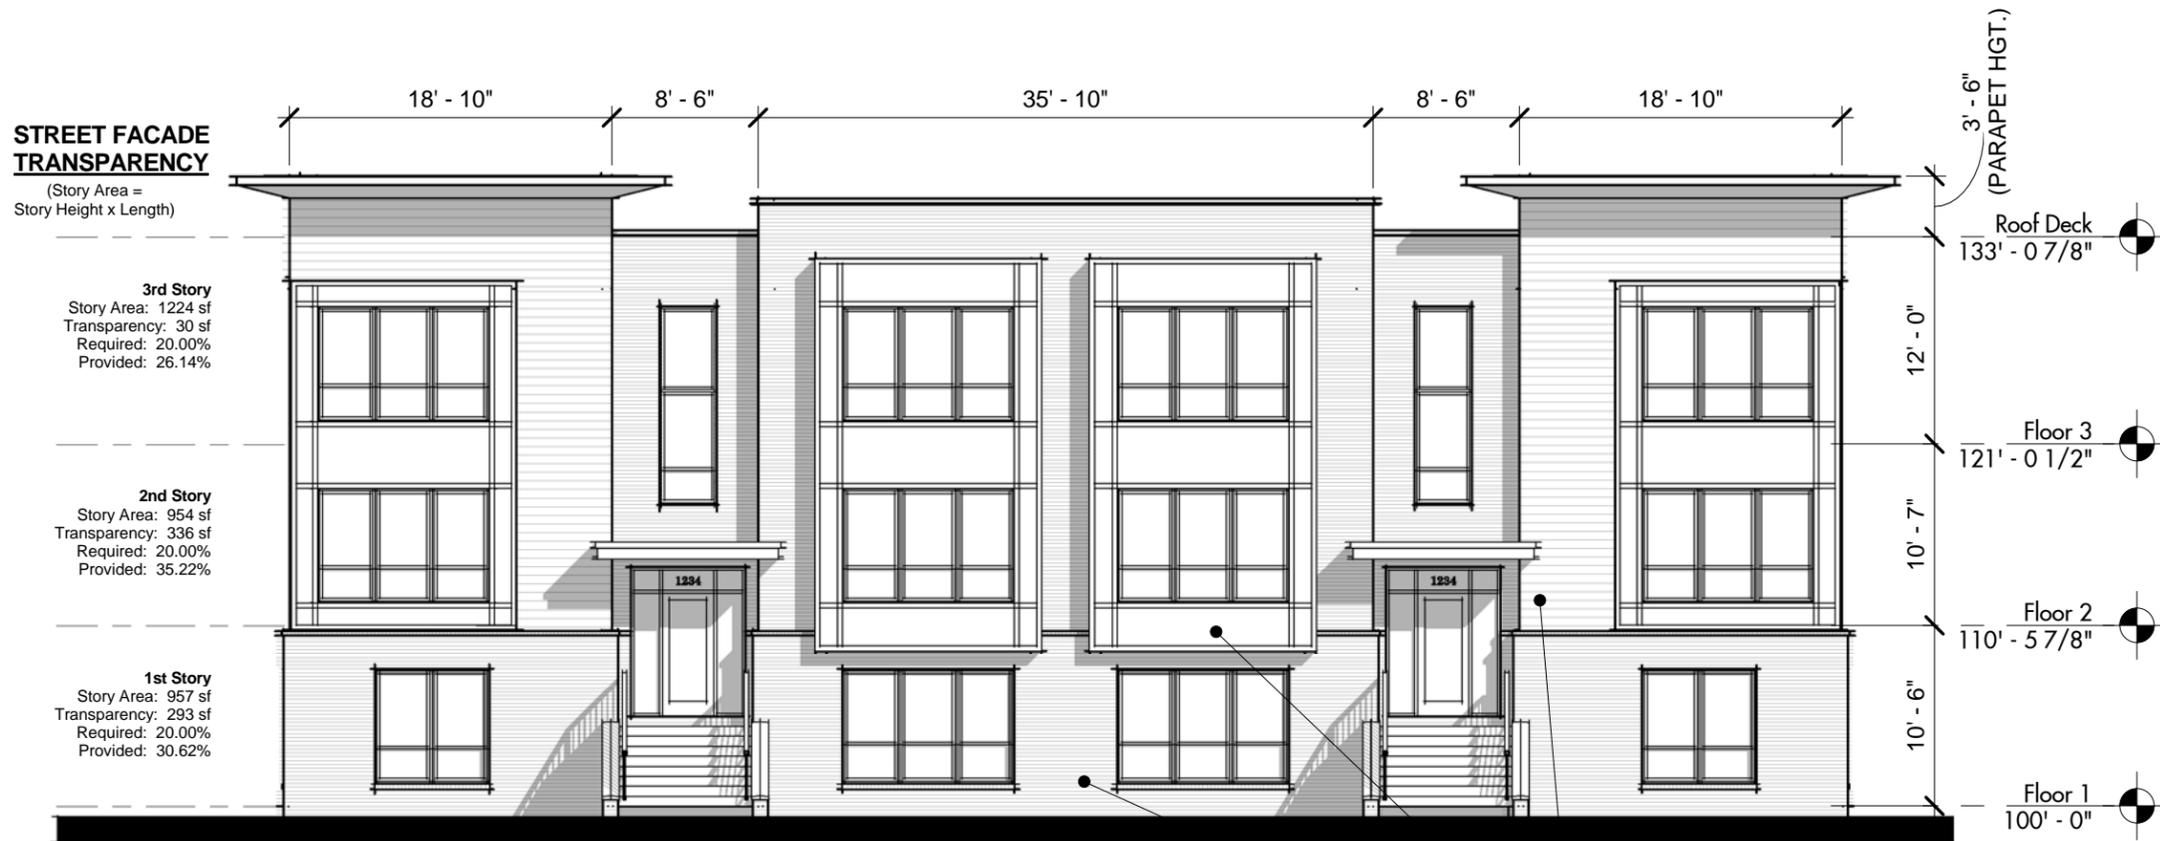
### Bldg A Front Elevation

- COMPOSITE SIDING
- CEMENTITIOUS PANEL
- BRICK

**Total Facade Area\* = 2,244 SF**

Material	Primary/Secondary	Area (SF)	Percentage	Required	Met?
Brick	Primary	1,152	51.34%		
Glass Storefront	Primary	116	5.17%		
		<b>1,268</b>	<b>56.51%</b>	<b>80%</b>	<b>N</b>
Composite Siding	Secondary	407	18.14%		
Cementitious Panel	Secondary	569	25.36%		
		<b>976</b>	<b>43.49%</b>	<b>&lt;20%</b>	<b>N</b>

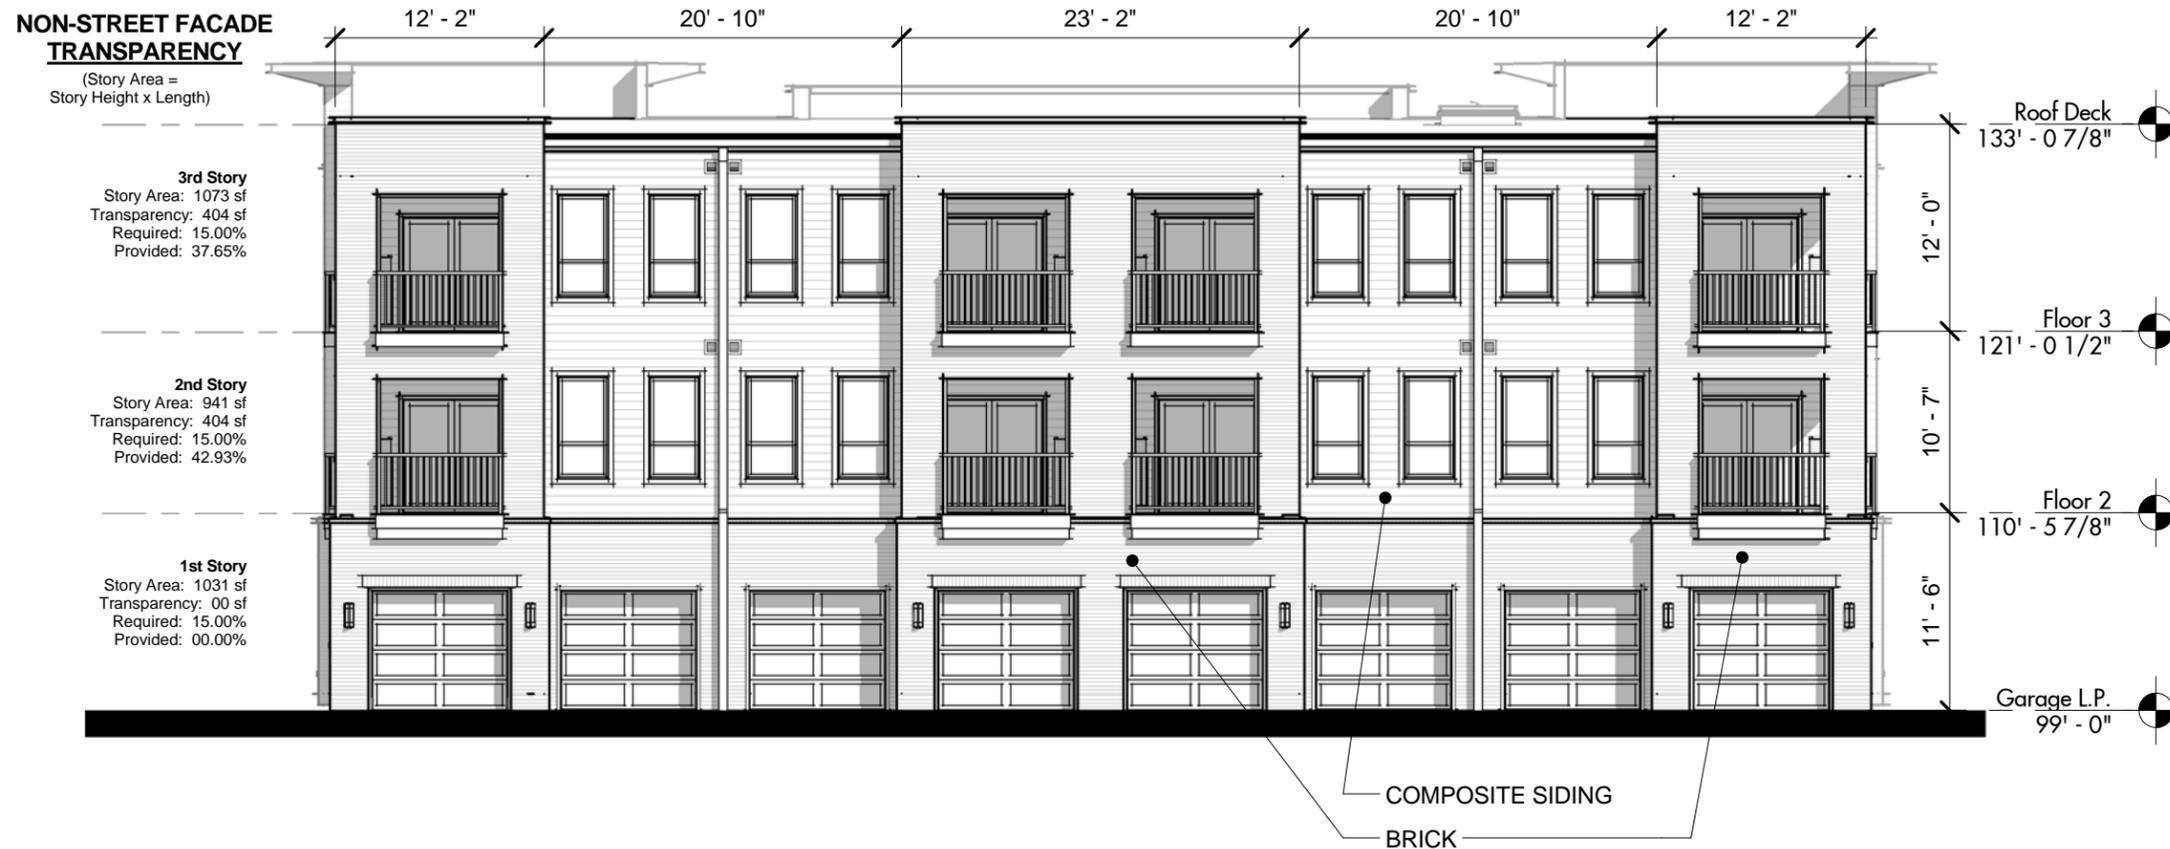
**Bldg A Rear Elevation**  
3/32" = 1'-0"

**Total Facade Area\* = 1,603 SF**

Material	Primary/Secondary	Area (SF)	Percentage	Required	Met?
Brick	Primary	1,080	67.37%		
Glass Storefront	Primary	0	0.00%		
		<b>1,080</b>	<b>67.37%</b>	<b>80%</b>	<b>N</b>
Composite Siding	Secondary	523	32.63%		
Cementitious Panel	Secondary	0	0.00%		
		<b>523</b>	<b>32.63%</b>	<b>&lt;20%</b>	<b>N</b>

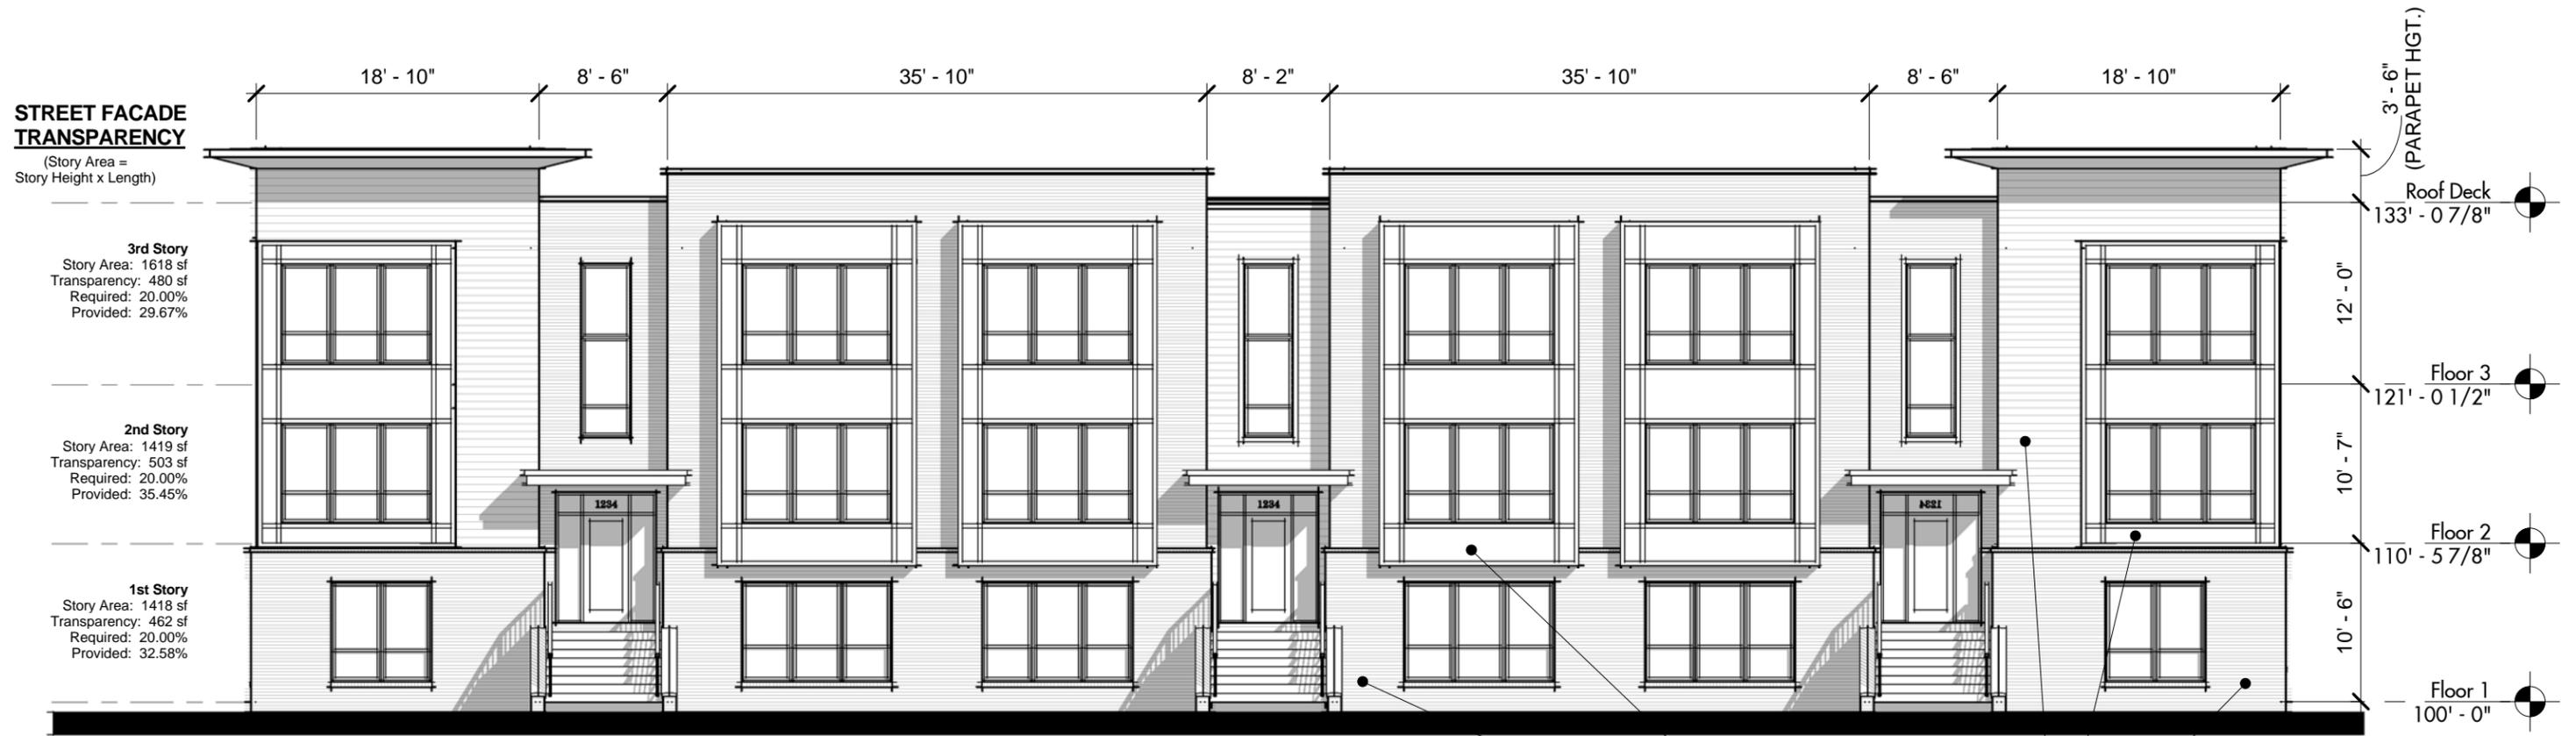
### Bldg B Front Elevation

- COMPOSITE SIDING
- CEMENTITIOUS PANEL
- BRICK

**Total Facade Area\* = 3,285 SF**

Material	Primary/Secondary	Area (SF)	Percentage	Required	Met?
Brick	Primary	1,677	51.05%		
Glass Storefront	Primary	173	5.27%		
		<b>1,850</b>	<b>56.32%</b>	<b>80%</b>	<b>N</b>
Composite Siding	Secondary	507	15.43%		
Cementitious Panel	Secondary	928	28.25%		
		<b>1,435</b>	<b>43.68%</b>	<b>&lt;20%</b>	<b>N</b>

**3rd Story**  
Story Area: 554 sf  
Transparency: 117 sf  
Required: 20.00%  
Provided: 21.12%

**2nd Story**  
Story Area: 486 sf  
Transparency: 117 sf  
Required: 20.00%  
Provided: 24.07%

**1st Story**  
Story Area: 483 sf  
Transparency: 73 sf  
Required: 20.00%  
Provided: 15.11%

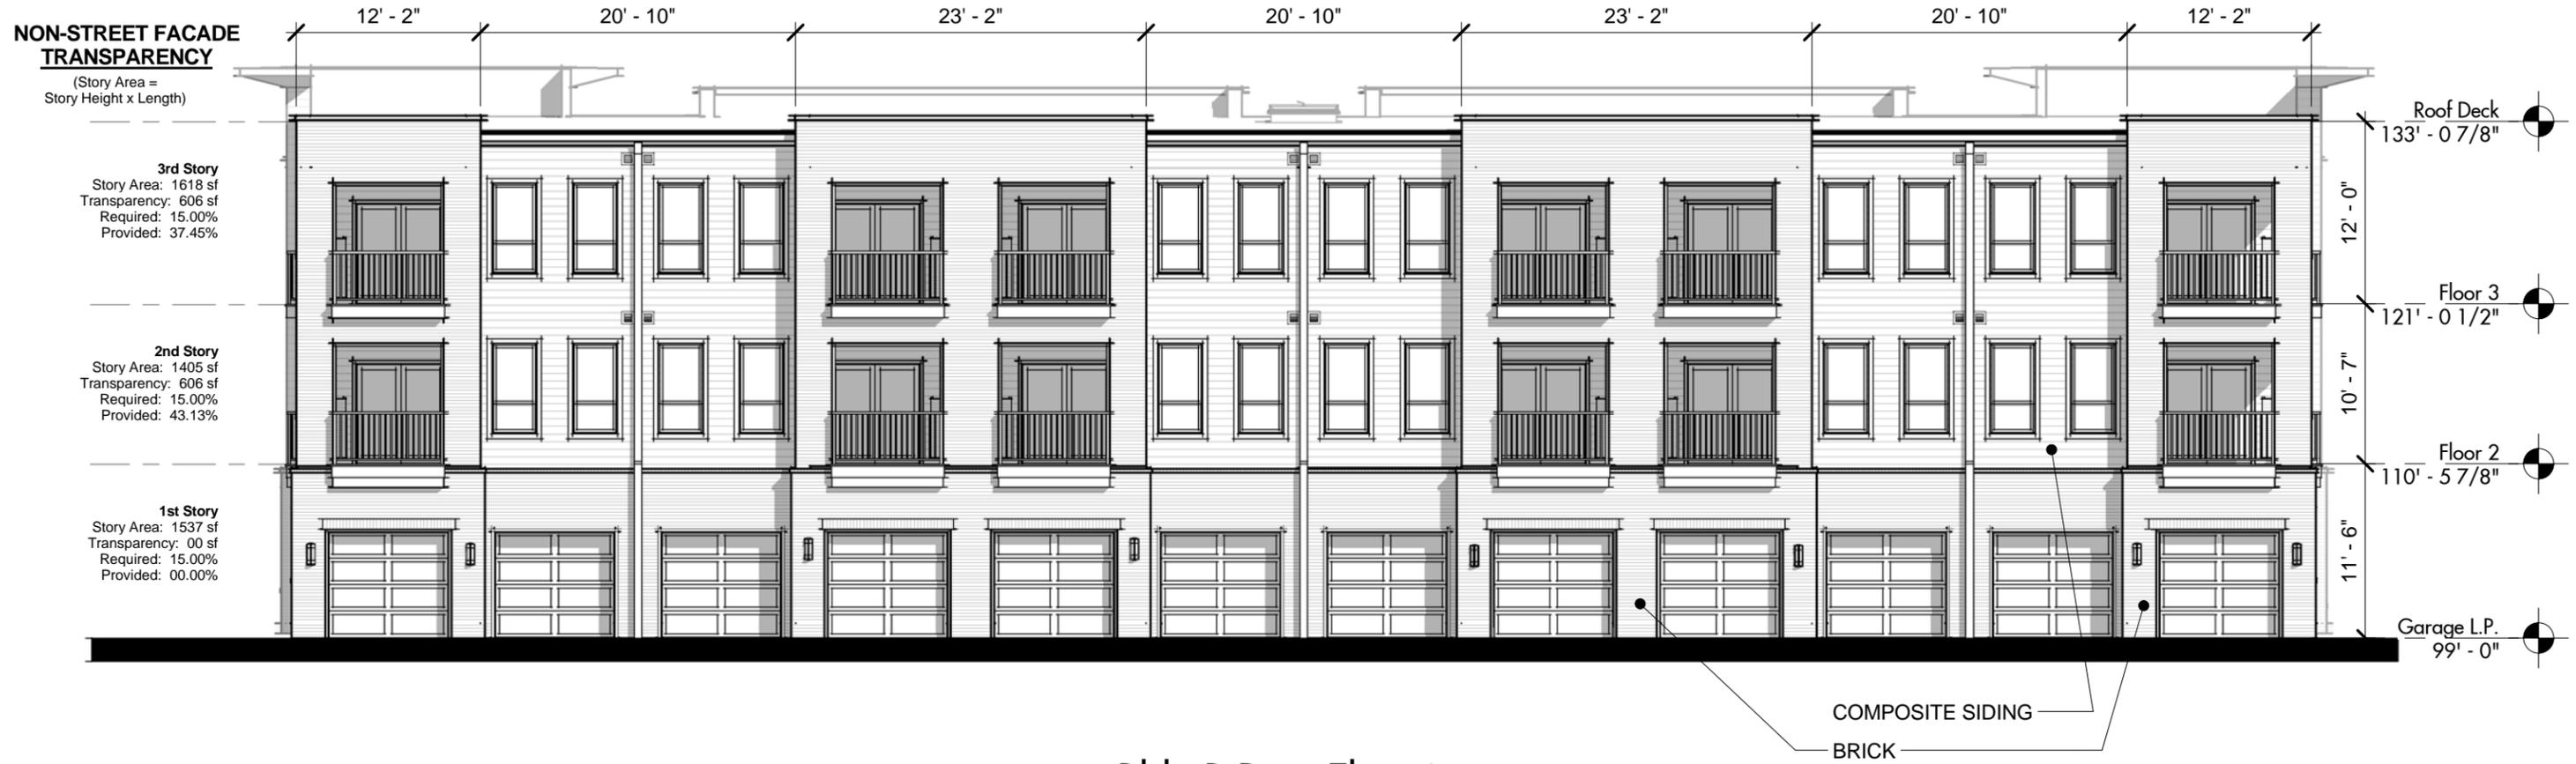
**Bldg B Rear Elevation**  
3/32" = 1'-0"

**Total Facade Area\* = 2,379 SF**  
\*Windows/Doors not included in Facade Area

Material	Primary/Secondary	Area (SF)	Percentage	Required	Met?
Brick	Primary	1,594	67.00%		
Glass Storefront	Primary	0	0.00%		
		<b>1,594</b>	<b>67.00%</b>	<b>80%</b>	<b>N</b>
Composite Siding	Secondary	785	33.00%		
Cementitious Panel	Secondary	0	0.00%		
		<b>785</b>	<b>33.00%</b>	<b>&lt;20%</b>	<b>N</b>

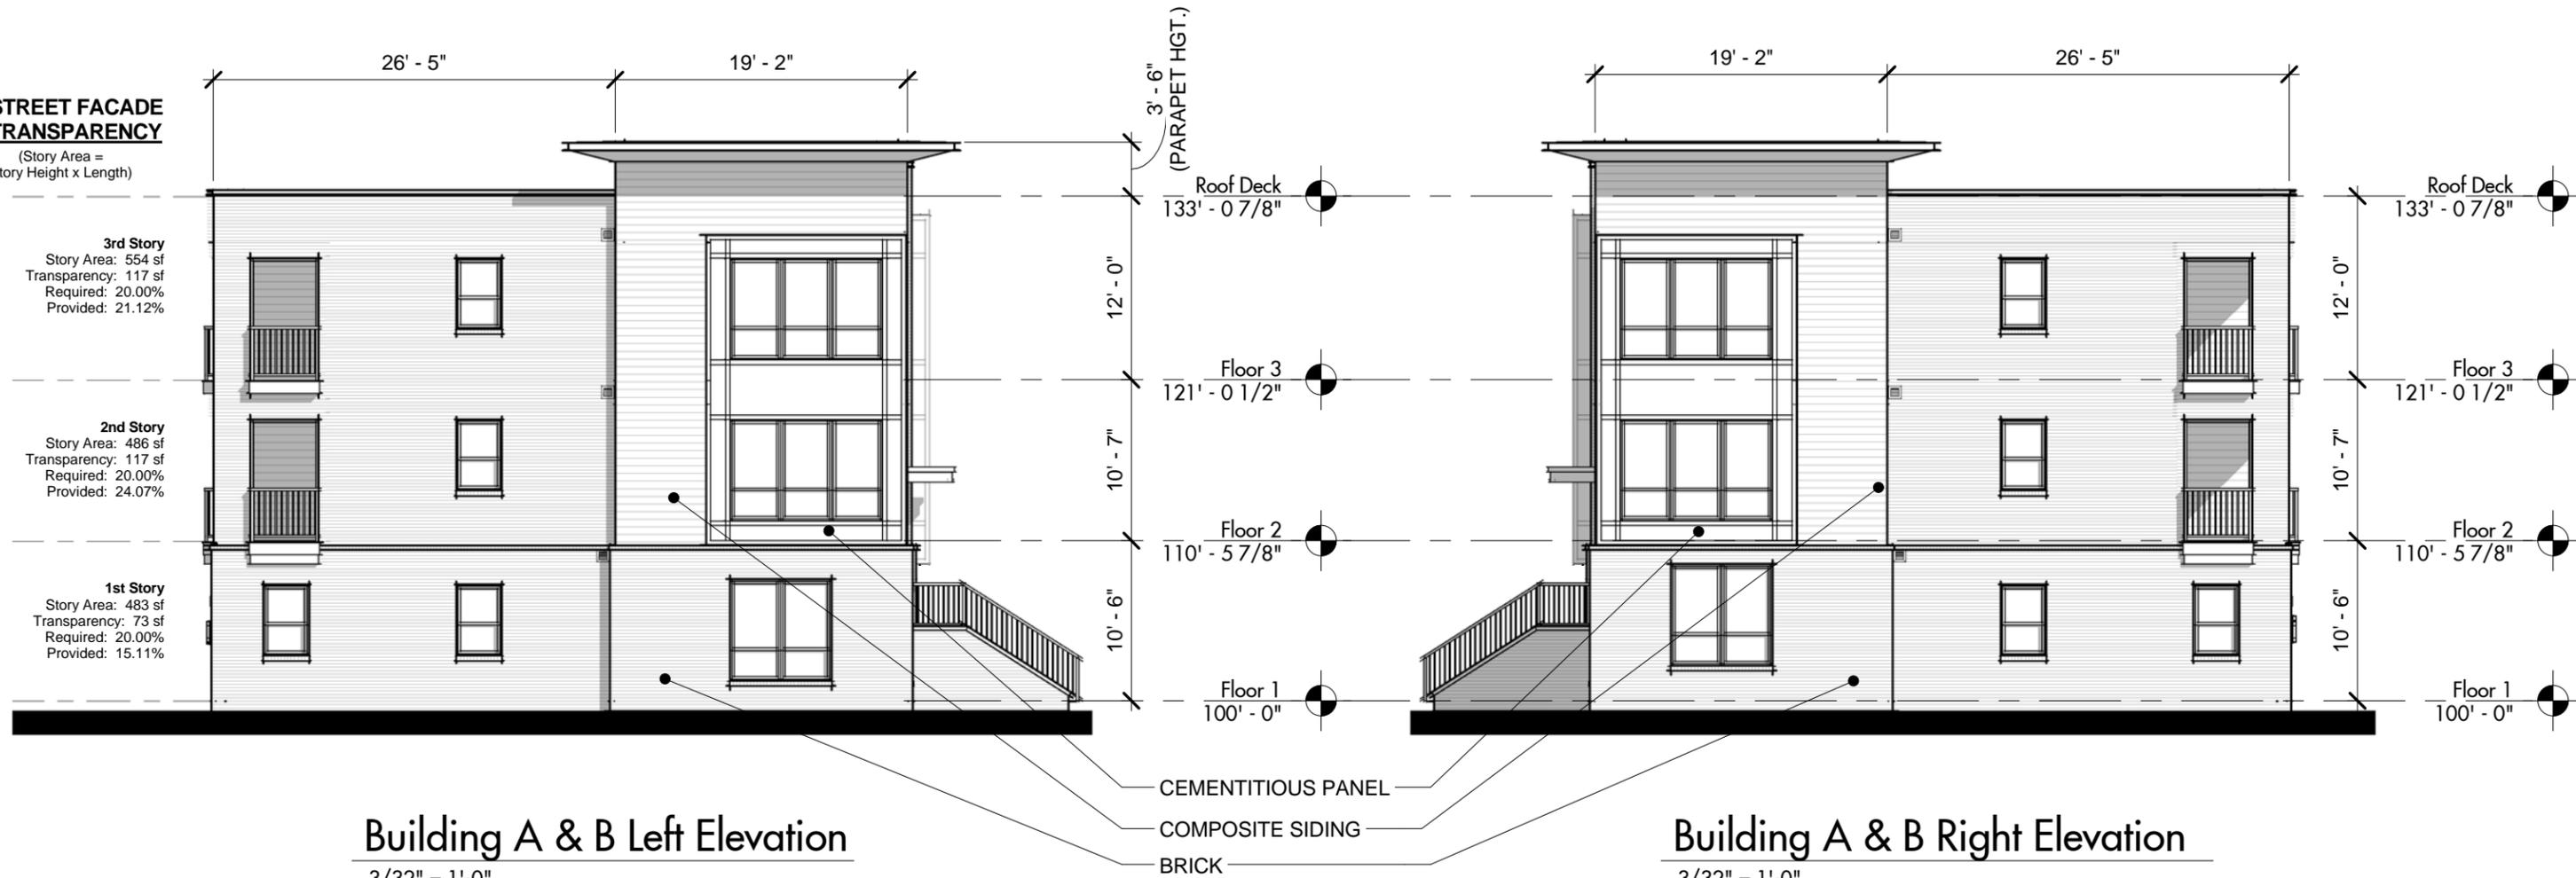
**Building A & B Left Elevation**

**Building A & B Right Elevation**

**Total Facade Area\* = 1,270 SF**

Material	Primary/Secondary	Area (SF)	Percentage	Required	Met?
Brick	Primary	924	72.76%		
Glass Storefront	Primary	0	0.00%		
		<b>924</b>	<b>72.76%</b>	<b>80%</b>	<b>N</b>
Composite Siding	Secondary	213	16.77%		
Cementitious Panel	Secondary	133	10.47%		
		<b>346</b>	<b>27.24%</b>	<b>&lt;20%</b>	<b>N</b>

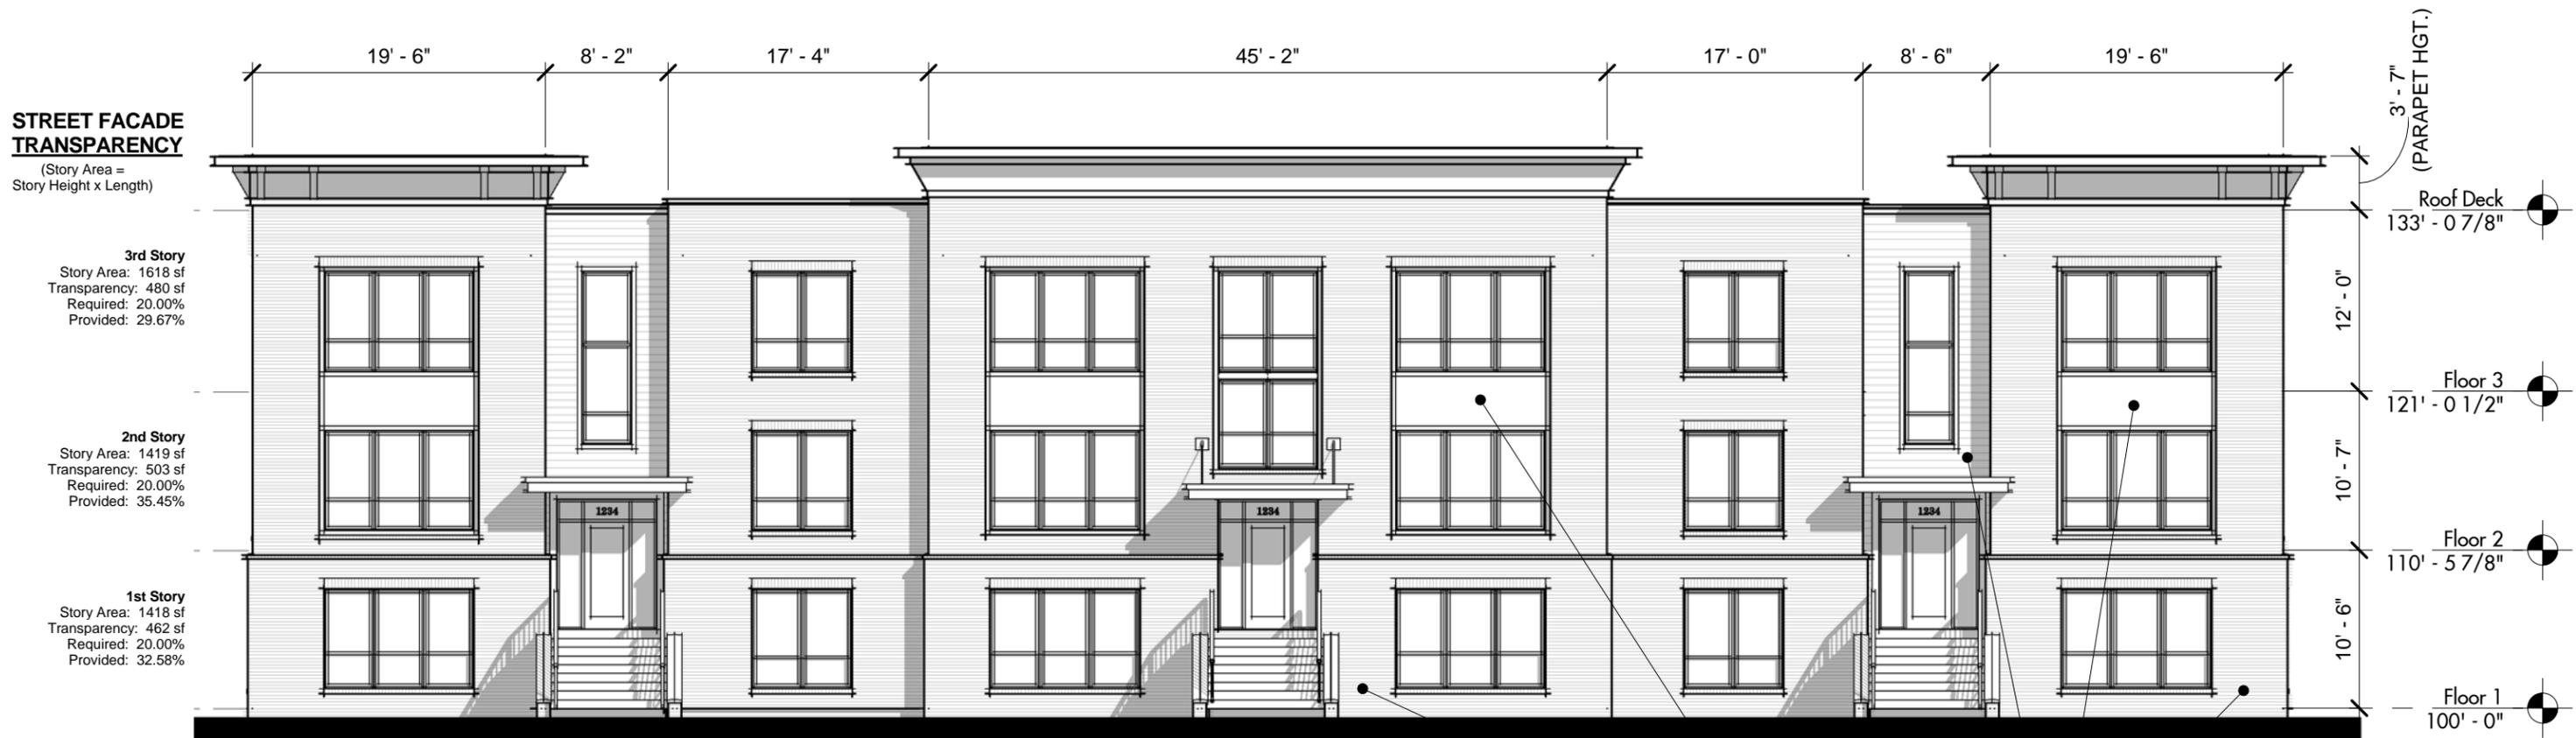
### Bldg C Front Elevation

**STREET FACADE TRANSPARENCY**  
(Story Area = Story Height x Length)

**3rd Story**  
Story Area: 1618 sf  
Transparency: 480 sf  
Required: 20.00%  
Provided: 29.67%

**2nd Story**  
Story Area: 1419 sf  
Transparency: 503 sf  
Required: 20.00%  
Provided: 35.45%

**1st Story**  
Story Area: 1418 sf  
Transparency: 462 sf  
Required: 20.00%  
Provided: 32.58%

**Total Facade Area\* = 3,130 SF**

Material	Primary/Secondary	Area (SF)	Percentage	Required	Met?
Brick	Primary	2,588	82.68%		
Glass Storefront	Primary	173	5.53%		
		<b>2,761</b>	<b>88.21%</b>	<b>80%</b>	<b>Y</b>
Composite Siding	Secondary	205	6.55%		
Cementitious Panel	Secondary	164	5.24%		
		<b>369</b>	<b>11.79%</b>	<b>&lt;20%</b>	<b>Y</b>

COMPOSITE SIDING  
CEMENTITIOUS PANEL  
BRICK

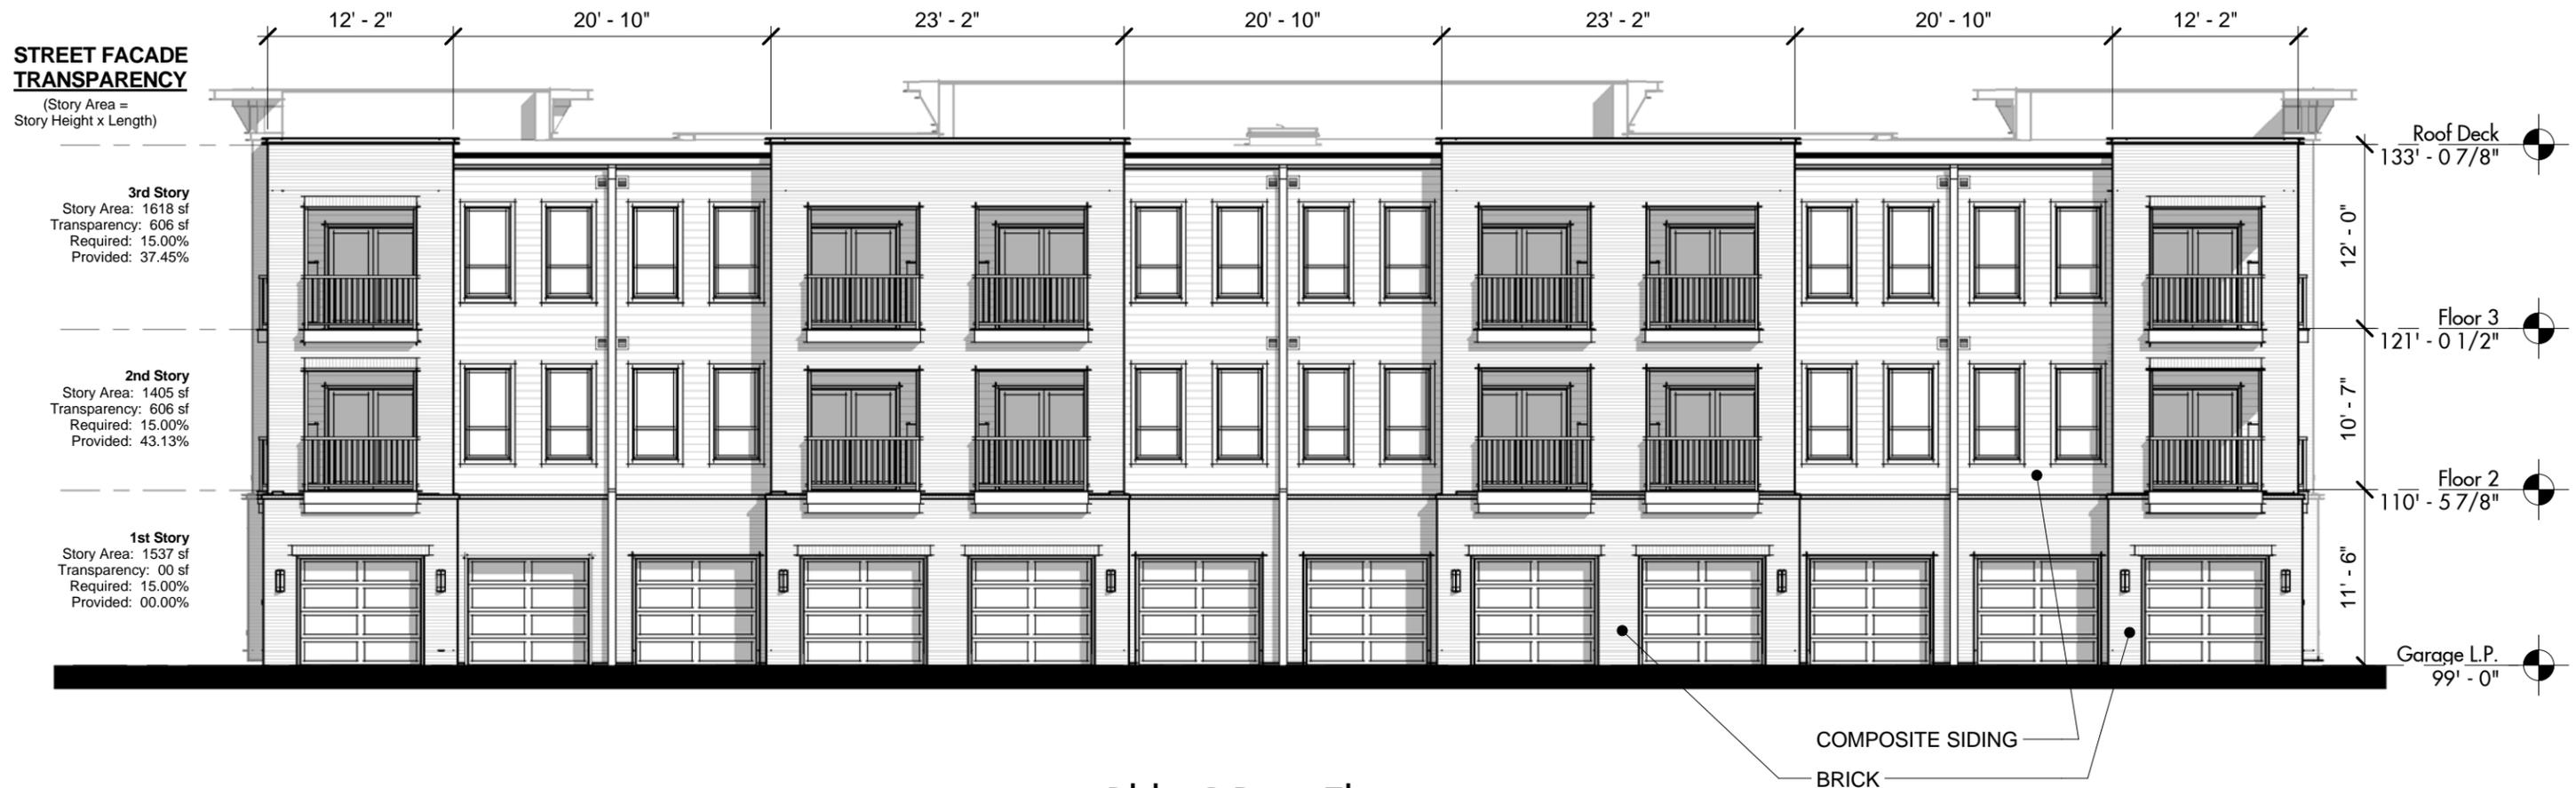
### Bldg C Rear Elevation

**Total Facade Area\* = 2,379 SF**

Material	Primary/Secondary	Area (SF)	Percentage	Required	Met?
Brick	Primary	1,594	67.00%		
Glass Storefront	Primary	0	0.00%		
		<b>1,594</b>	<b>67.00%</b>	<b>80%</b>	<b>N</b>
Composite Siding	Secondary	785	33.00%		
Cementitious Panel	Secondary	0	0.00%		
		<b>785</b>	<b>33.00%</b>	<b>&lt;20%</b>	<b>N</b>

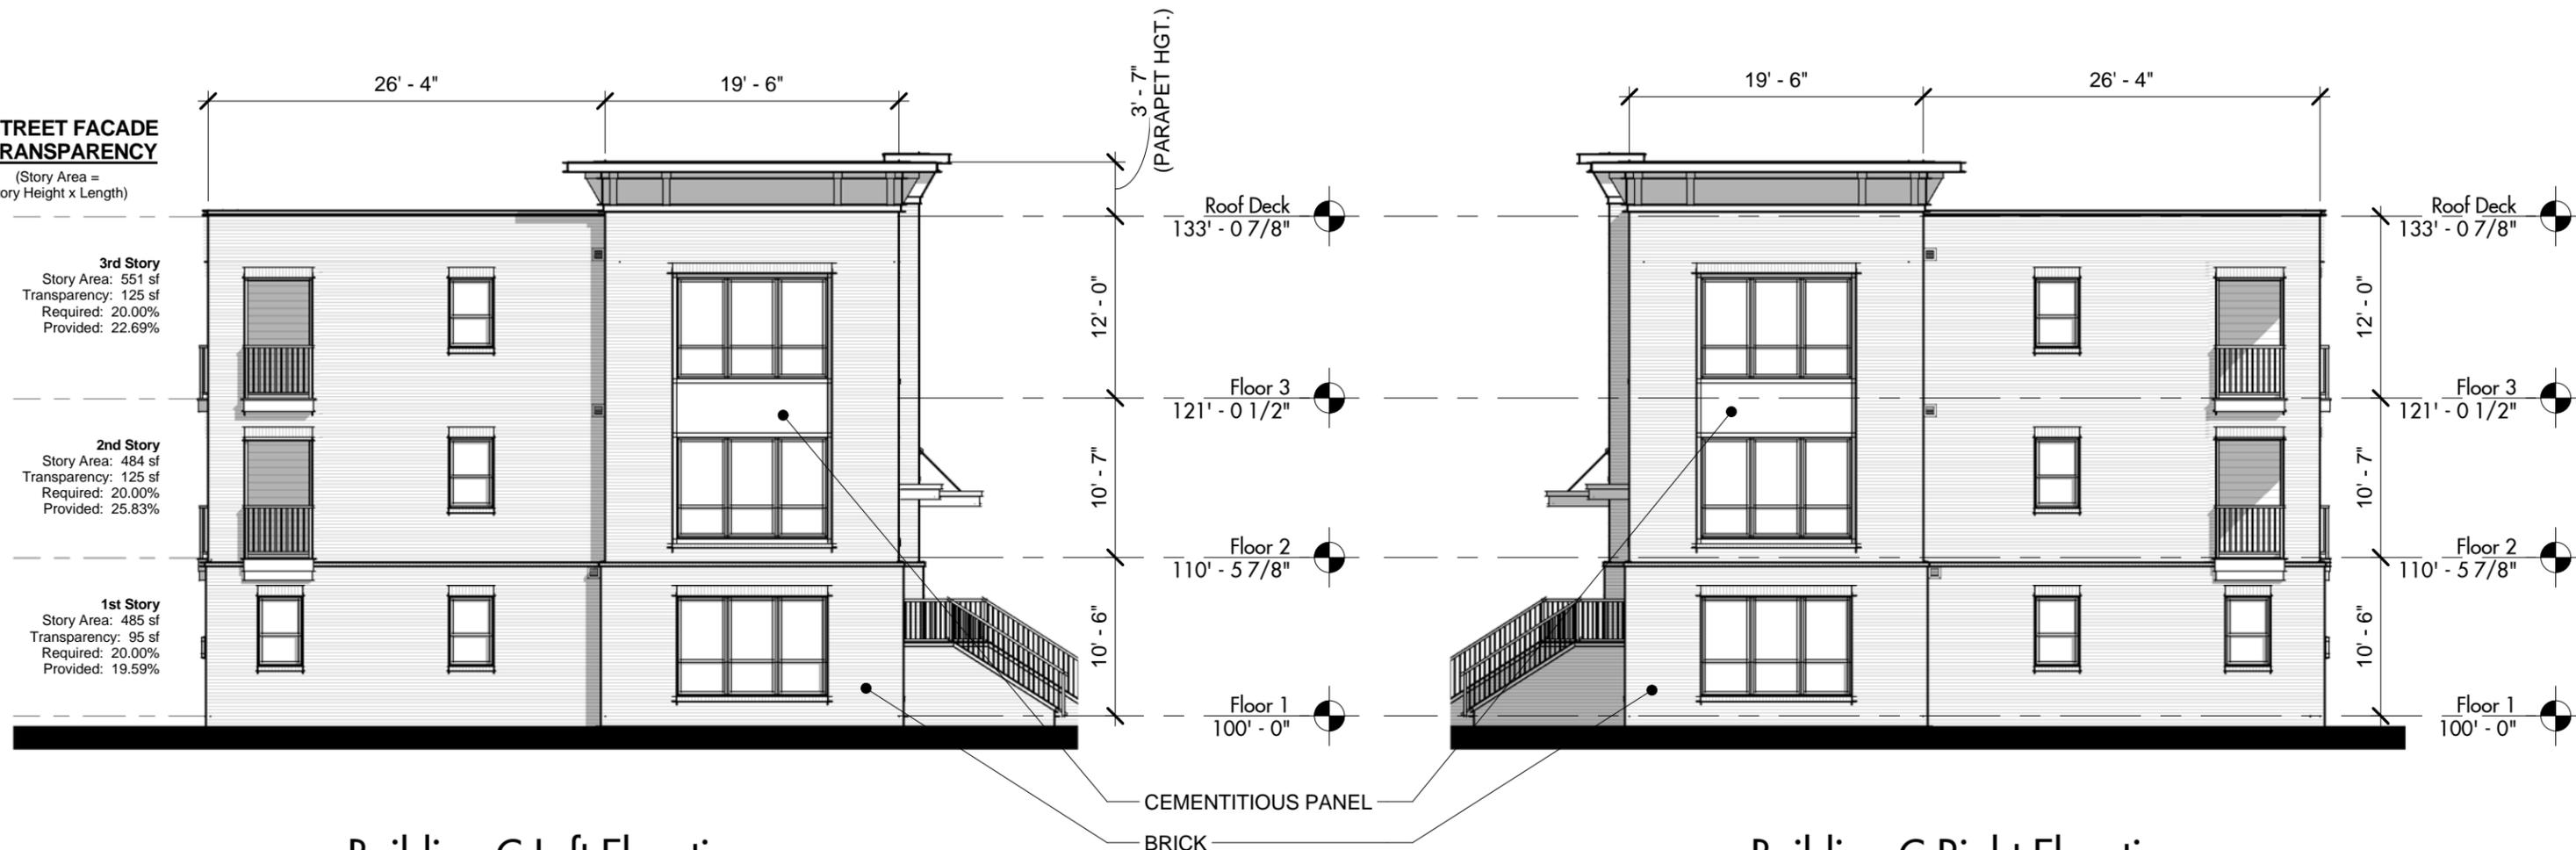
**Building C Left Elevation**

**Building C Right Elevation**

**Total Facade Area\* = 1,225 SF**

Material	Primary/Secondary	Area (SF)	Percentage	Required	Met?
Brick	Primary	1,184	96.65%		
Glass Storefront	Primary	0	0.00%		
		<b>1,184</b>	<b>96.65%</b>	<b>80%</b>	<b>Y</b>
Composite Siding	Secondary	0	0.00%		
Cementitious Panel	Secondary	41	3.35%		
		<b>41</b>	<b>3.35%</b>	<b>&lt;20%</b>	<b>Y</b>

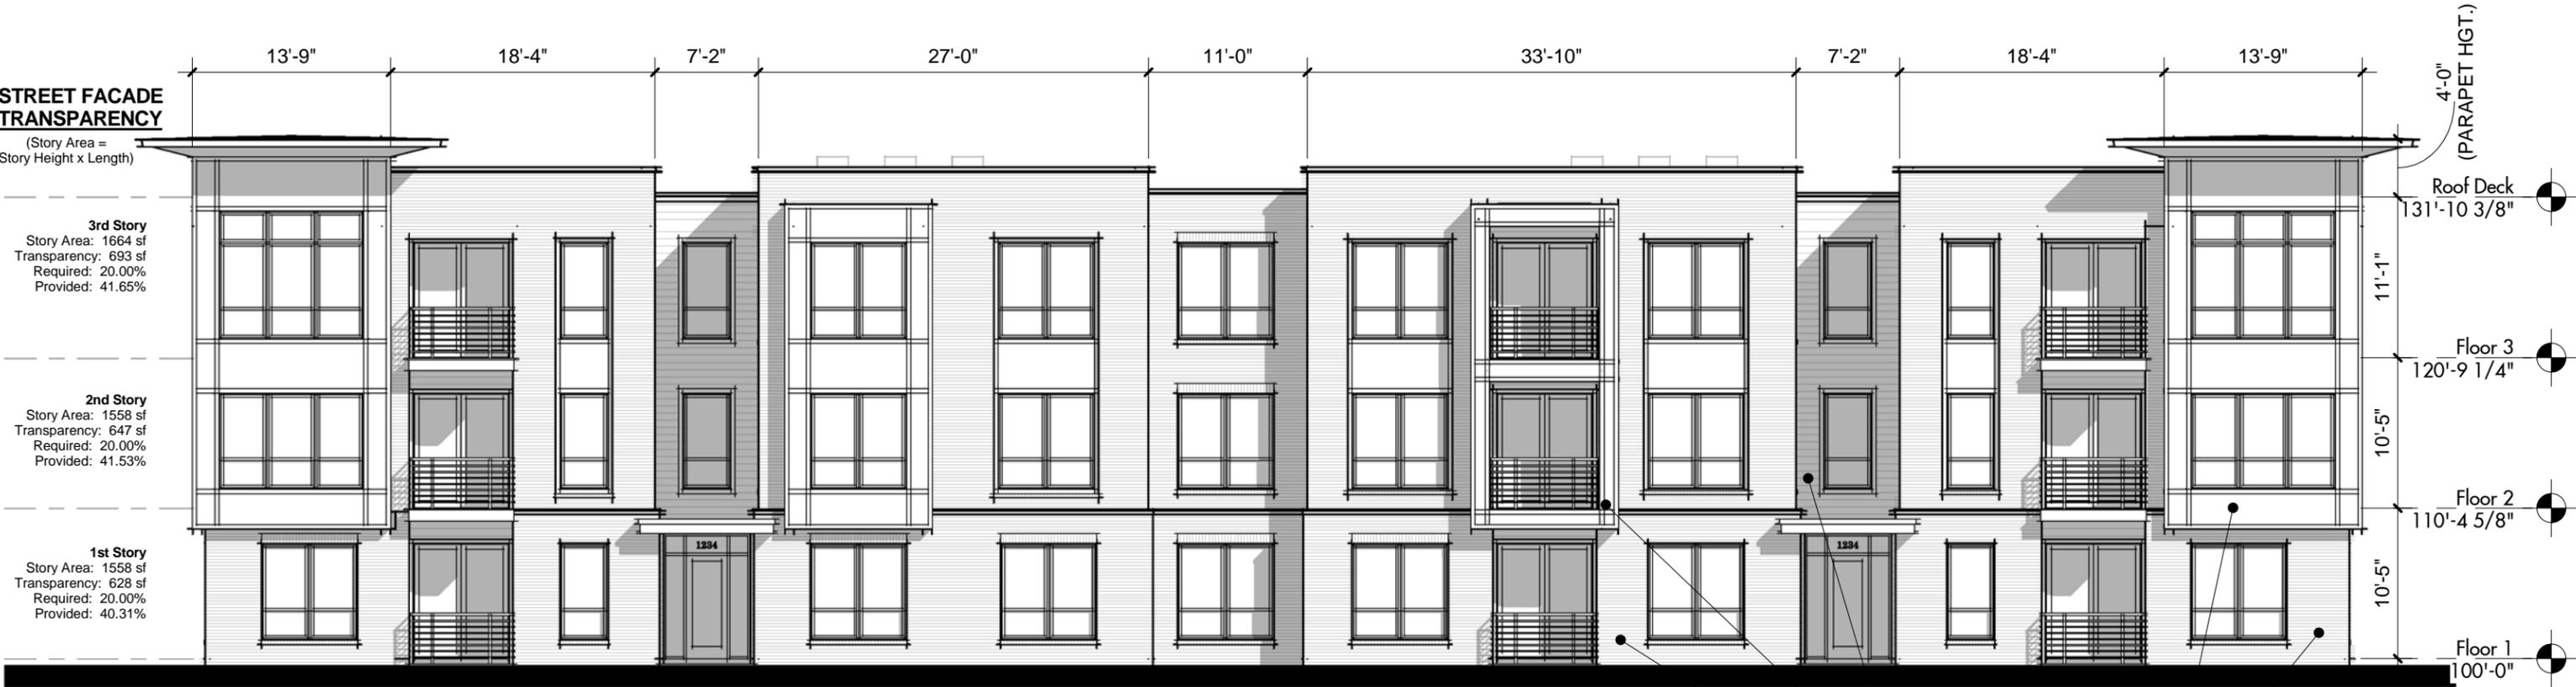
**D & E Front Elevation**

**STREET FACADE TRANSPARENCY**

**3rd Story**  
 Story Area: 1664 sf  
 Transparency: 693 sf  
 Required: 20.00%  
 Provided: 41.65%

**2nd Story**  
 Story Area: 1558 sf  
 Transparency: 647 sf  
 Required: 20.00%  
 Provided: 41.53%

**1st Story**  
 Story Area: 1558 sf  
 Transparency: 628 sf  
 Required: 20.00%  
 Provided: 40.31%

- COMPOSITE SIDING
- CEMENTITIOUS PANEL
- BRICK

**Total Facade Area\* = 3,101 SF**  
 \*Windows/Doors not included in Facade Area

Material	Primary/Secondary	Area (SF)	Percentage	Required	Met?
Brick	Primary	2,075	66.91%		
Glass Storefront	Primary	104	3.35%		
		<b>2,179</b>	<b>70.27%</b>	<b>80%</b>	<b>N</b>
Composite Siding	Secondary	195	6.29%		
Cementitious Panel	Secondary	727	23.44%		
		<b>922</b>	<b>29.73%</b>	<b>&lt;20%</b>	<b>N</b>

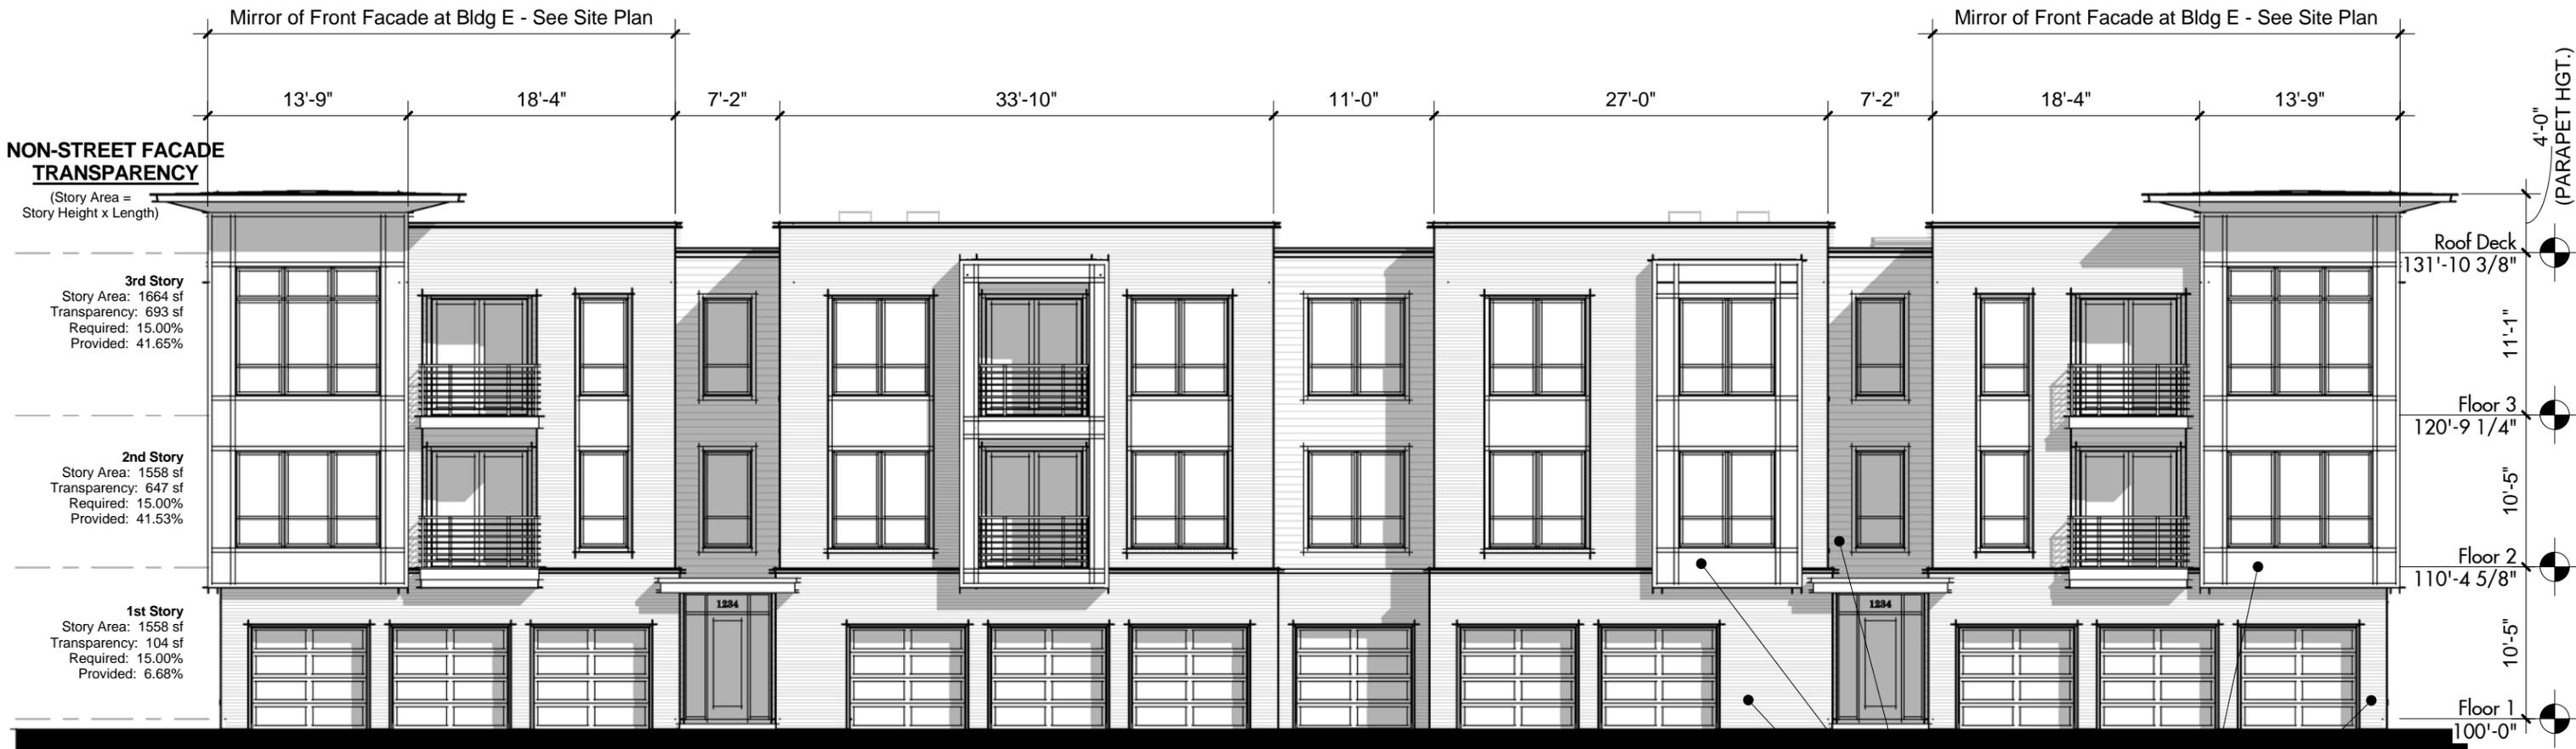
**D Rear Elevation\***

**NON-STREET FACADE  
TRANSPARENCY**

**3rd Story**  
Story Area: 1664 sf  
Transparency: 693 sf  
Required: 15.00%  
Provided: 41.65%

**2nd Story**  
Story Area: 1558 sf  
Transparency: 647 sf  
Required: 15.00%  
Provided: 41.53%

**1st Story**  
Story Area: 1558 sf  
Transparency: 104 sf  
Required: 15.00%  
Provided: 6.68%

3/32" = 1'-0"  
\*Building E Rear Elevation Similar

**Total Facade Area\* = 2,946 SF**  
\*Windows/Doors not included in Facade Area

Material	Primary/Secondary	Area (SF)	Percentage	Required	Met?
Brick	Primary	1,771	60.12%		
Glass Storefront	Primary	104	3.53%		
		<b>1,875</b>	<b>63.65%</b>	<b>80%</b>	<b>N</b>
Composite Siding	Secondary	344	11.68%		
Cementitious Panel	Secondary	727	24.68%		
		<b>1,071</b>	<b>36.35%</b>	<b>&lt;20%</b>	<b>N</b>

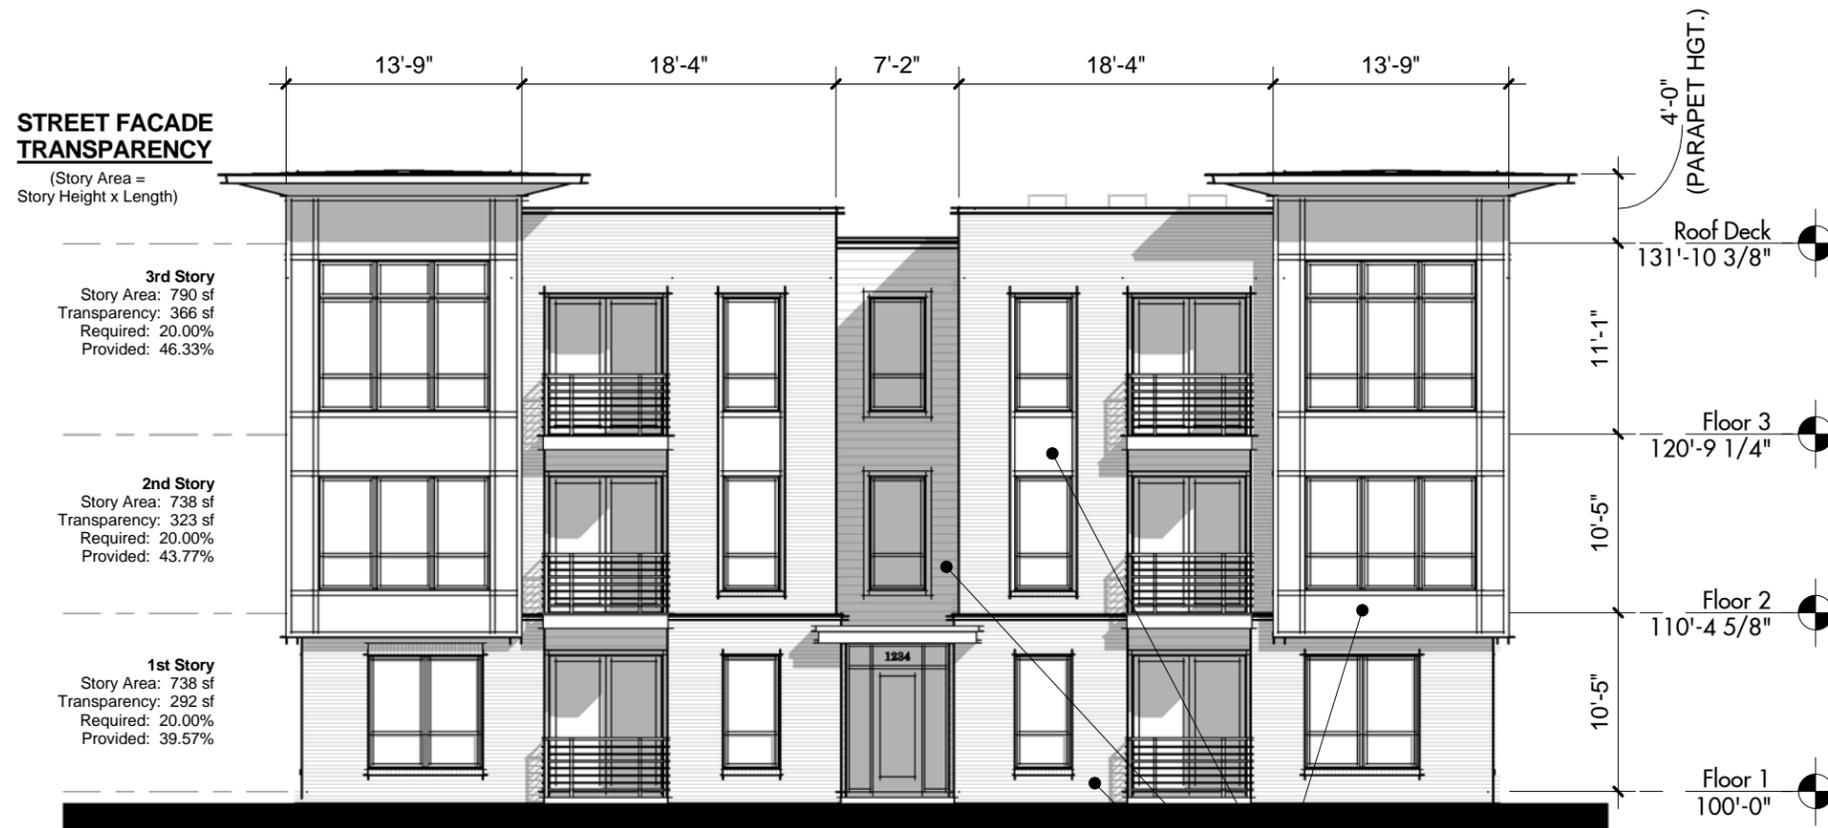
### H Front Elevation

- COMPOSITE PANEL
- CEMENTITIOUS SIDING
- BRICK

**Total Facade Area\* = 1,398 SF**

Material	Primary/Secondary	Area (SF)	Percentage	Required	Met?
Brick	Primary	823	58.87%		
Glass Storefront	Primary	52	3.72%		
		<b>875</b>	<b>62.59%</b>	<b>80%</b>	<b>N</b>
Composite Siding	Secondary	103	7.37%		
Cementitious Panel	Secondary	420	30.04%		
		<b>523</b>	<b>37.41%</b>	<b>&lt;20%</b>	<b>N</b>
