Tuller Flats | Dublin, OH  
 Clubhouse  
 2-12-2015

Townhomes & Garden Apartments

Garden Units

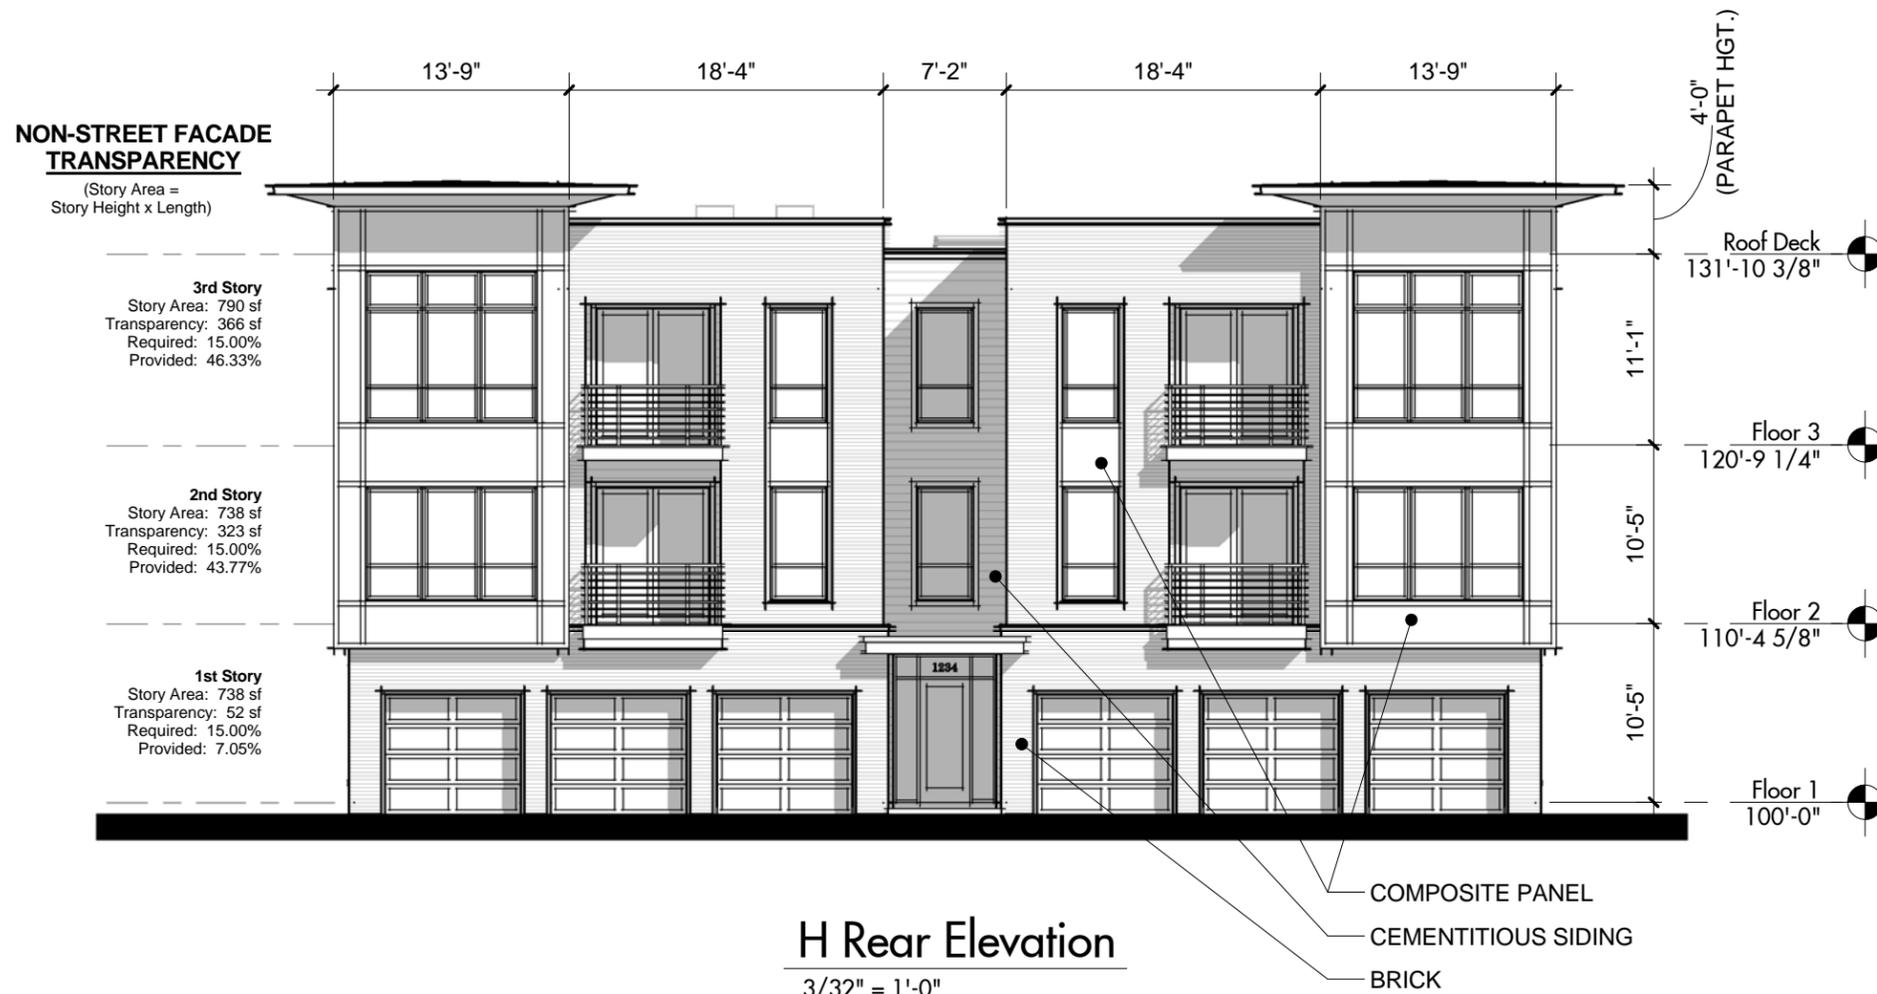
**Total Facade Area\* = 1,308 SF**

Material	Primary/Secondary	Area (SF)	Percentage	Required	Met?
Brick	Primary	733	56.04%		
Glass Storefront	Primary	52	3.98%		
		<b>785</b>	<b>60.02%</b>	<b>80%</b>	<b>N</b>
Composite Siding	Secondary	103	7.87%		
Cementitious Panel	Secondary	420	32.11%		
		<b>523</b>	<b>39.98%</b>	<b>&lt;20%</b>	<b>N</b>

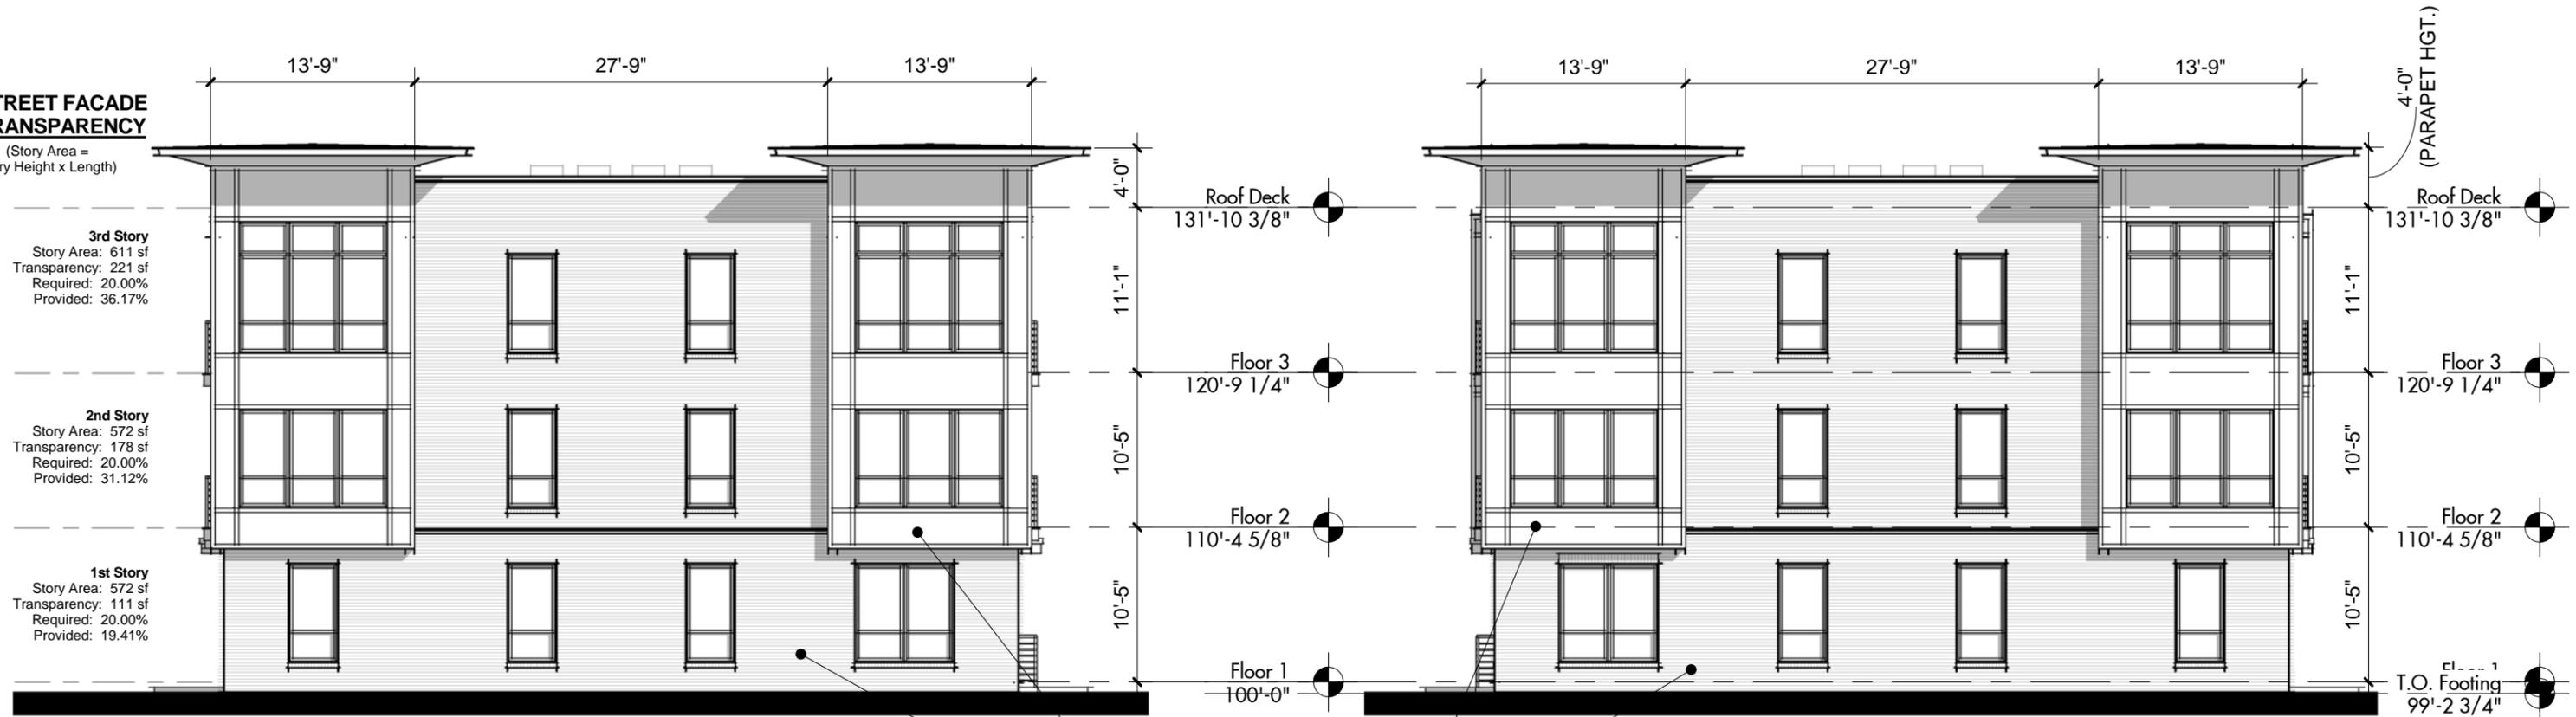
**D, E & H Left Elevation**

**STREET FACADE TRANSPARENCY**

**3rd Story**  
 Story Area: 611 sf  
 Transparency: 221 sf  
 Required: 20.00%  
 Provided: 36.17%

**2nd Story**  
 Story Area: 572 sf  
 Transparency: 178 sf  
 Required: 20.00%  
 Provided: 31.12%

**1st Story**  
 Story Area: 572 sf  
 Transparency: 111 sf  
 Required: 20.00%  
 Provided: 19.41%

**D, E & H Right Elevation**

**Total Facade Area\* = 1,400 SF**

Material	Primary/Secondary	Area (SF)	Percentage	Required	Met?
Brick	Primary	1,006	71.86%		
Glass Storefront	Primary	0	0.00%		
		<b>1,006</b>	<b>71.86%</b>	<b>80%</b>	<b>N</b>
Composite Siding	Secondary	0	0.00%		
Cementitious Panel	Secondary	394	28.14%		
		<b>394</b>	<b>28.14%</b>	<b>&lt;20%</b>	<b>N</b>

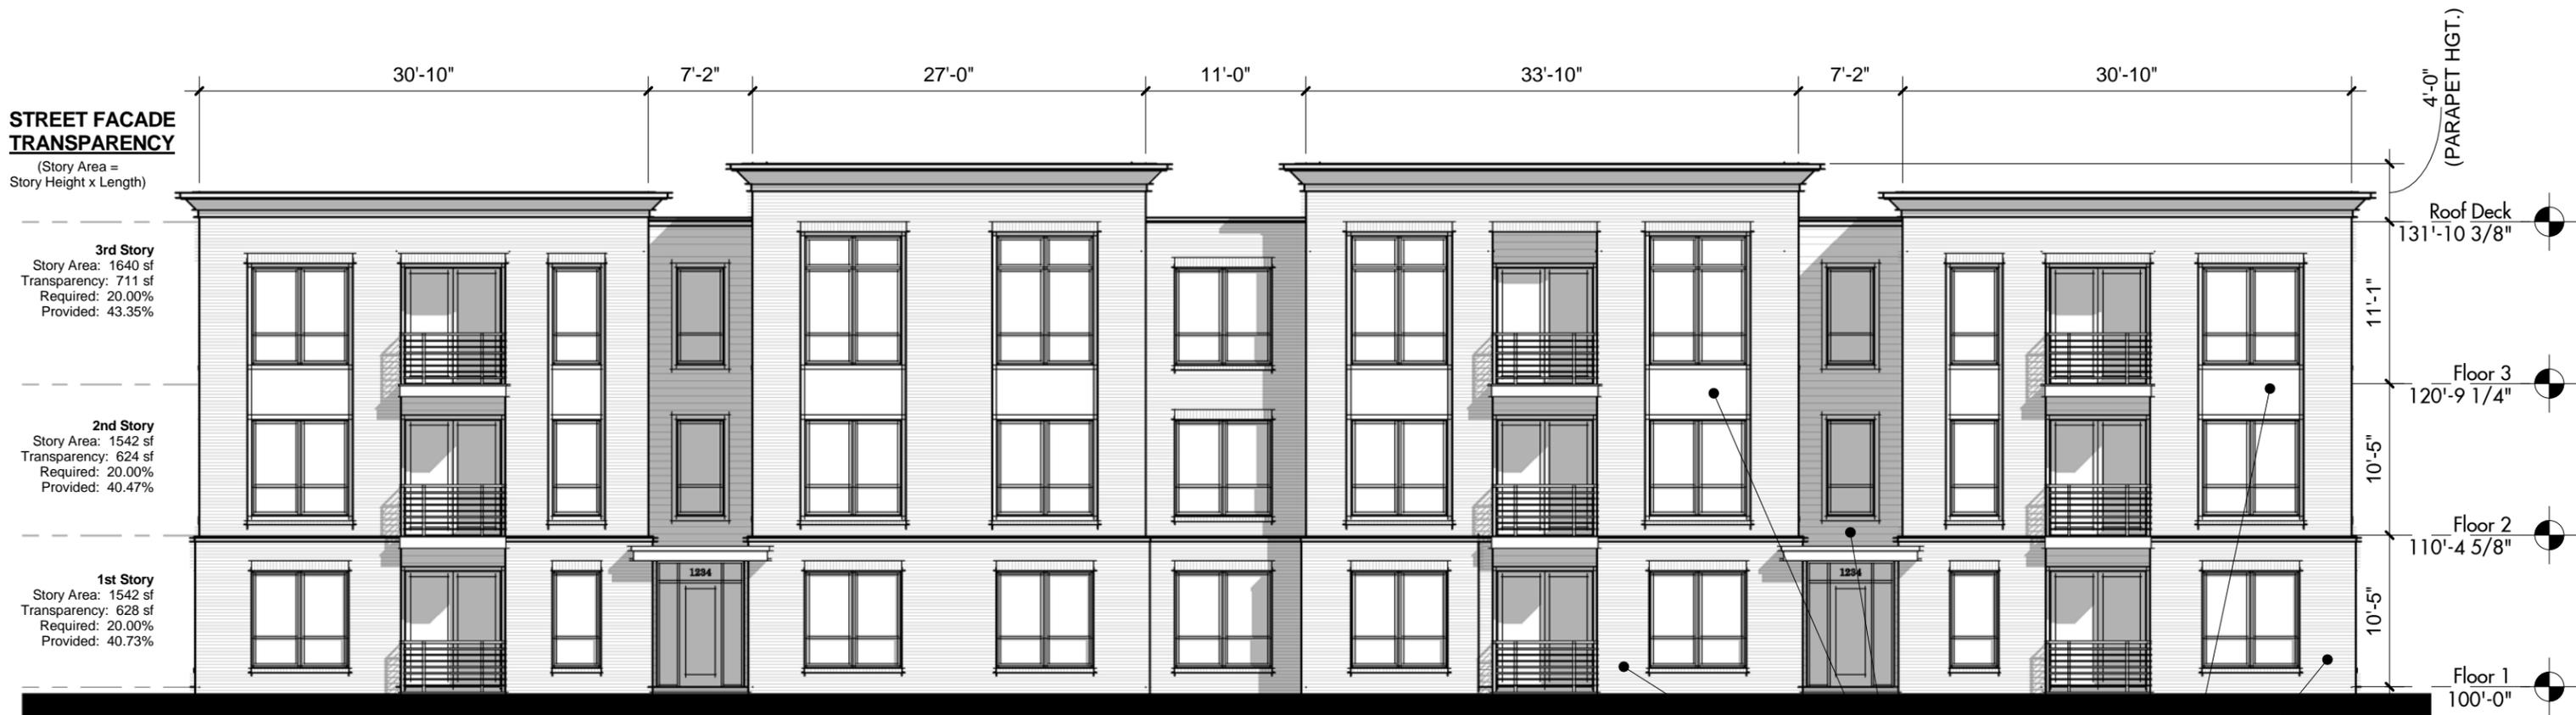
### F & G Front Elevation

**Total Facade Area\* = 2,928 SF**

Material	Primary/Secondary	Area (SF)	Percentage	Required	Met?
Brick	Primary	2,438	83.27%		
Glass Storefront	Primary	104	3.55%		
		<b>2,542</b>	<b>86.82%</b>	<b>80%</b>	<b>Y</b>
Composite Siding	Secondary	195	6.66%		
Cementitious Panel	Secondary	191	6.52%		
		<b>386</b>	<b>13.18%</b>	<b>&lt;20%</b>	<b>Y</b>

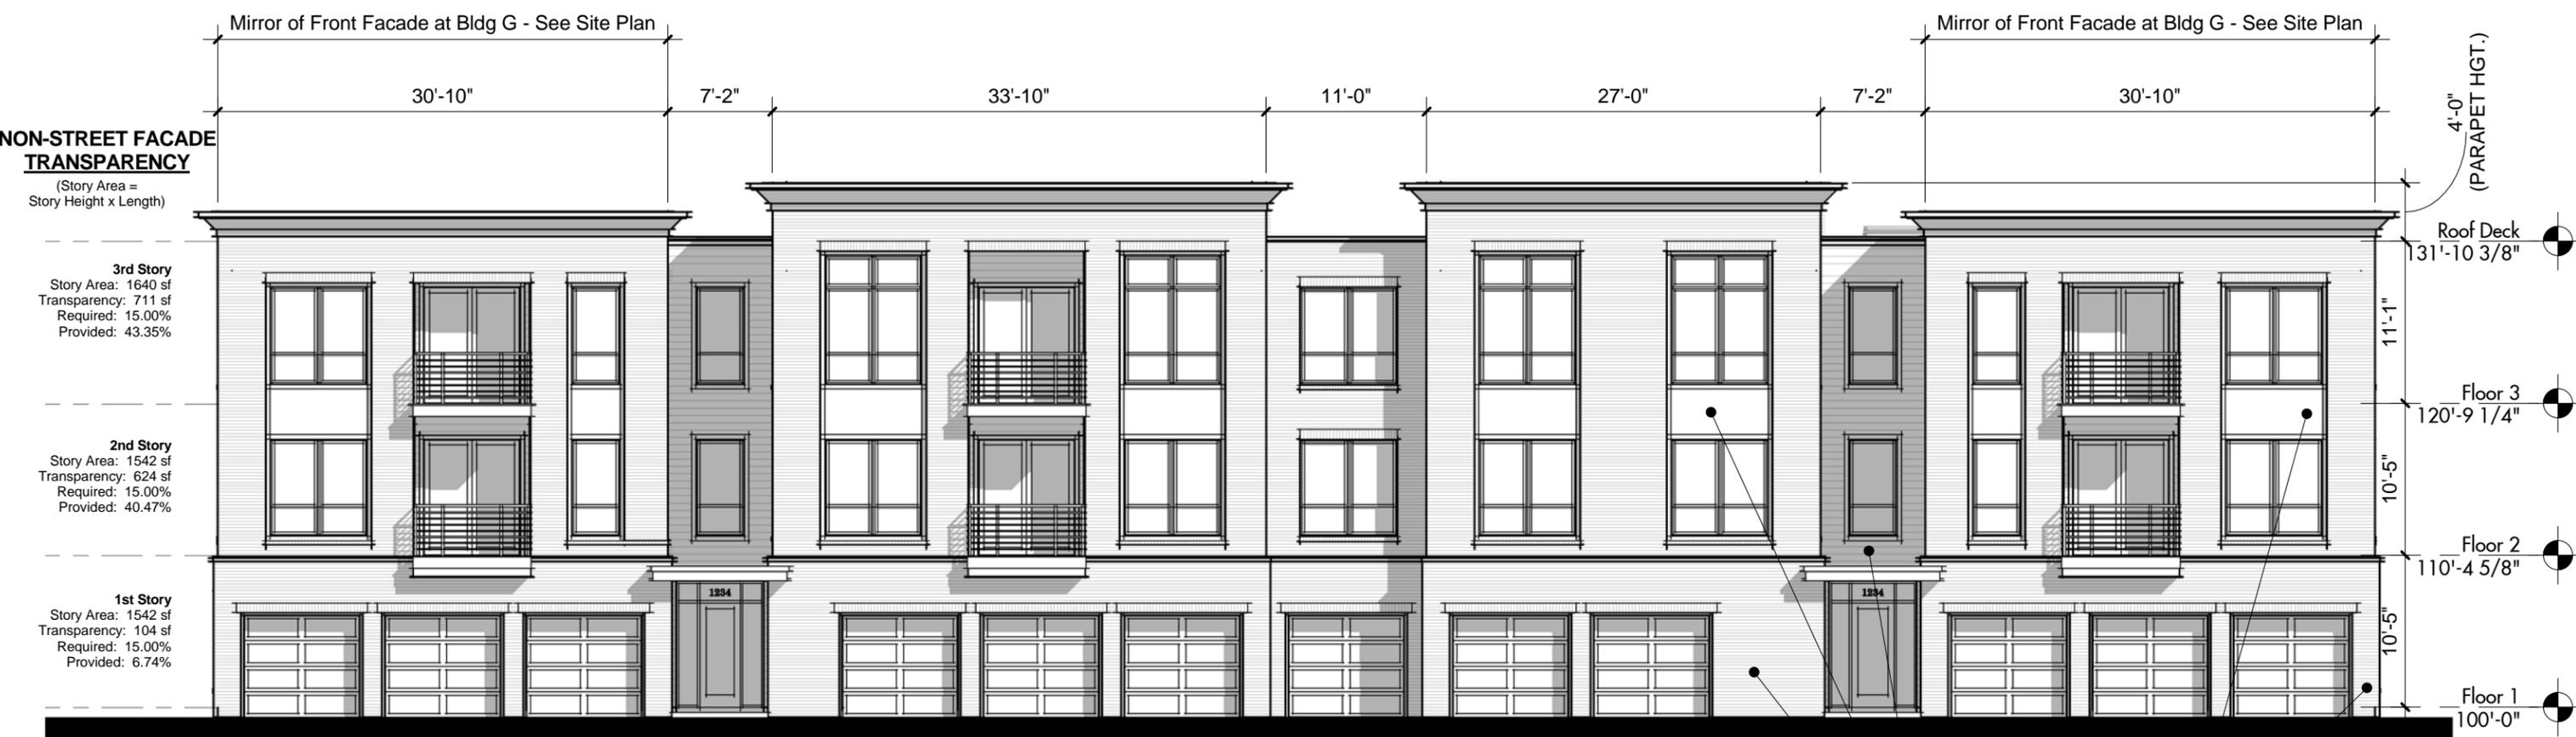
**F Rear Elevation\***

**NON-STREET FACADE TRANSPARENCY**  
(Story Area = Story Height x Length)

**3rd Story**  
Story Area: 1640 sf  
Transparency: 711 sf  
Required: 15.00%  
Provided: 43.35%

**2nd Story**  
Story Area: 1542 sf  
Transparency: 624 sf  
Required: 15.00%  
Provided: 40.47%

**1st Story**  
Story Area: 1542 sf  
Transparency: 104 sf  
Required: 15.00%  
Provided: 6.74%

3/32" = 1'-0"  
\*Building G Rear Elevation Similar

**Total Facade Area\* = 2,773 SF**  
\*Windows/Doors not included in Facade Area

Material	Primary/Secondary	Area (SF)	Percentage	Required	Met?
Brick	Primary	2,283	82.33%		
Glass Storefront	Primary	104	3.75%		
		<b>2,387</b>	<b>86.08%</b>	<b>80%</b>	<b>Y</b>
Composite Siding	Secondary	195	7.03%		
Cementitious Panel	Secondary	191	6.89%		
		<b>386</b>	<b>13.92%</b>	<b>&lt;20%</b>	<b>Y</b>

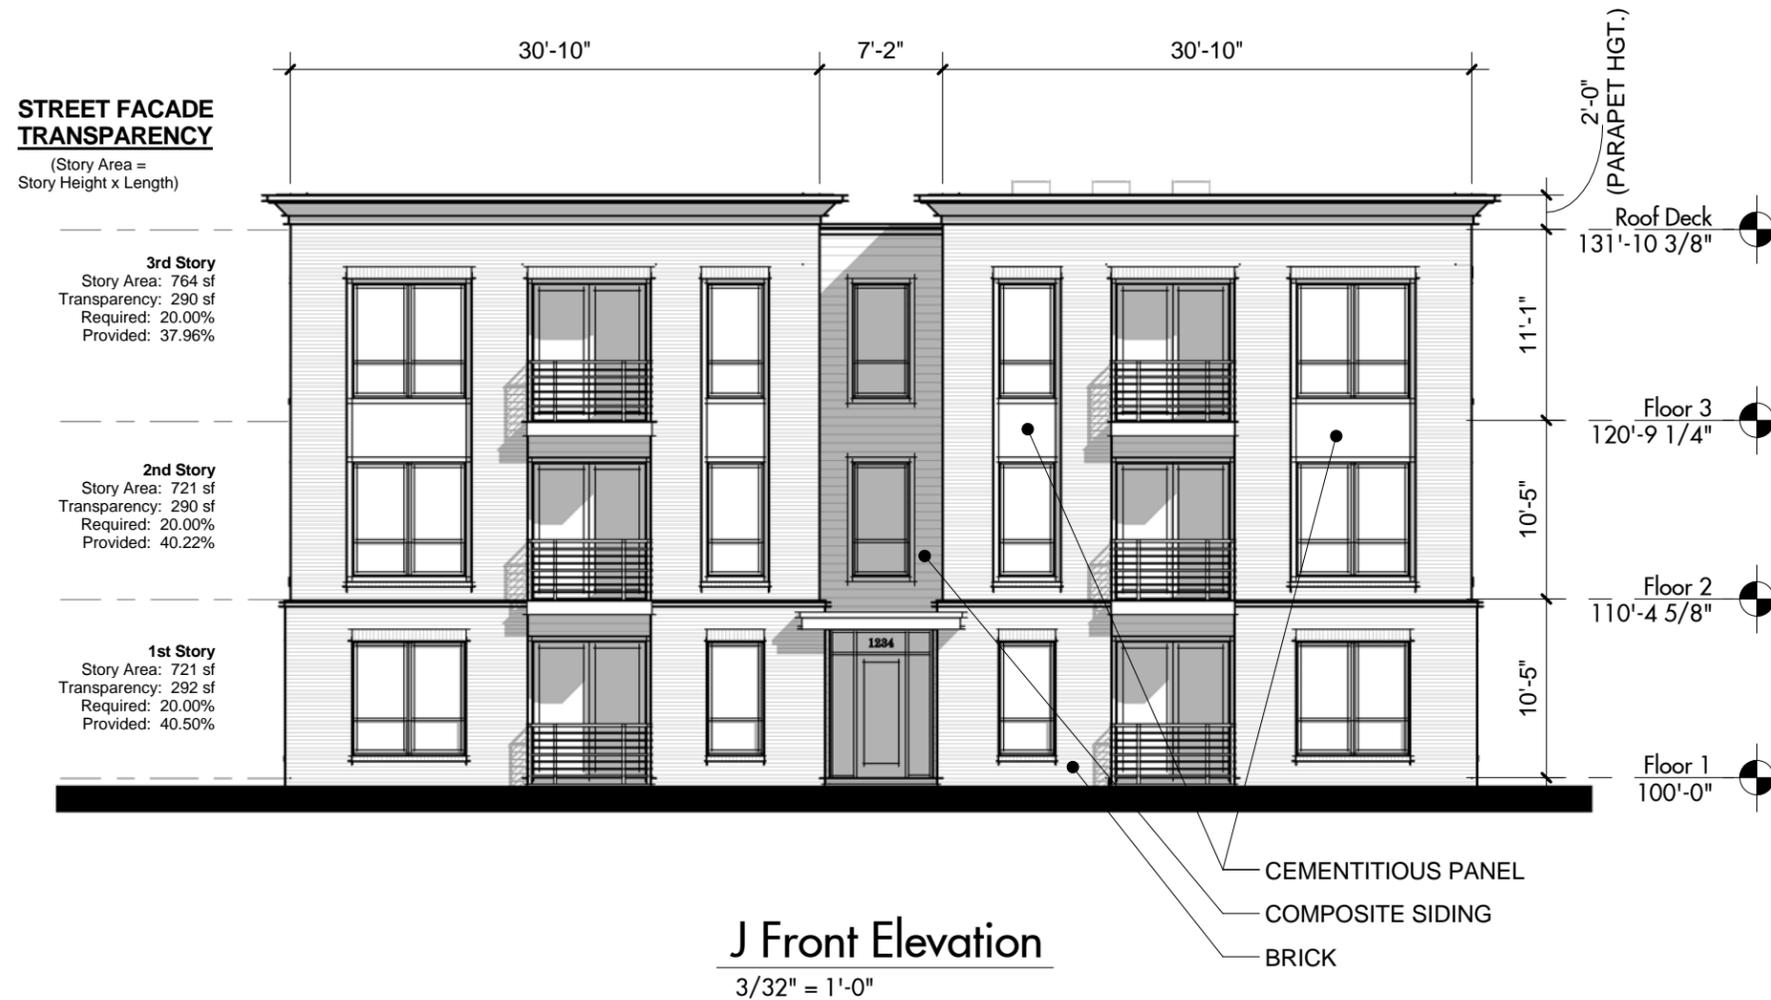
**Total Facade Area\* = 1,321 SF**  
\*Windows/Doors not included in Facade Area

Material	Primary/Secondary	Area (SF)	Percentage	Required	Met?
Brick	Primary	1,088	82.36%		
Glass Storefront	Primary	52	3.94%		
		<b>1,140</b>	<b>86.30%</b>	<b>80%</b>	<b>Y</b>
Composite Siding	Secondary	98	7.42%		
Cementitious Panel	Secondary	83	6.28%		
		<b>181</b>	<b>13.70%</b>	<b>&lt;20%</b>	<b>Y</b>

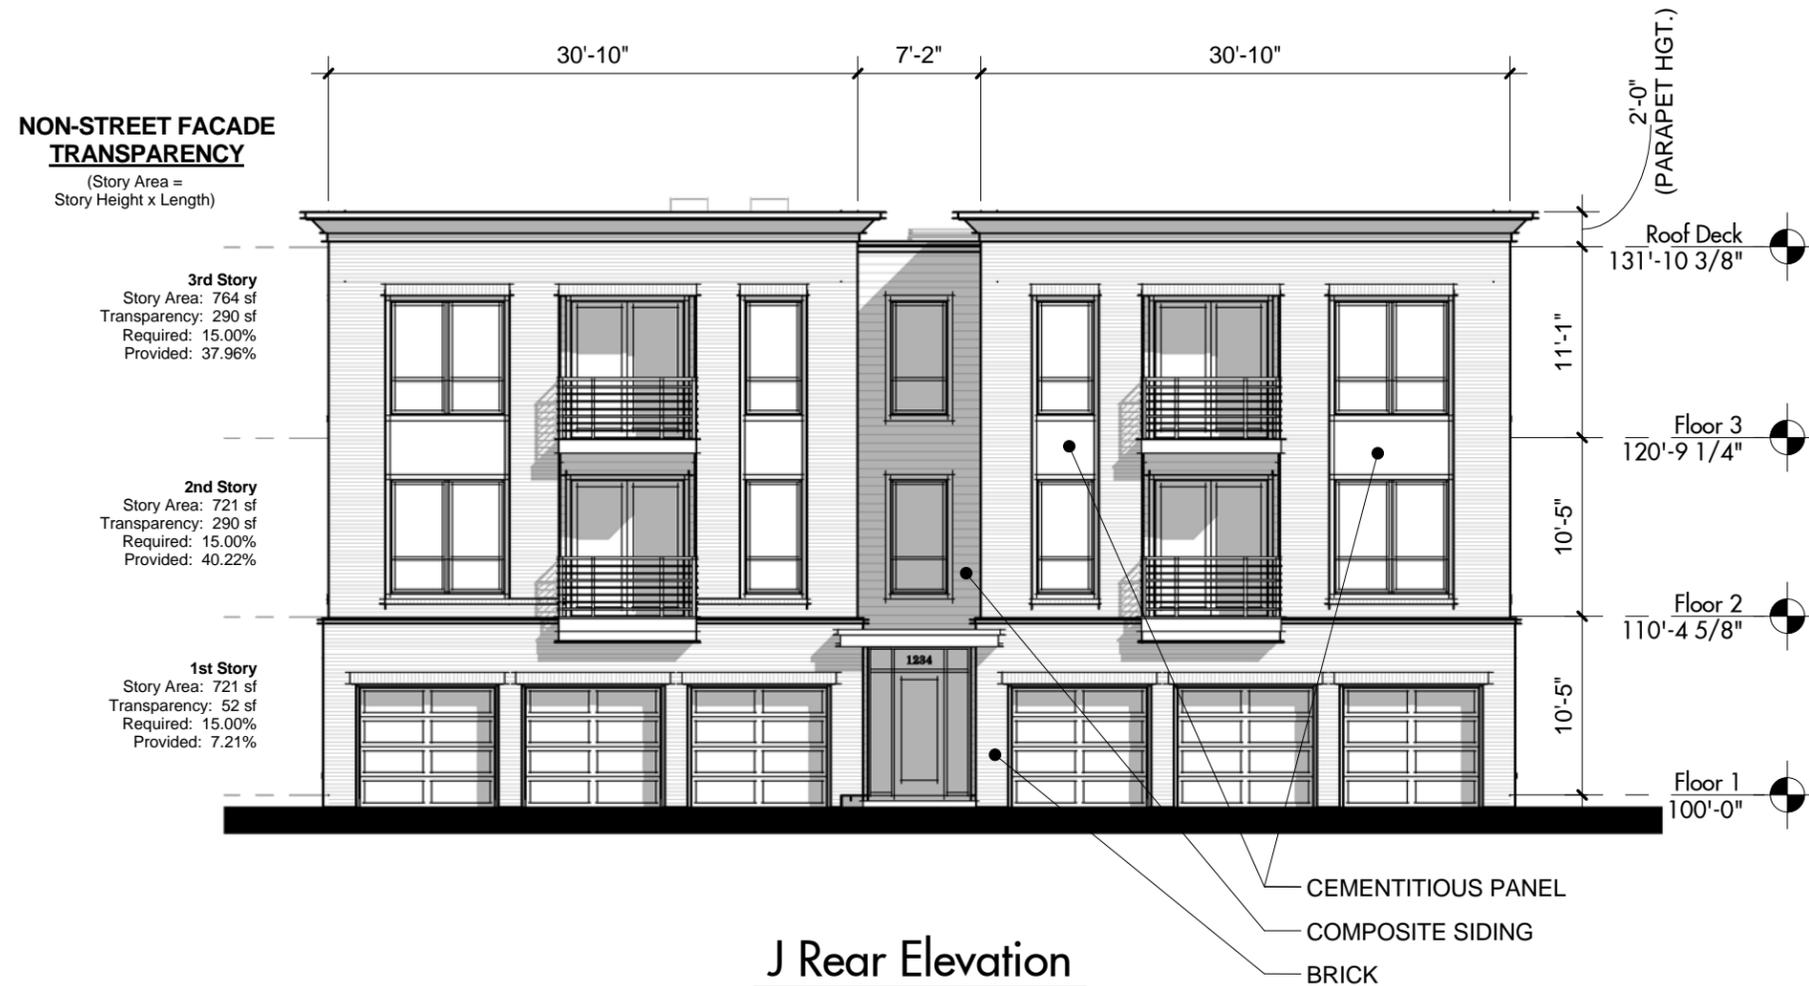
**Total Facade Area\* = 1,233 SF**

Material	Primary/Secondary	Area (SF)	Percentage	Required	Met?
Brick	Primary	1,000	81.10%		
Glass Storefront	Primary	52	4.22%		
		<b>1,052</b>	<b>85.32%</b>	<b>80%</b>	<b>Y</b>
Composite Siding	Secondary	98	7.95%		
Cementitious Panel	Secondary	83	6.73%		
		<b>181</b>	<b>14.68%</b>	<b>&lt;20%</b>	<b>Y</b>

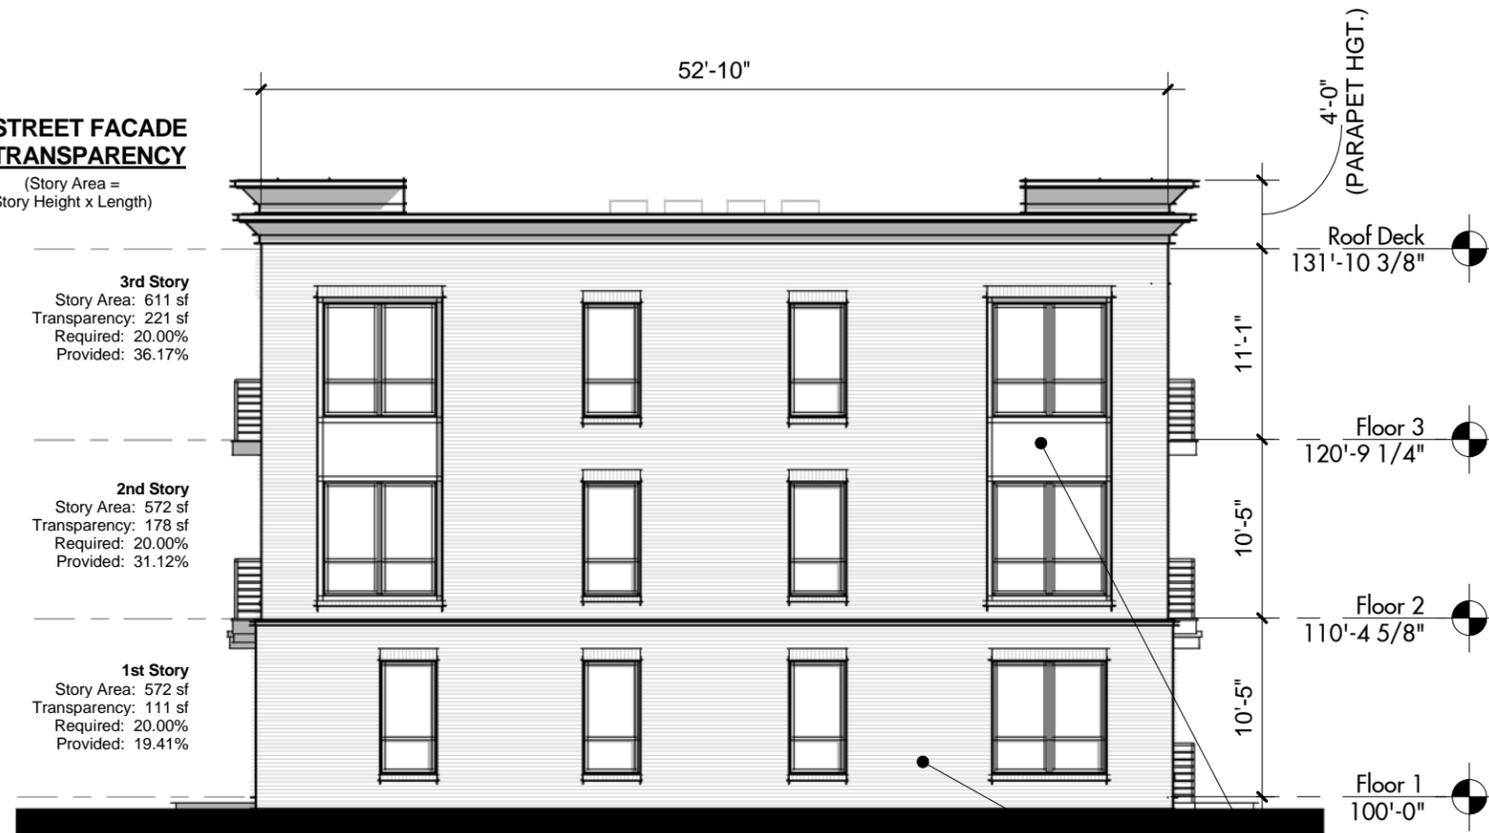
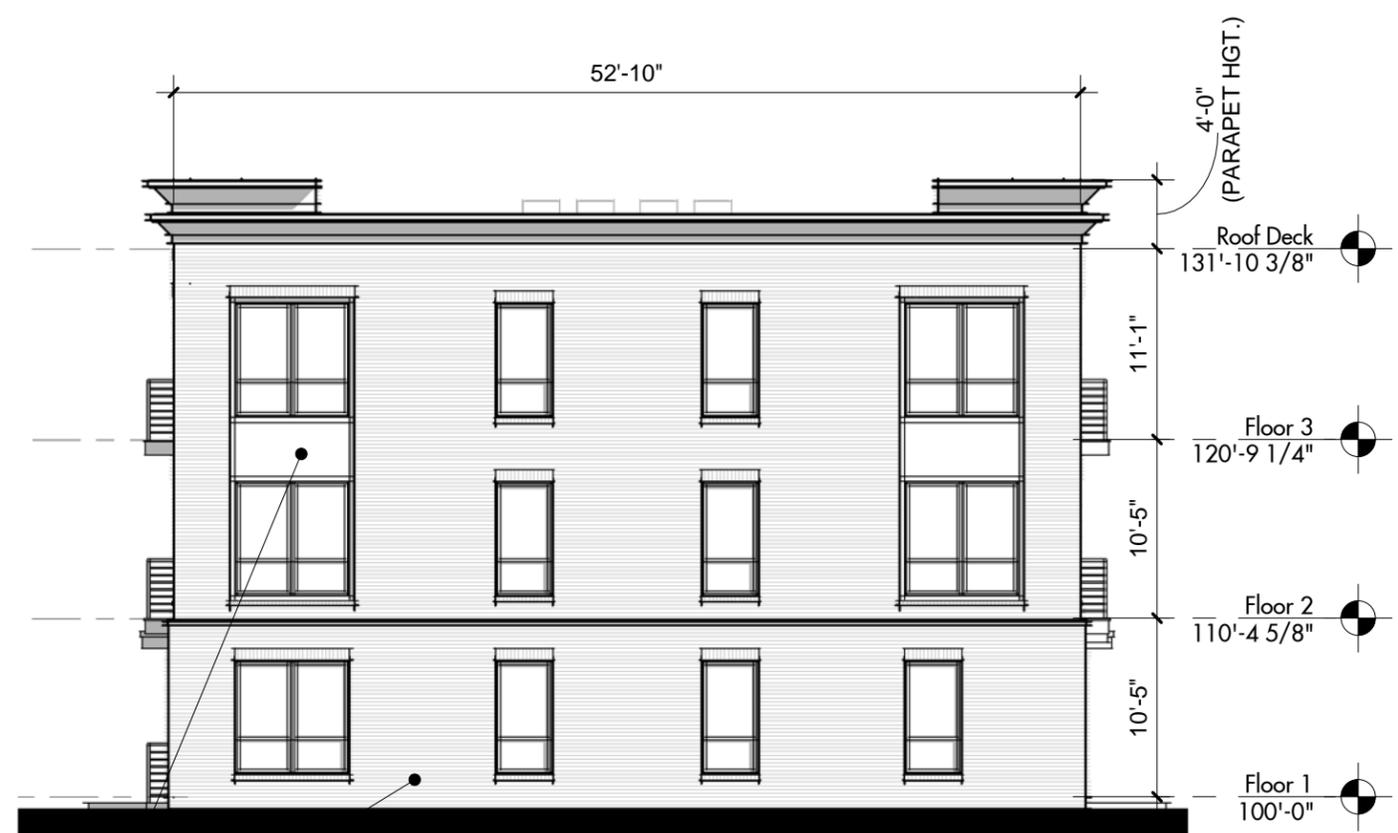
**F, G & J Left Elevation**

**STREET FACADE  
TRANSPARENCY**

**3rd Story**  
Story Area: 611 sf  
Transparency: 221 sf  
Required: 20.00%  
Provided: 36.17%

**2nd Story**  
Story Area: 572 sf  
Transparency: 178 sf  
Required: 20.00%  
Provided: 31.12%

**1st Story**  
Story Area: 572 sf  
Transparency: 111 sf  
Required: 20.00%  
Provided: 19.41%

**F, G & J Right Elevation**

**Total Facade Area\* = 1,428 SF**

Material	Primary/Secondary	Area (SF)	Percentage	Required	Met?
Brick	Primary	1,374	96.22%		
Glass Storefront	Primary	0	0.00%		
		<b>1,374</b>	<b>96.22%</b>	<b>80%</b>	<b>Y</b>
Composite Siding	Secondary	0	0.00%		
Cementitious Panel	Secondary	54	3.78%		
		<b>54</b>	<b>3.78%</b>	<b>&lt;20%</b>	<b>Y</b>

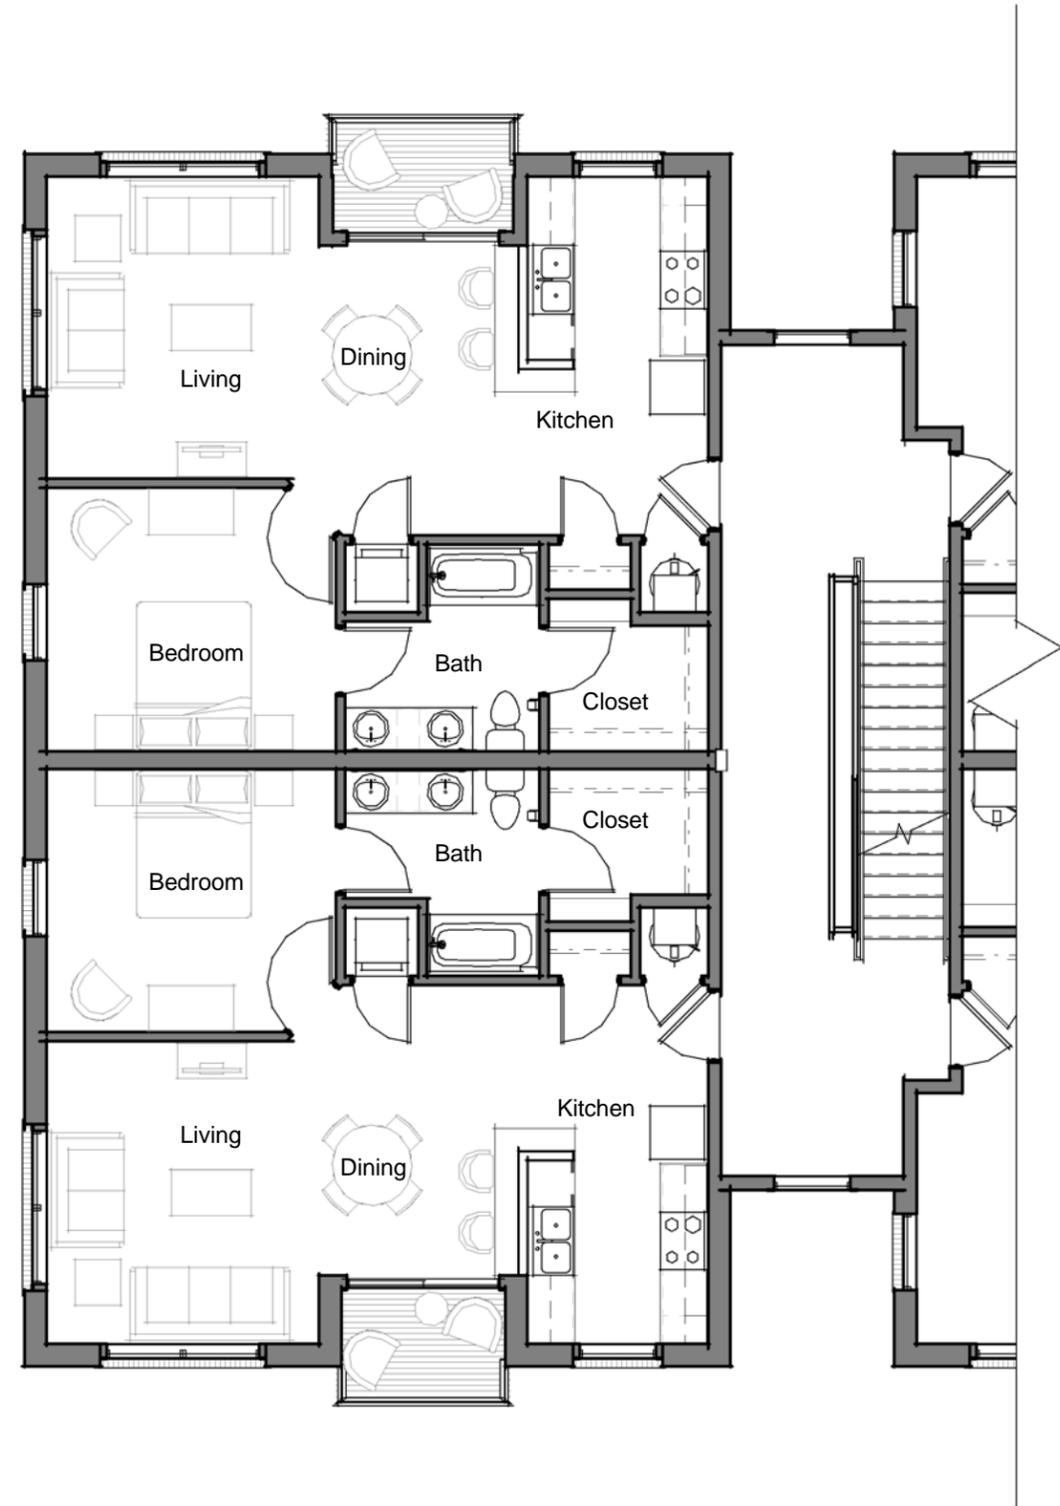
Unit Plan - Floor 2 & 3  
1/8" = 1'-0"

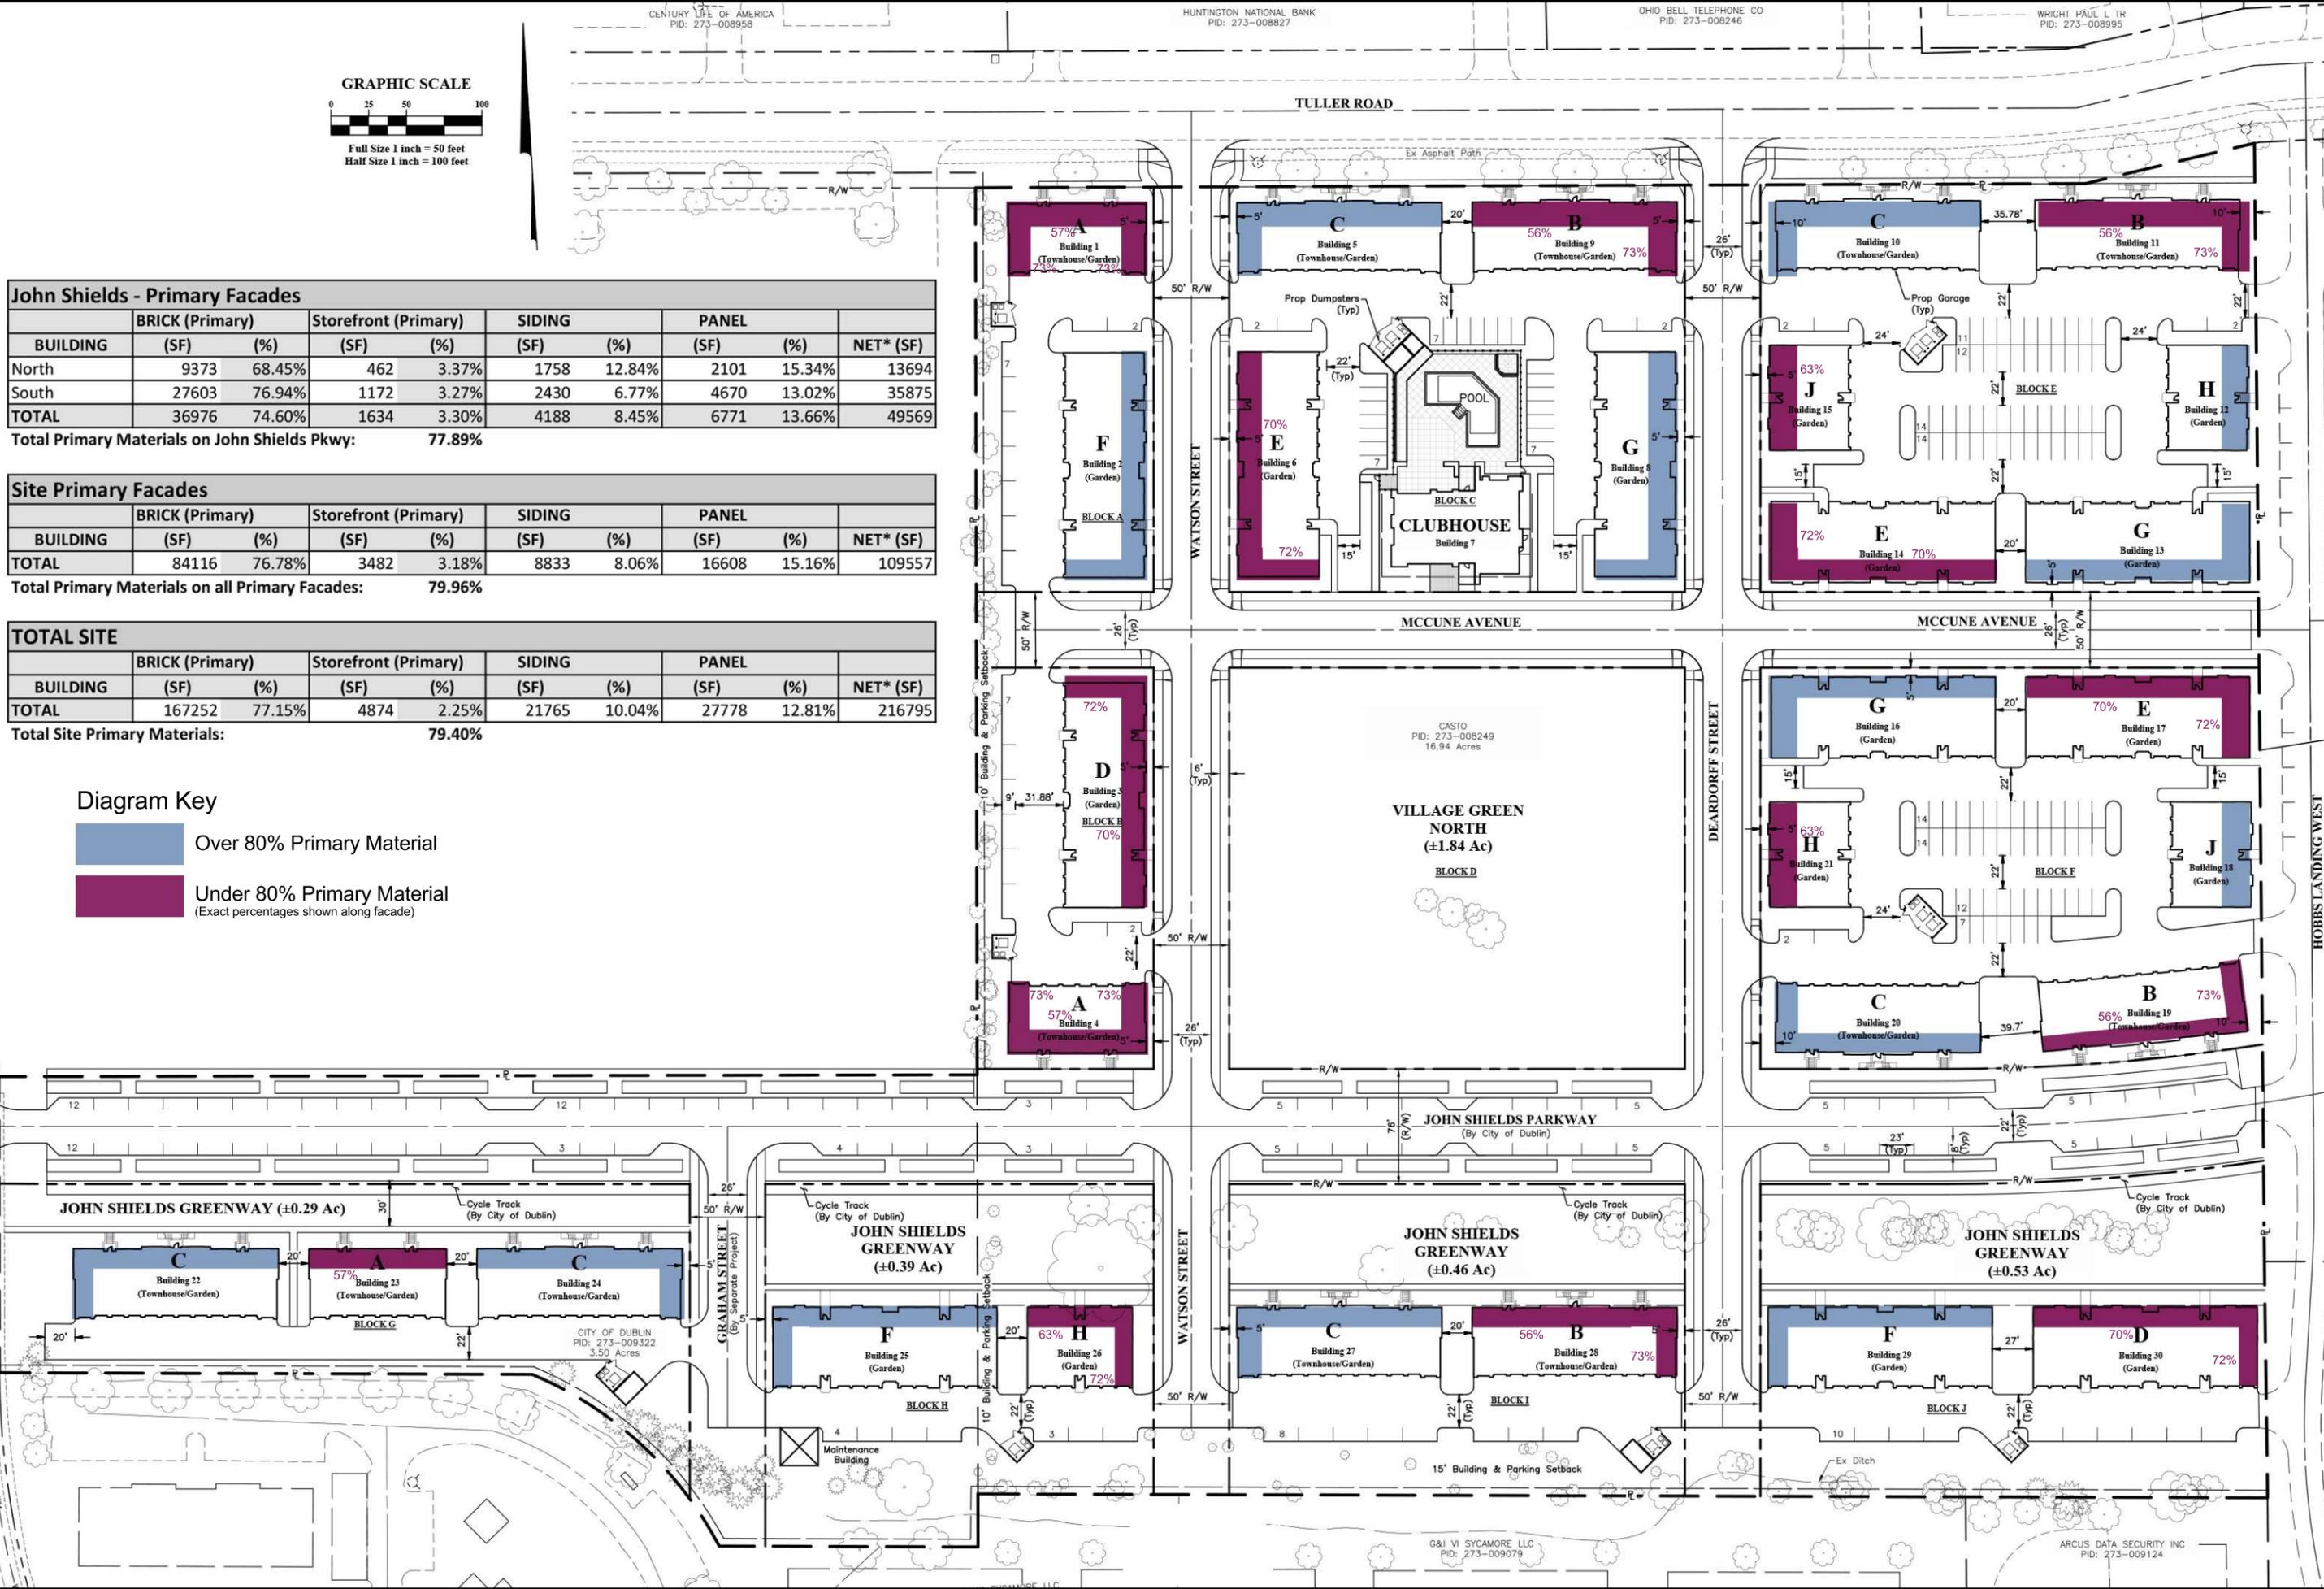
**John Shields - Primary Facades**

Total Primary Materials on John Shields Pkwy: **77.89%**

**Site Primary Facades**

Total Primary Materials on all Primary Facades: **79.96%**

Total Site Primary Materials: **79.40%**

**Diagram Key**

- Over 80% Primary Material
- Under 80% Primary Material (Exact percentages shown along facade)
