17-089ARB– DEMOLITION

Request for demolition of a portion of an existing single-family home and two detached garages.

17-089ARB
Architectural Review Board - Demolition
Yoder Residence - Demolition
5927 Rings Road

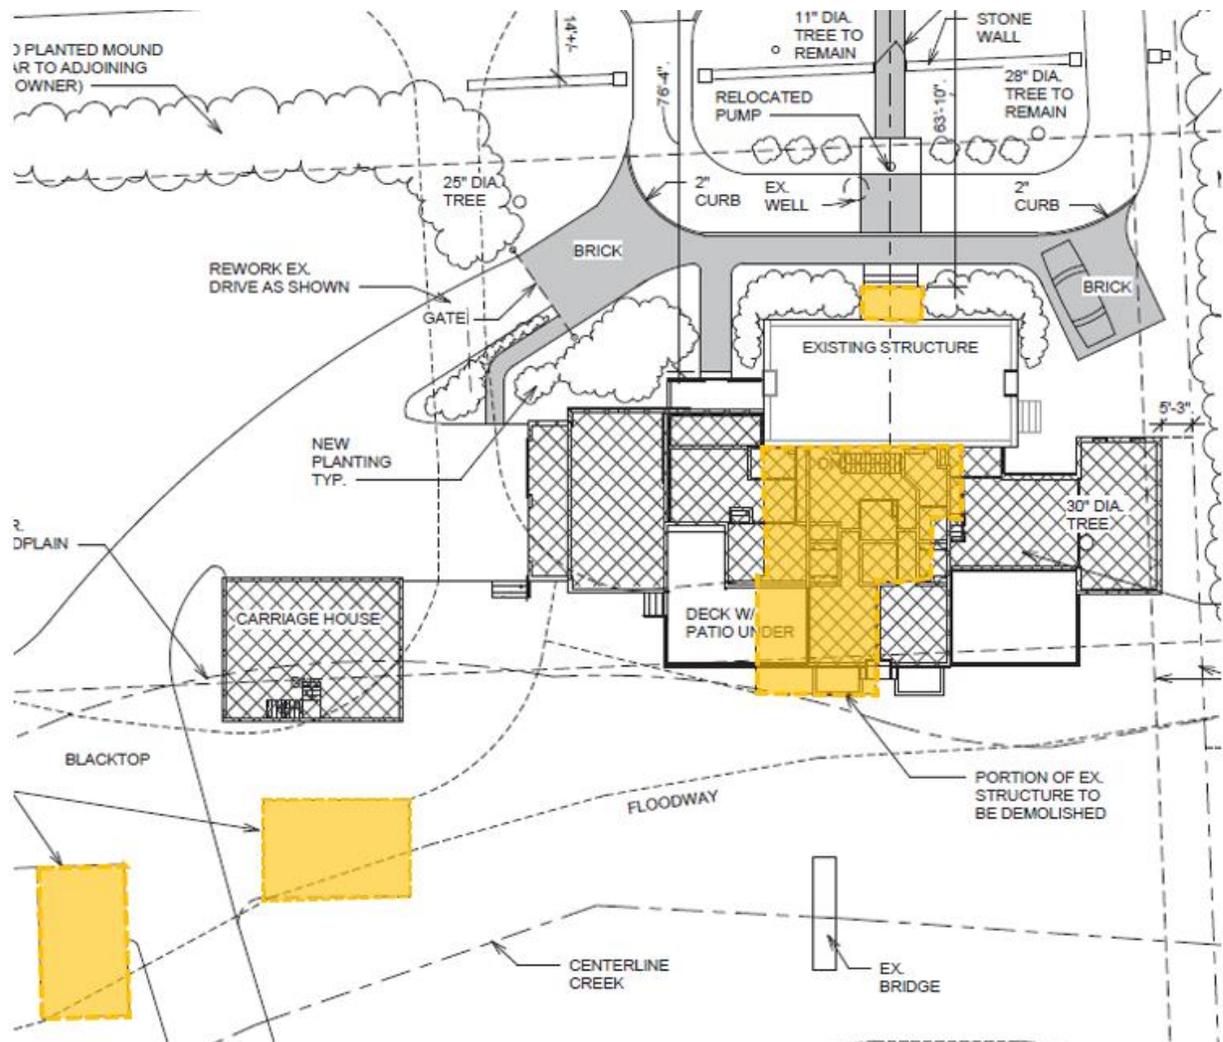
3. Site Plan

The site plan below shows the areas to be demolished in yellow. The hatched areas are proposed additions, as part of a separate application.

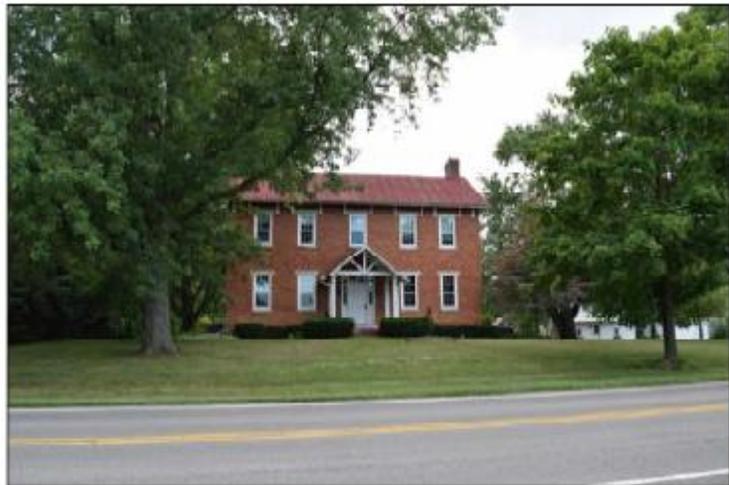
The site contains a two-story gable-roof brick house dating to ca. 1855 (date based on Franklin County Auditor website and architectural characteristics). The consultant assess that “the residence has a stone foundation, a rectangular plan, a gable-front wood-frame porch, a seam-metal side-gable roof, two interior brick chimneys and decorative Italianate brackets along the roofline. The six-over-six light sash windows have stone sills and lintels while wood-frame Gothic-arc windows provide light to the attic. The seven panel Greek Revival-style wood front door has sidelights and a transom with decorative molding and brackets.”

The consultant identified “several rear extensions include an approximately 21’ x 22’ one-story gable-roof brick component, an approximately 7’ x 12’ one-story wood-frame addition, an approximately 7’ x 10’ one-story brick addition, and an approximately 19’ x 20’ one-story wood frame garage with a slate roof.” Additionally, the gable-roof brick extension appears to be original to the house or a very early addition since it has the same brick and brick coursing (5-course American bond) and a continuous stone foundation. It also has a similar seam metal roof and six-over-six light sash windows with stone sills and lintels.
