Re: SR 161/Riverside Drive Traffic Operations Update

Background

City Council has requested an update regarding the traffic operations at the SR 161/Riverside Drive roundabout. The SR 161/Riverside Drive roundabout opened to traffic in the early hours of August 13, 2016. Since the opening of the roundabout and the previous staff report dated August 31, 2016, which is attached for your reference, several physical and operational changes have been made. These changes are mainly due to construction progress and field observations.

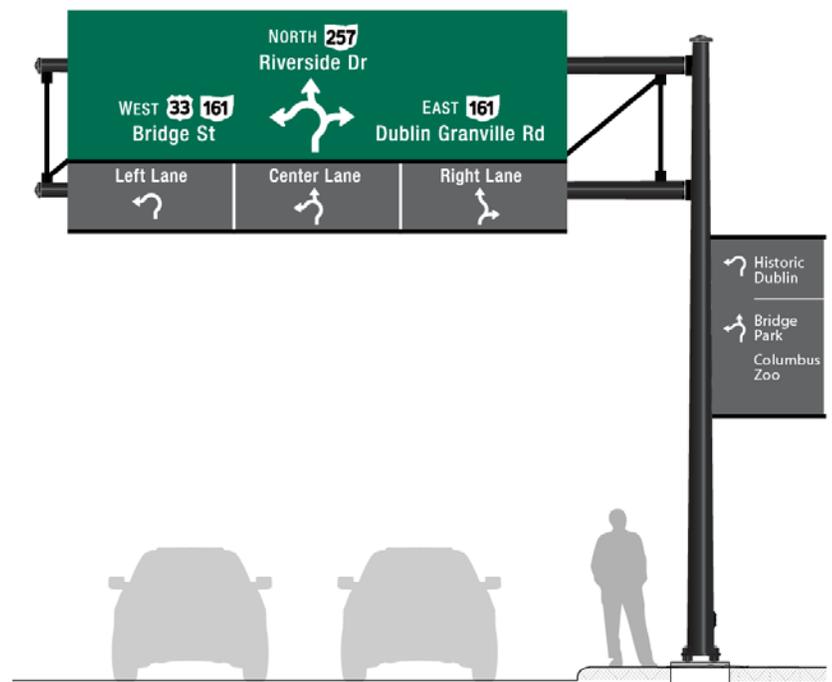
The permanent overhead signs for each approach to the intersection were installed on September 29, 2016 (see Figure 1). The temporary wood poles, strain wires, and flat sheet signs were removed. The permanent signs will also receive lighting before the final close-out of the construction project. The contractor has ordered the light fixtures, but they have not been delivered, so staff is unsure of the anticipated installation date. Staff has been working with the contractor, however, to emphasize the importance of the installation of the lights as soon practical after they are received.

Figure 1: Permanent Overhead Sign (Northbound)

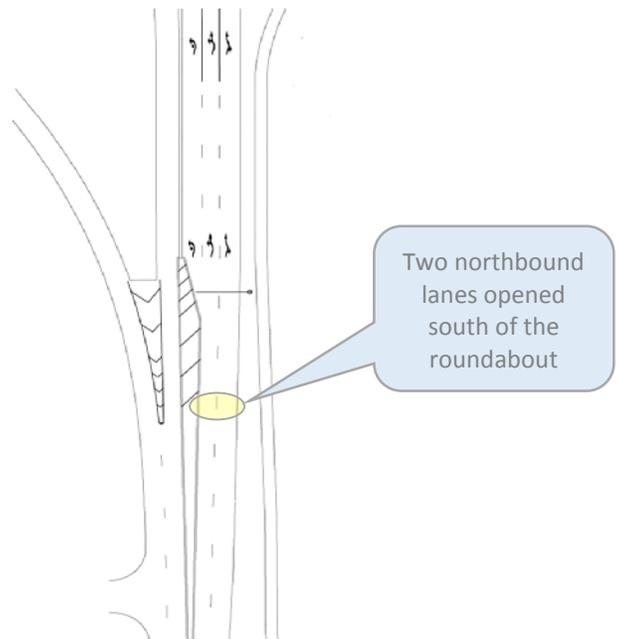
As construction progressed, additional travel lanes opened. The section of Riverside Drive south of the roundabout approach opened in the middle of October, as shown in Figure 2. In conjunction with the permanent overhead signs, the additional northbound lane has helped drivers choose the appropriate lane earlier and reinforce that there are two through lanes available through the intersection.

Figure 2: NB Lane Open South of the Roundabout

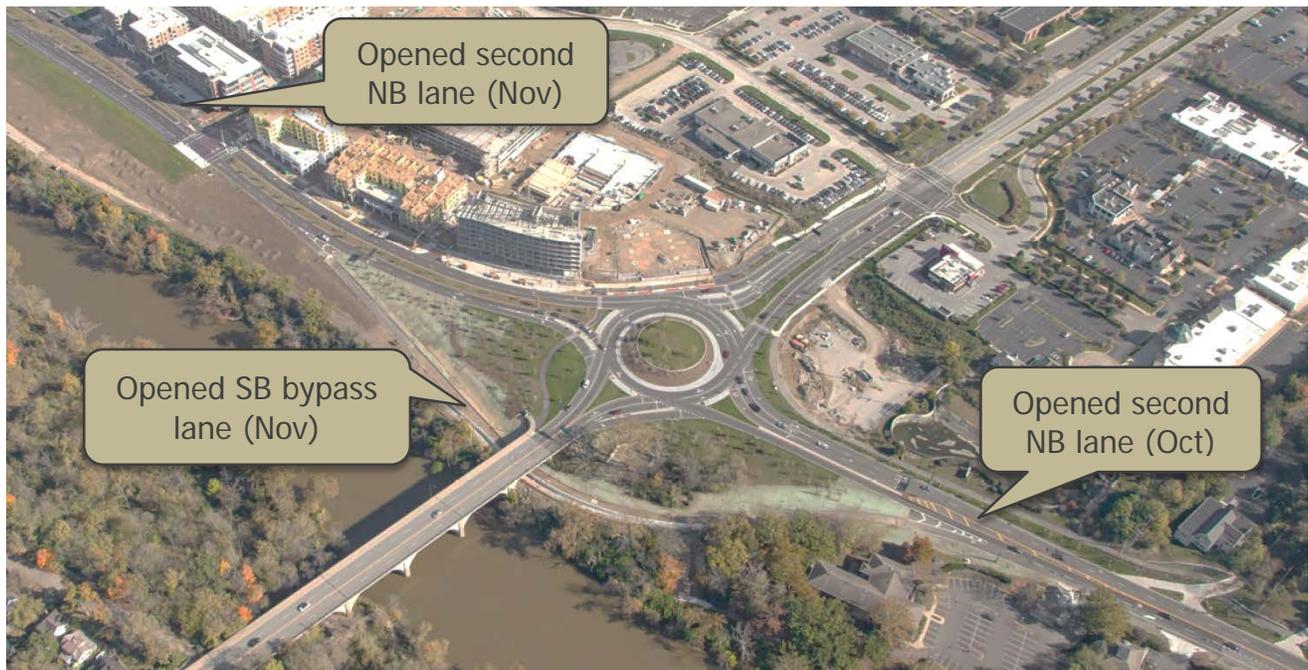
The southbound bypass lane opened, along with the second northbound lane of Riverside Drive north of the roundabout on November 11, 2016. (See Figure 3) This was the final day of active roadway construction for the project.

The opening of the southbound bypass lane has removed approximately 7,000 to 10,000 vehicles per day, reducing the number of vehicles at the surface intersection, which could potentially conflict. Likewise, the opening of the second northbound lane north of the roundabout has been important as now drivers can maintain their lane through the active project area, or in other words, not have to change lanes to remain on Riverside Drive, which reduces the number of potential conflicts.

Figure 3: Open Lanes

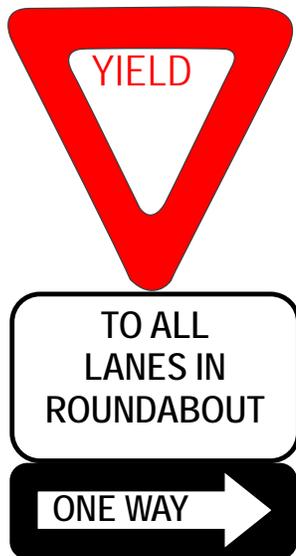
On September 15, 2016, the plaques under the yield signs were amended to read "To all lanes in Roundabout" on the northbound, southbound, and westbound approaches. Eastbound was not revised, as there is only one circulating lane at this entry. The northbound signs were further modified on October 5, 2016 to simply read "To BOTH Lanes." (See Figures 4 and 5).

Figure 4: Revised YIELD Sign Assembly

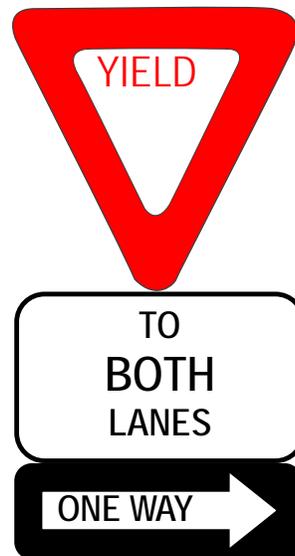
Since the northbound approach is the most complex, it is important that the messaging for this approach is as simple and clear as possible. This sign modification simplifies the message that the approach must yield to the two circulating lanes in the roundabout.

Figure 5: Revised Northbound YIELD Sign Assembly

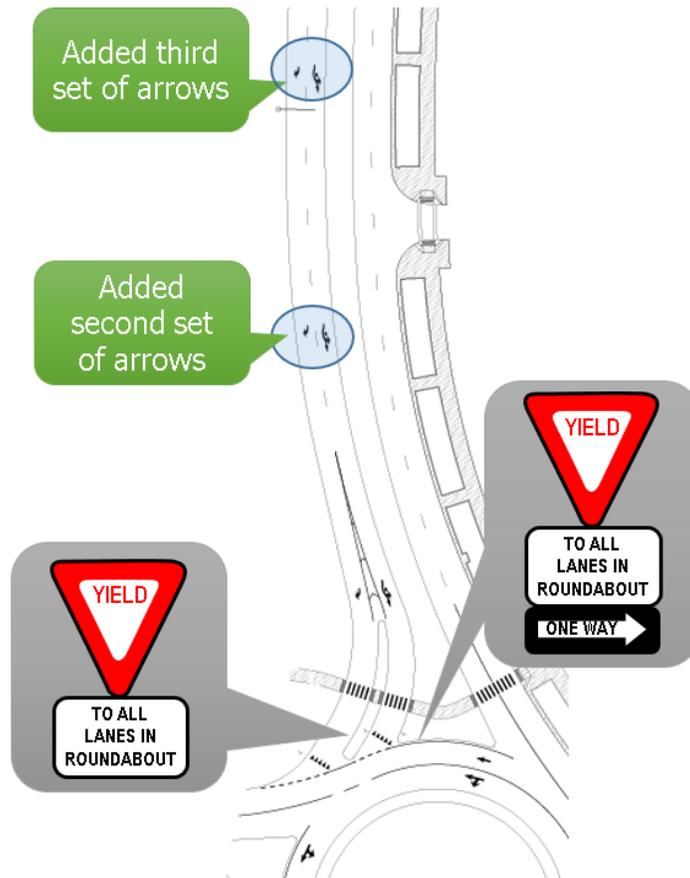
A third set of southbound lane arrows was added on September 16, 2016. (See Figure 6) There is a small hill on this approach that was limiting the visibility of the previous arrows placed. This final set was placed to ensure drivers have enough time to choose the appropriate lane prior to the final approach to the roundabout.

Figure 4: Southbound Lane Arrows

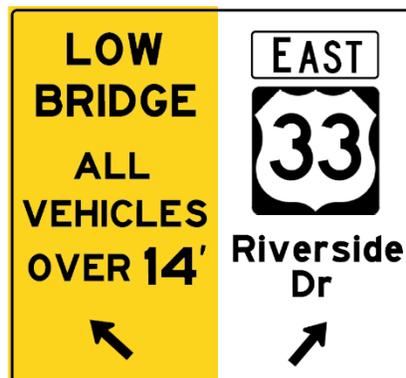
The week of November 7, 2016, a sign was installed for SB traffic to avoid the low clearance under the bridge for oversized vehicles (See Figure 7). This sign was placed prior to the diverge point for the southbound bypass lane to ensure drivers have time to choose the most appropriate lane.

Figure 5: Southbound Clearance Sign

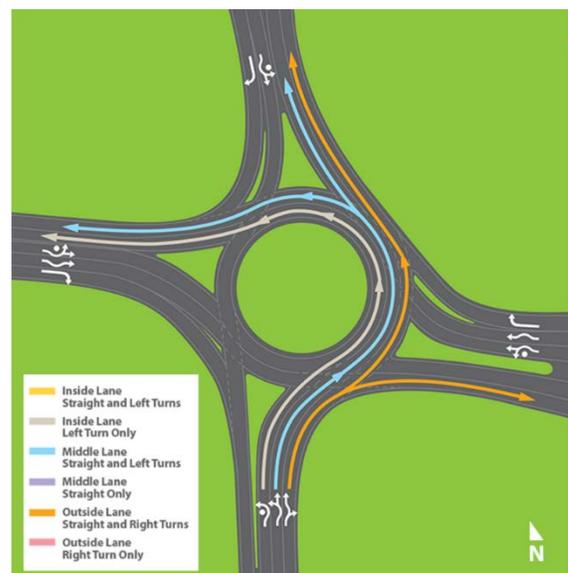
The directed enforcement watched for Failure to Yield violations and other driving activity likely to increase the risk of a traffic crash. Violators were identified by the Highway Patrol Pilot and stopped by Dublin officers in the area. The focus of the detail was to educate our drivers than write citations. Using a pamphlet provided by engineering staff containing graphics similar to this example, officers explained to drivers how to properly navigate the roundabout safely. Every driver officers spoke with expressed confusion over how to proceed at the intersection,

Figure 6: Enforcement Detail
Education Graphic

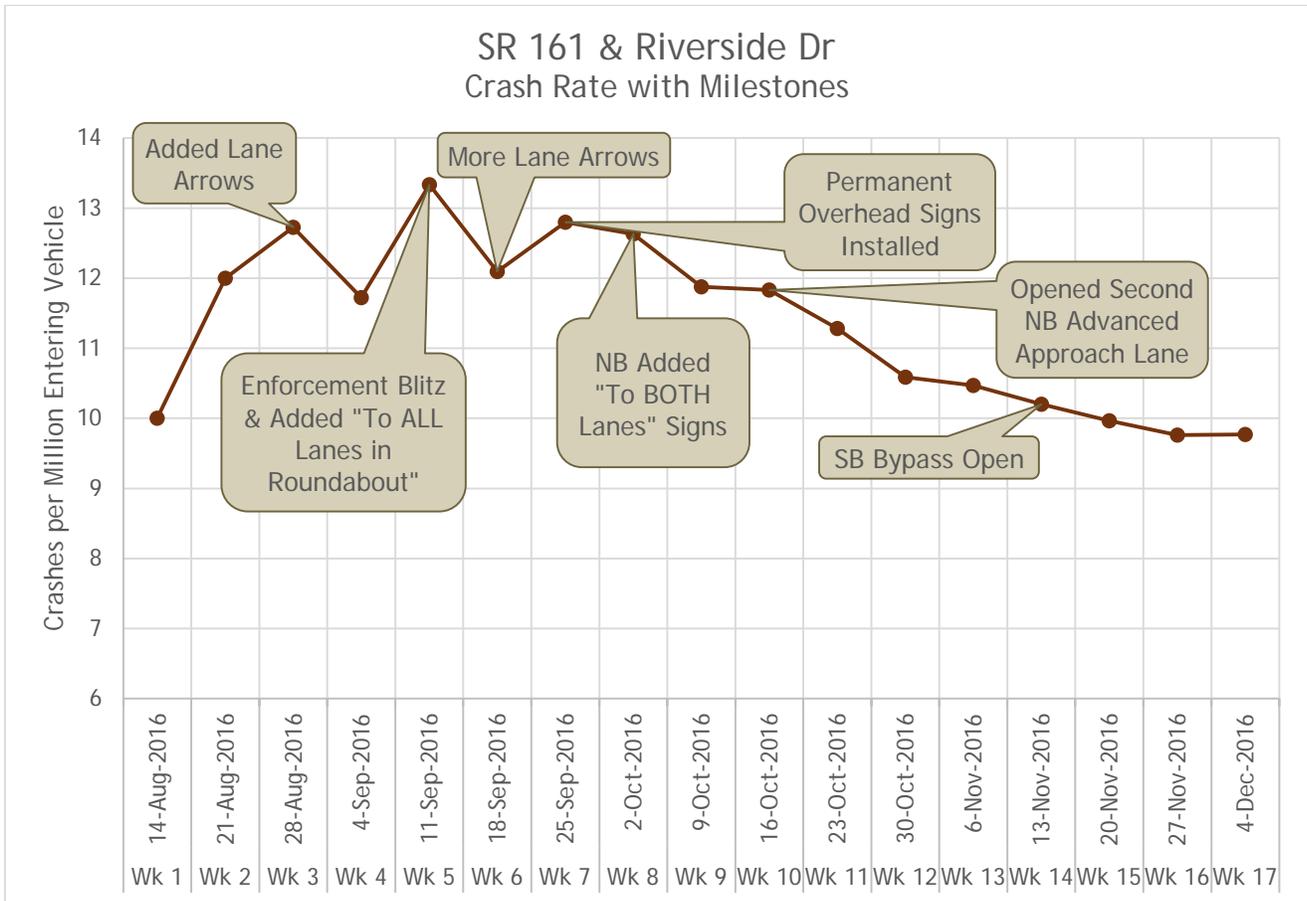
As shown in Figure 9, physical intersection changes are plotted with the running crash rate (crashes per million entering vehicles). Each change is cumulative, working systematically to enhance the entire intersection operations. However, two individual improvements appear to have had significant positive influences: (1) adding the "To BOTH Lanes" signs in the northbound direction and (2) opening the second NB lane prior to the three lane section on Riverside Drive. While still relatively early, it also appears that the opening of the southbound bypass lane is having a very positive effect on the roundabout operations.

Figure 7: Crash Rates with Milestones

Opening the southbound bypass lane in the middle of November removed an estimated 7,000 to 10,000 vehicles per day through the roundabout. At the same time, the construction crews opened the second northbound lane on Riverside Drive north of the roundabout and cleared construction equipment from the site. The bypass lane eliminates a significant amount of potential conflict from the roundabout, and improves the intersection operation, reducing delay. The number of reported crashes since the bypass lane opened, shows about a 40% reduction comparing weekly roundabout crashes before and after the change.
