# Karen Bokor, B.S., M.Arch. DESIGN CONSULTANT

## HISTORICAL ANALYSIS AND DESIGN REVIEW:

**Property Address:** 60 Franklin Street

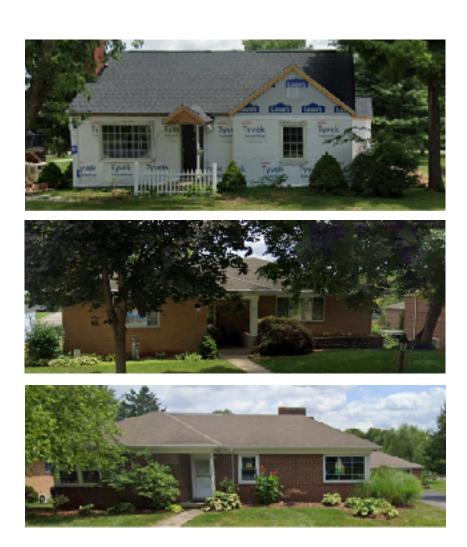
Front facades (north to south):

Below are photos of the homes on this block for reference from north to south of both front and rear facades:
