**COHATCH RIVERVIEW  
PRELIMINARY DEVELOPMENT PACKAGE  
08.30.2024**

## Welcome to Riverview Village! COhatch's new National Headquarters is a one-of-a-kind coworking and entrepreneurship community.

The Riverview Village project comprises a combination of restored historic homes, a ground-up new build, and several outdoor experiences. The main goal is to revitalize the underused riverfront area by creating a modern-day village where innovative start-ups, growing small businesses, freelancers, non-profits, and hybrid companies meet and engage the community.

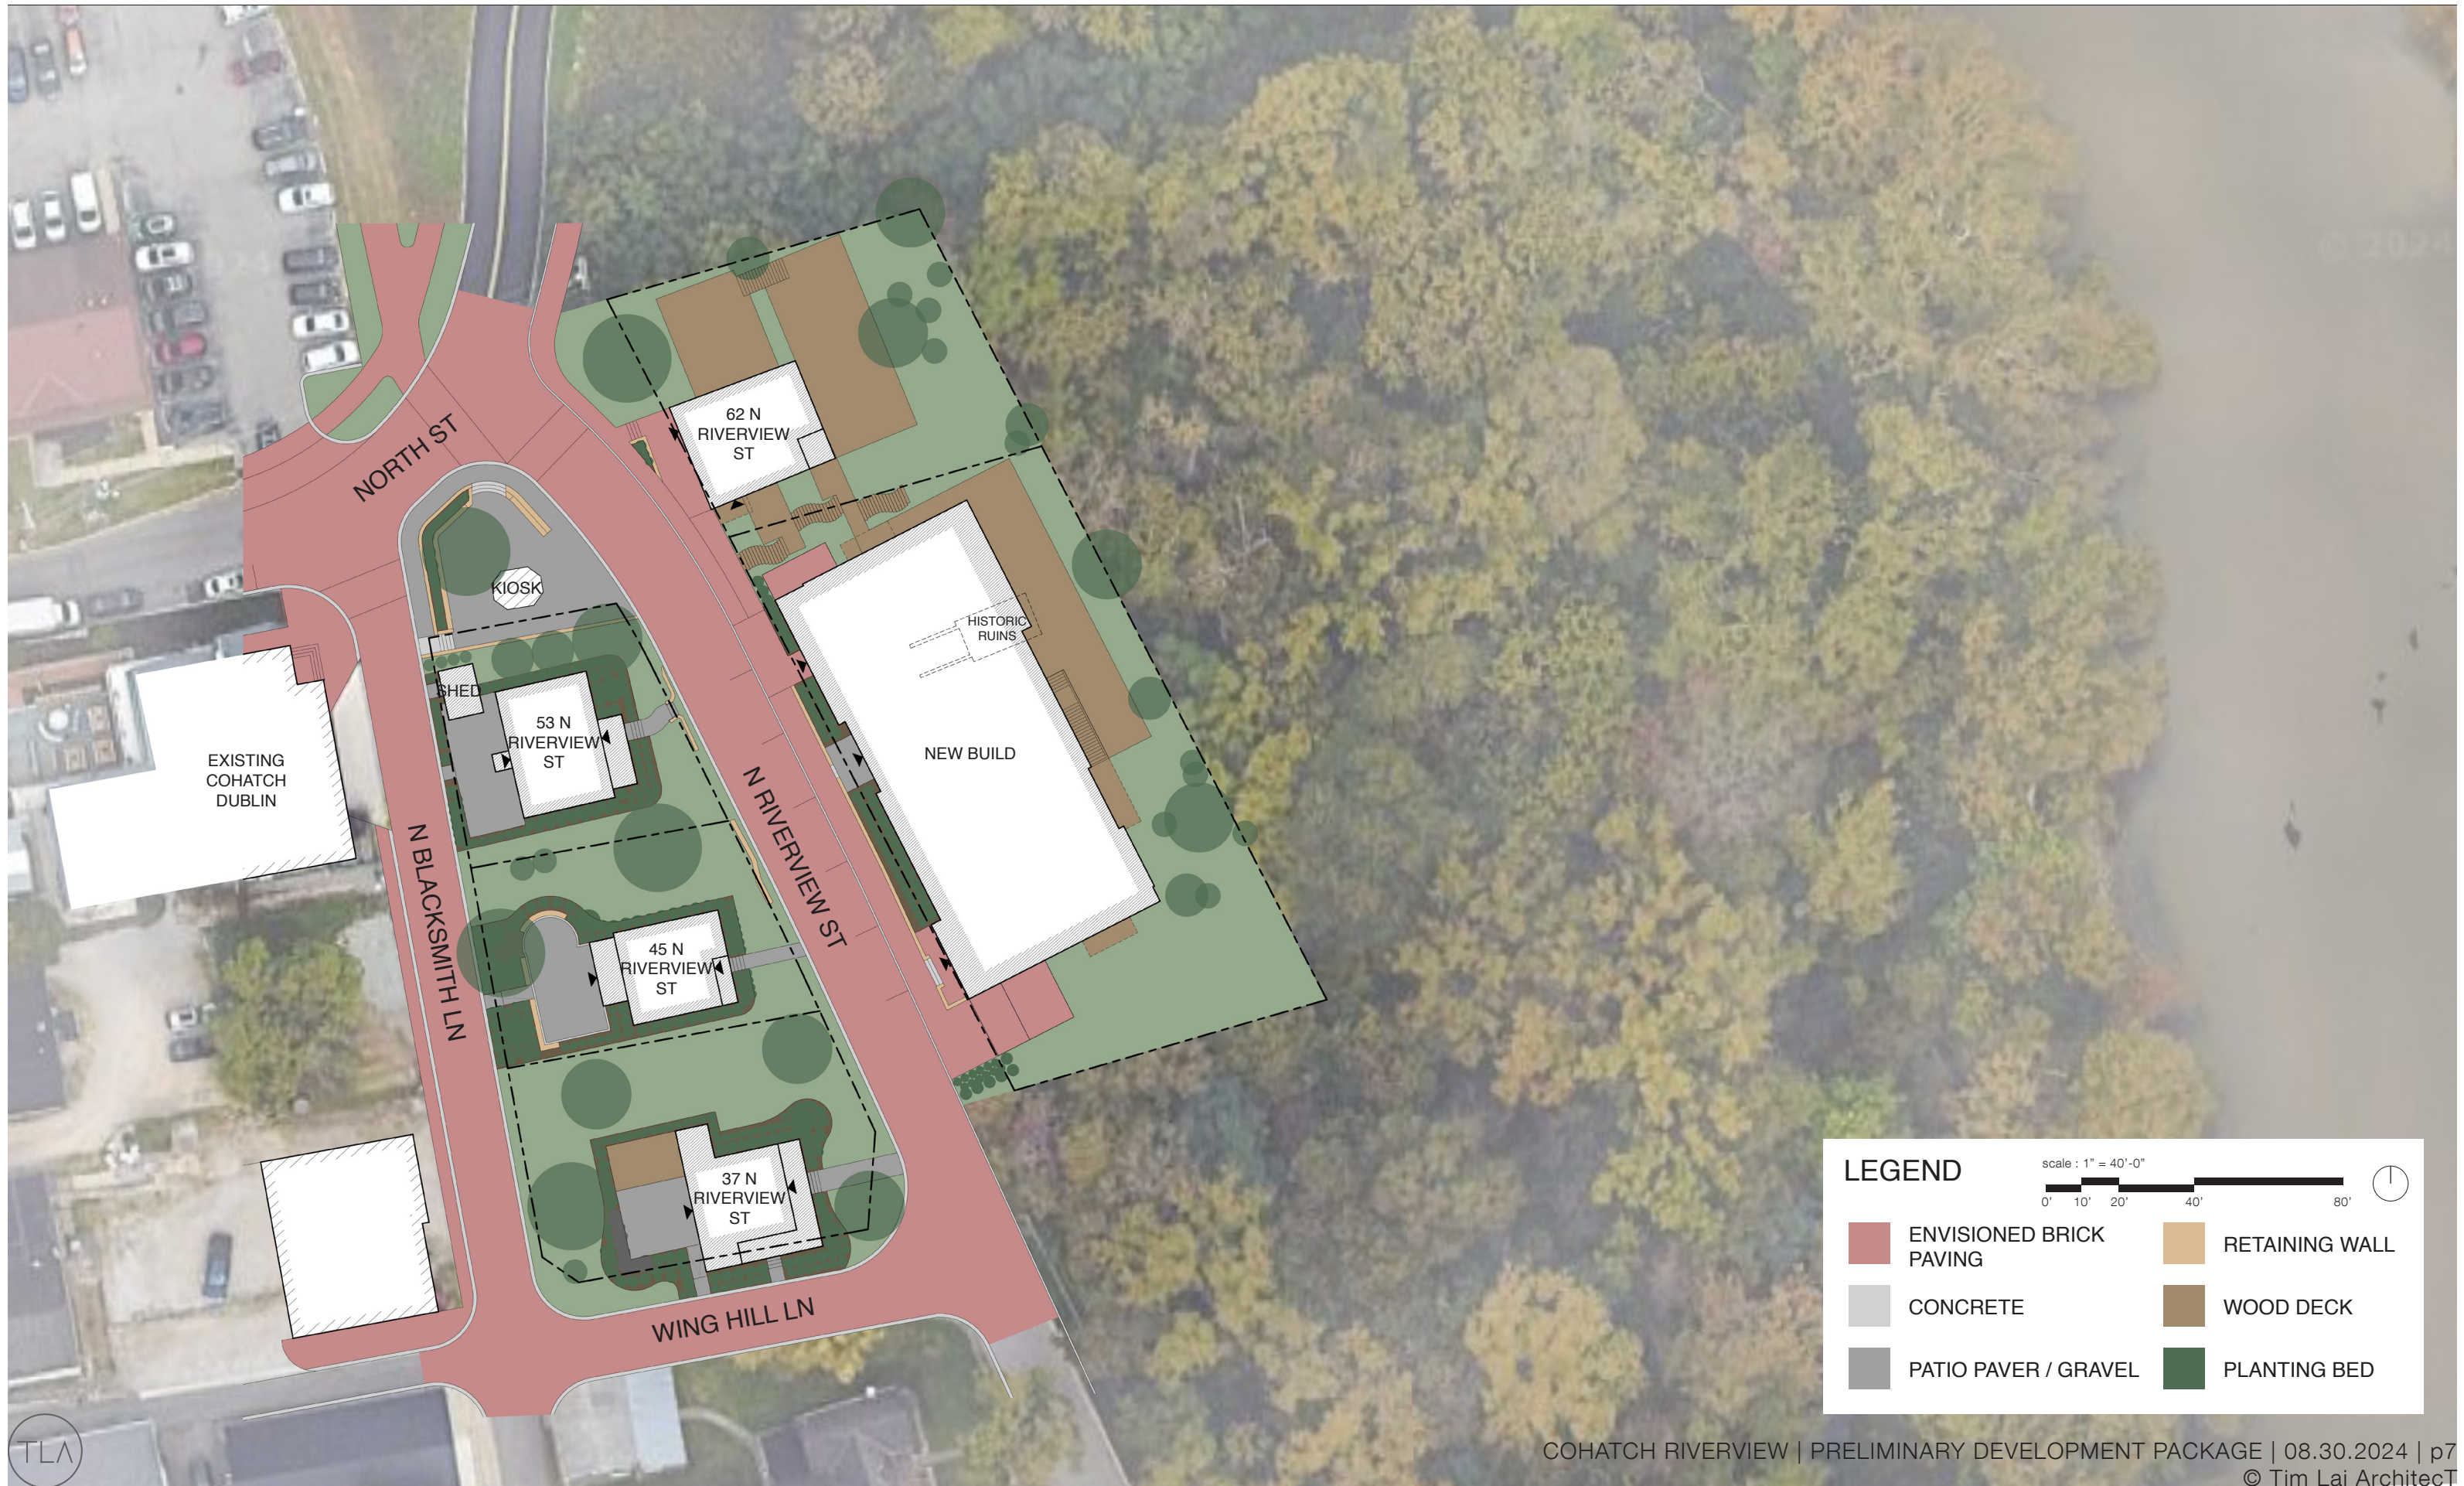
**LEGEND** scale : 1" = 40'-0"

<ul style="list-style-type: none"> <li><span style="display: inline-block; width: 15px; height: 15px; background-color: #c0392b; margin-right: 5px;"></span> ENVISIONED BRICK PAVING</li> <li><span style="display: inline-block; width: 15px; height: 15px; background-color: #95a5a6; margin-right: 5px;"></span> CONCRETE</li> <li><span style="display: inline-block; width: 15px; height: 15px; background-color: #7f7f7f; margin-right: 5px;"></span> PATIO PAVER / GRAVEL</li> </ul>	<ul style="list-style-type: none"> <li><span style="display: inline-block; width: 15px; height: 15px; background-color: #d35400; margin-right: 5px;"></span> RETAINING WALL</li> <li><span style="display: inline-block; width: 15px; height: 15px; background-color: #8e6c4a; margin-right: 5px;"></span> WOOD DECK</li> <li><span style="display: inline-block; width: 15px; height: 15px; background-color: #2e7d32; margin-right: 5px;"></span> PLANTING BED</li> </ul>

The Riverview Village is pedestrian-friendly by design. Envisioned brick-paved roads will demarcate the village premises and new sidewalks on North Street, N. Riverview St, and N. Blacksmith Ln will ensure walkability of the village. Some parking spaces are proposed along N. Riverview St for convenience and ample bike parking will be provided.

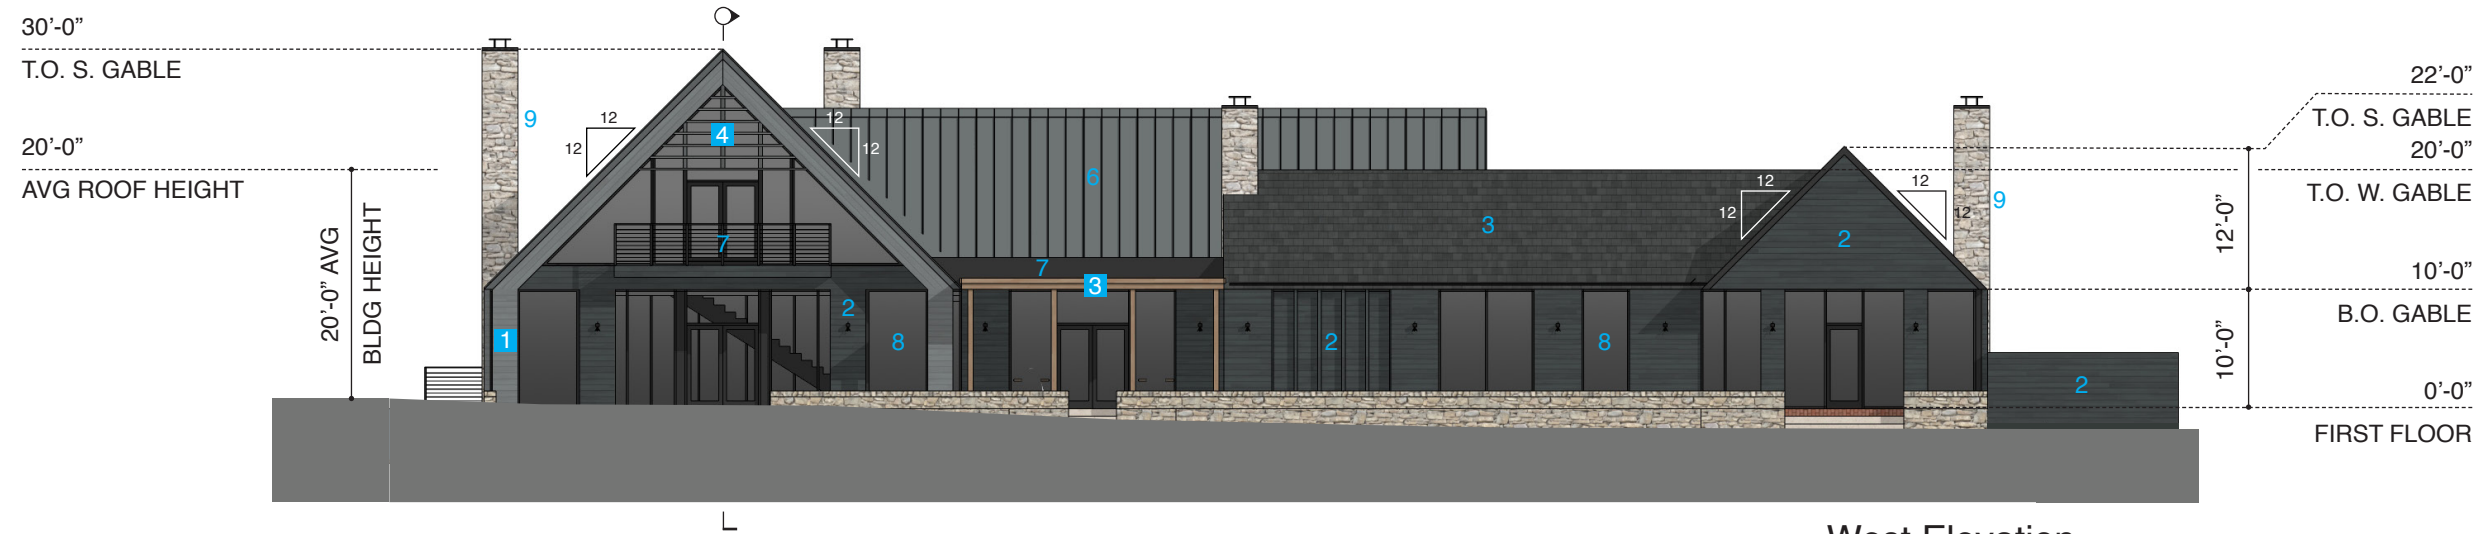
**West Elevation**

scale : 1/16" = 1'-0"

- 1 Stained wood siding, medium gray
- 2 Stained wood siding, dark gray
- 3 Cedar, clear coat
- 4 Stained wood louvres, medium gray
- 5 Composite slate roof
- 6 Standing seam metal roof, DMI dark bronze
- 7 Metal cladding, railing, and trim, dark bronze
- 8 Aluminum window w/ insulated glass, dark bronze finish
- 9 Limestone veneer
- 10 Passive flood vent
- 11 Steel structure, charcoal
- 12 Poured concrete piers, charcoal
- 13 Composite decking, BOD Timber Tech color Tigerwood

The new COhatch building is proposed along the east side of N Riverview St. A total of 14,250 square feet of office and meeting spaces will be available, with the building designed to acknowledge the intimate scale and vernacular style of Historic Dublin. Stone and wood are chosen as primary building materials for their natural beauty. The multiple gable roofs and stone-clad chimneys will help break up the massing and create an undulating roof-line that fits well with the surrounding structures of the historic district. In between this new building and the red cabin, the current stairs going down east to the river will be widened. This provides access connecting the new COhatch building, the lower deck of the red cabin, and eventually the public landings to the north of the red cabin. With the two newly constructed staircases and the expanded old staircase, the community and COhatch members will be able to meander through the woods and the outdoor spaces, which are not accessible to the public currently. These will result in a highly walkable and connected Village and riverfront.

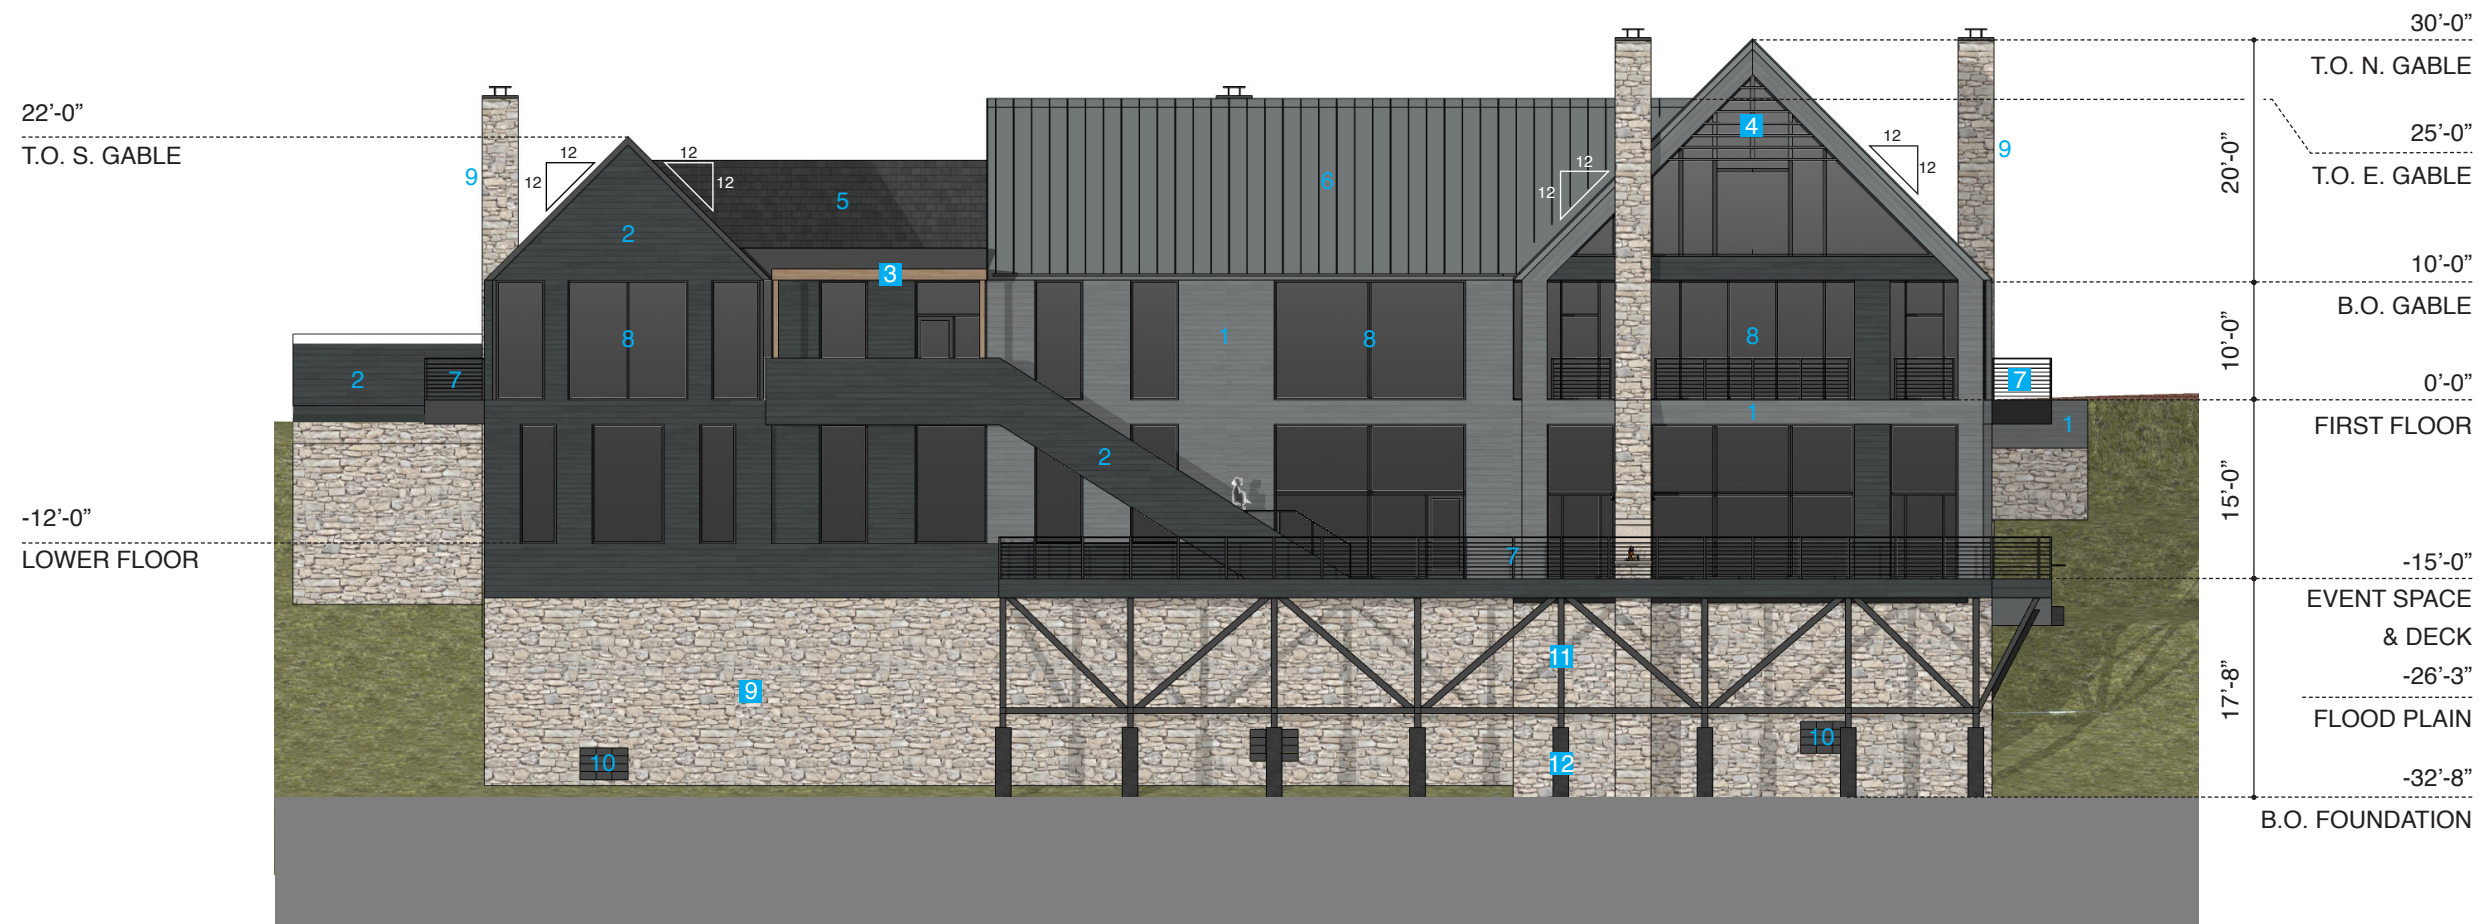
**East Elevation**

scale : 1/16" = 1'-0"

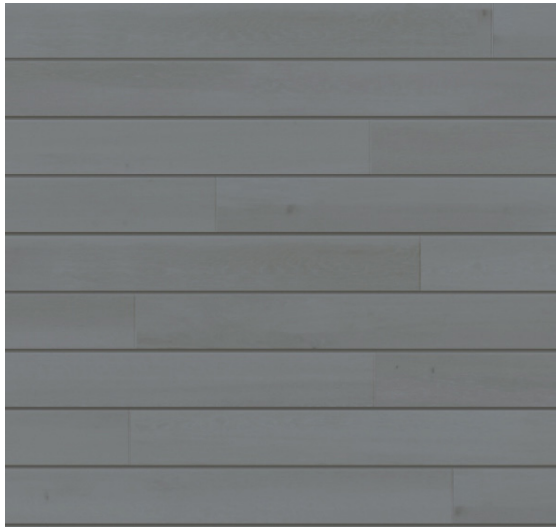
Stained wood siding, medium gray to match existing COHatch

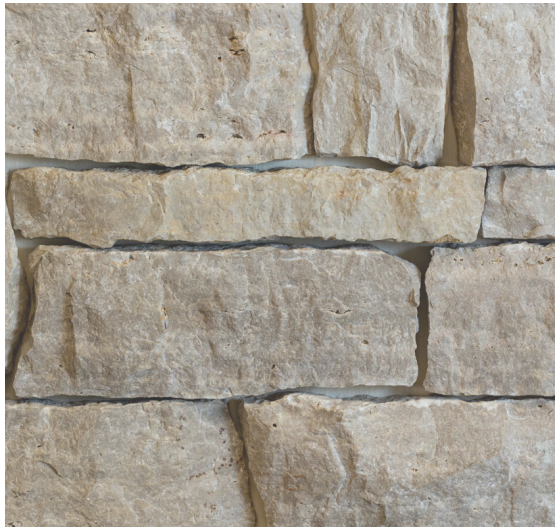
Limestone veneer over foundation and exterior wall

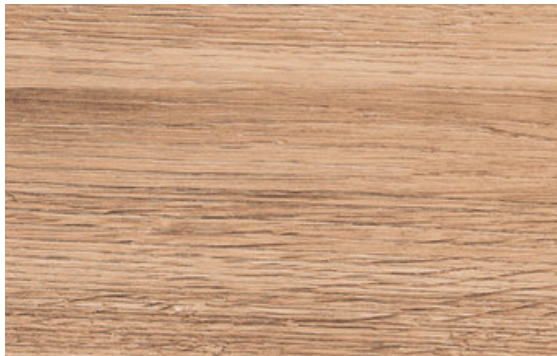
Cedar with clear coat

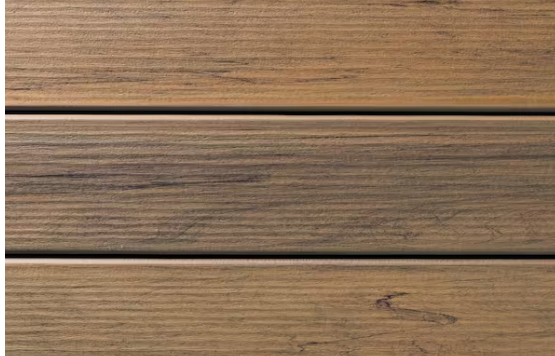
Composite decking, BOD Timber Tech color Tigerwood

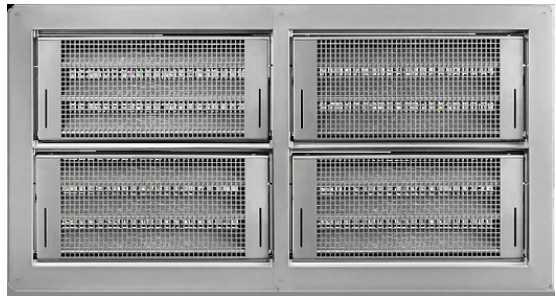
Passive flood vent at the bottom of foundation. If compensatory storage is satisfied through other means, this will be eliminated.

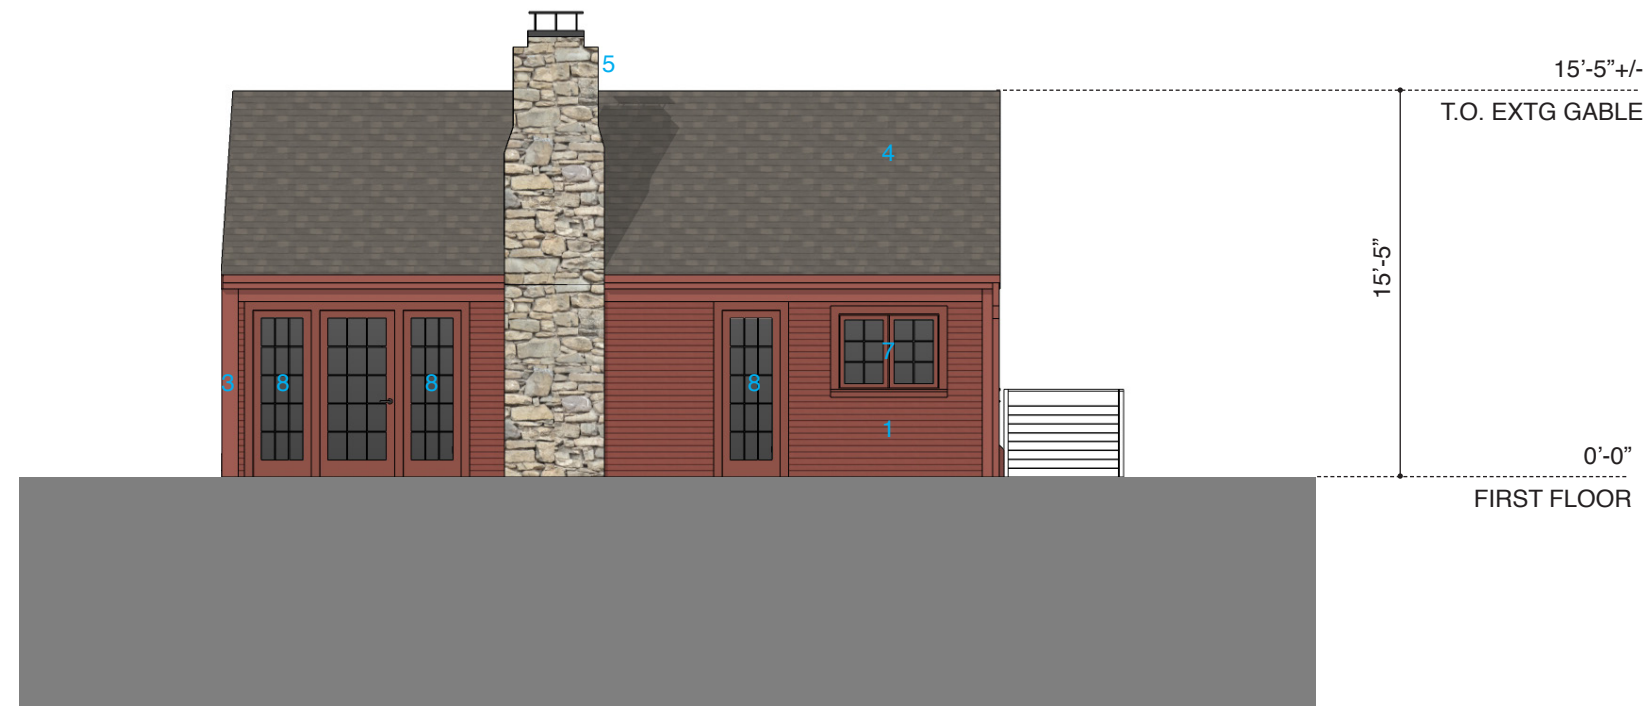
West Elevation

- 1 Restored 3" Horizontal Cedar Siding
- 2 Restored Cedar Board and Batten Siding
- 3 Cedar Trim
- 4 Asphalt shingle roof
- 5 Existing Stacked Stone
- 6 Existing Brick
- 7 Casement 6-lite Windows with Wood Casing
- 8 Fixed 15-lite Window with Wood Casing
- 9 Existing Concrete Foundation
- 10 Fiber Cement Board
- 11 Steel Deck Structure

The main portion of the red house will be restored. The existing horizontal and board & batten siding will be repaired and a new asphalt shingle roof will be installed. On its west elevation, the original entrance will be replaced with a fixed window. The existing arched window is not original to the cabin, and will be replaced with a three-bay door to become the main entrance with ADA access. On the south elevation, a service door and a small landing for temporary trash storage will be added to the first floor. On the north, an additional door is to be added at the B1 level for access to the upper deck.

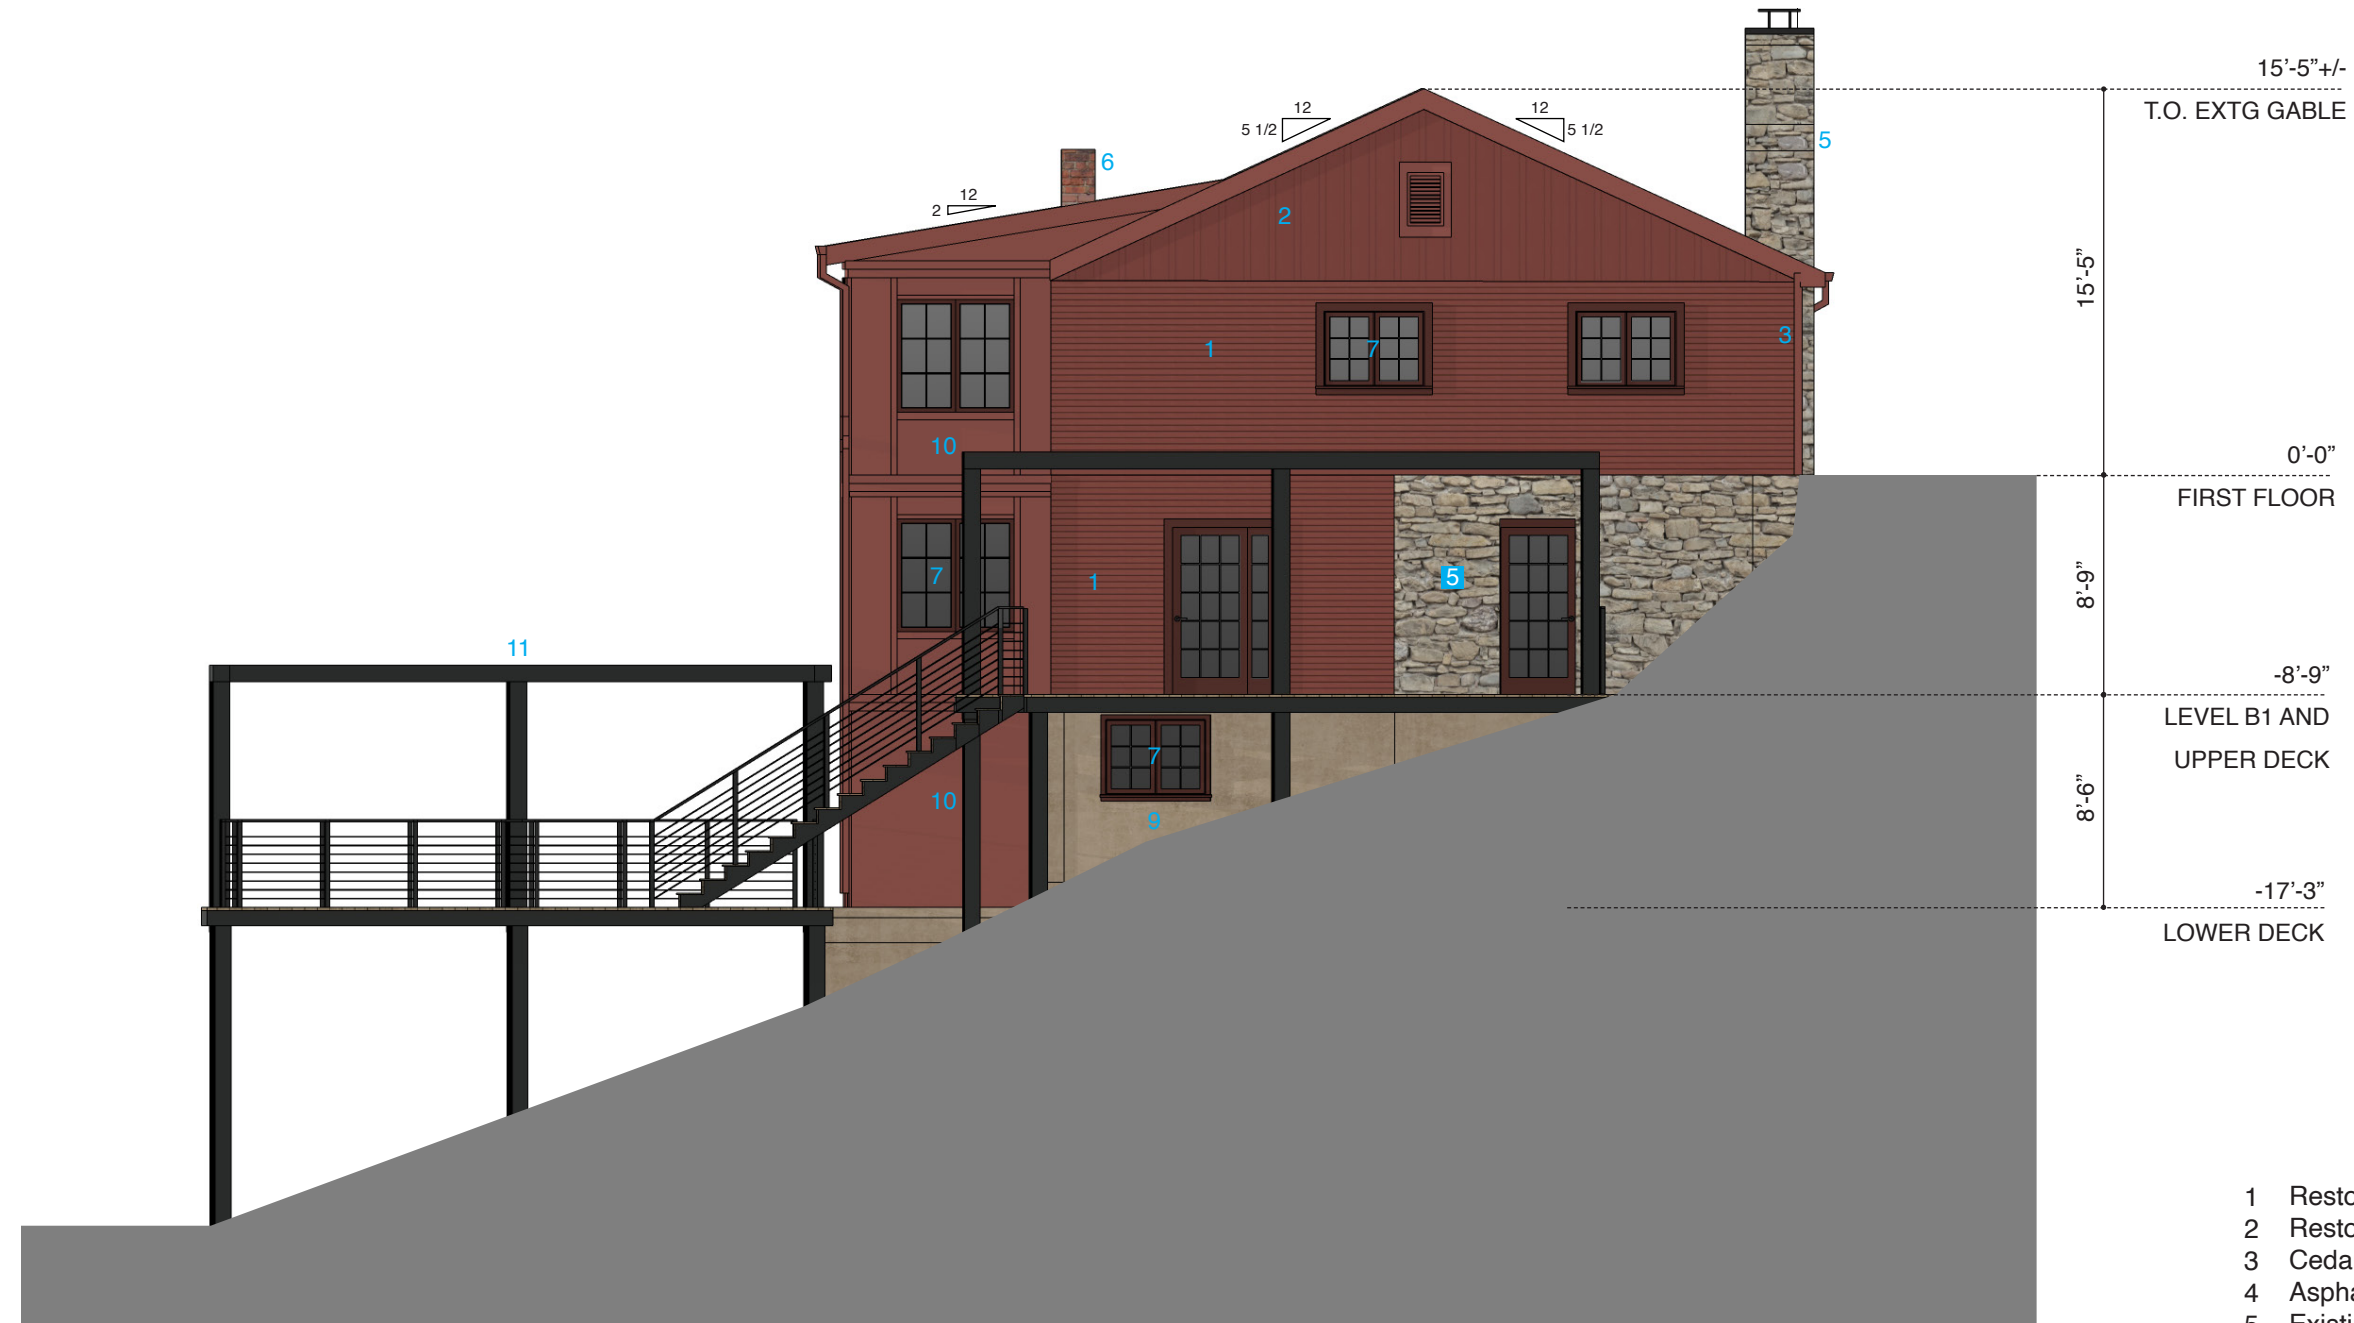
North Elevation

- 1 Restored 3" Horizontal Cedar Siding
- 2 Restored Cedar Board and Batten Siding
- 3 Cedar Trim
- 4 Asphalt shingle roof
- 5 Existing Stacked Stone
- 6 Existing Brick
- 7 Casement 6-lite Windows with Wood Casing
- 8 Fixed 15-lite Window with Wood Casing
- 9 Existing Concrete Foundation
- 10 Fiber Cement Board
- 11 Steel Structure

scale : 1/8" = 1'-0"

Two outdoor decks with seating and pergolas will be added to the north and east of the red cabin. The upper deck will be at the B1 level and have access to the future park and stairs. The lower deck will align with the existing exterior entrance at the rear addition of the house and have a connection to the deck of the new building. On this lowest level of the rear addition, a bi-fold door will be installed which opens up to the lower deck.

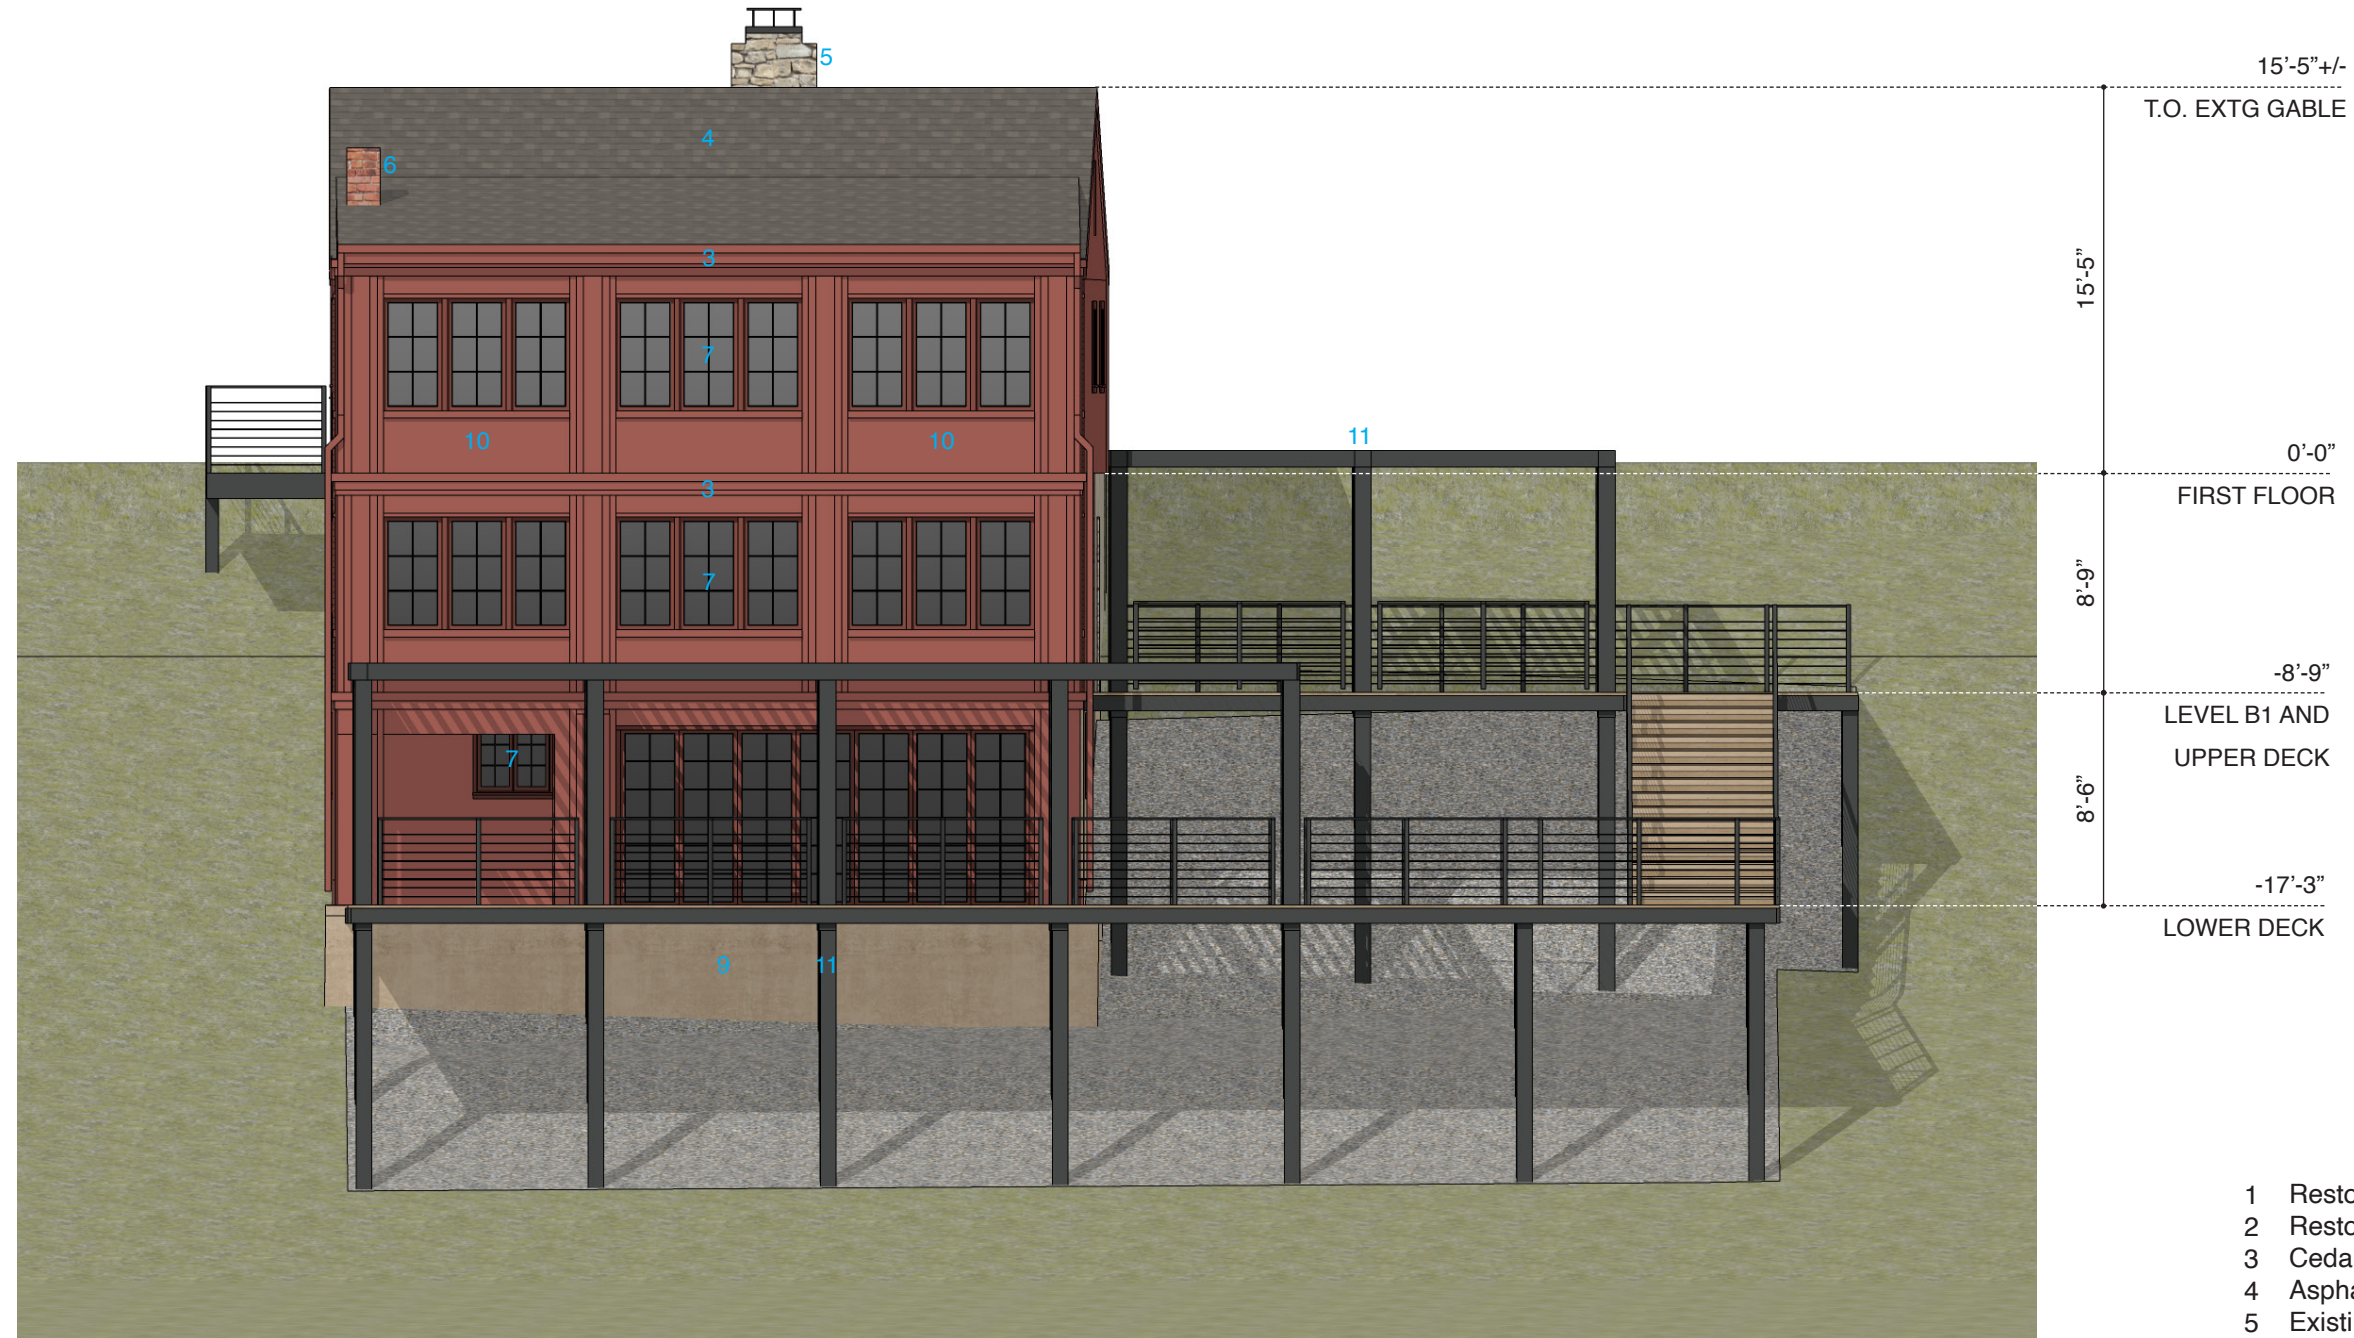
East Elevation

- 1 Restored 3" Horizontal Cedar Siding
- 2 Restored Cedar Board and Batten Siding
- 3 Cedar Trim
- 4 Asphalt shingle roof
- 5 Existing Stacked Stone
- 6 Existing Brick
- 7 Casement 6-lite Windows with Wood Casing
- 8 Fixed 15-lite Window with Wood Casing
- 9 Existing Concrete Foundation
- 10 Fiber Cement Board
- 11 Steel Structure

scale : 1/8" = 1'-0"

62 N Riverview - The proposed rear addition roof slope is 2:12 to match the slope of the original roof to be replaced. This is less than the required minimum of 3:12 slope of minor roofs.

On the east elevation, the rear addition has settled significantly and will be rebuilt on its existing foundation for the future restaurant use. The design of this addition references the open porch through the use of vertical trim boards and large casement windows, bringing in natural light from the east.

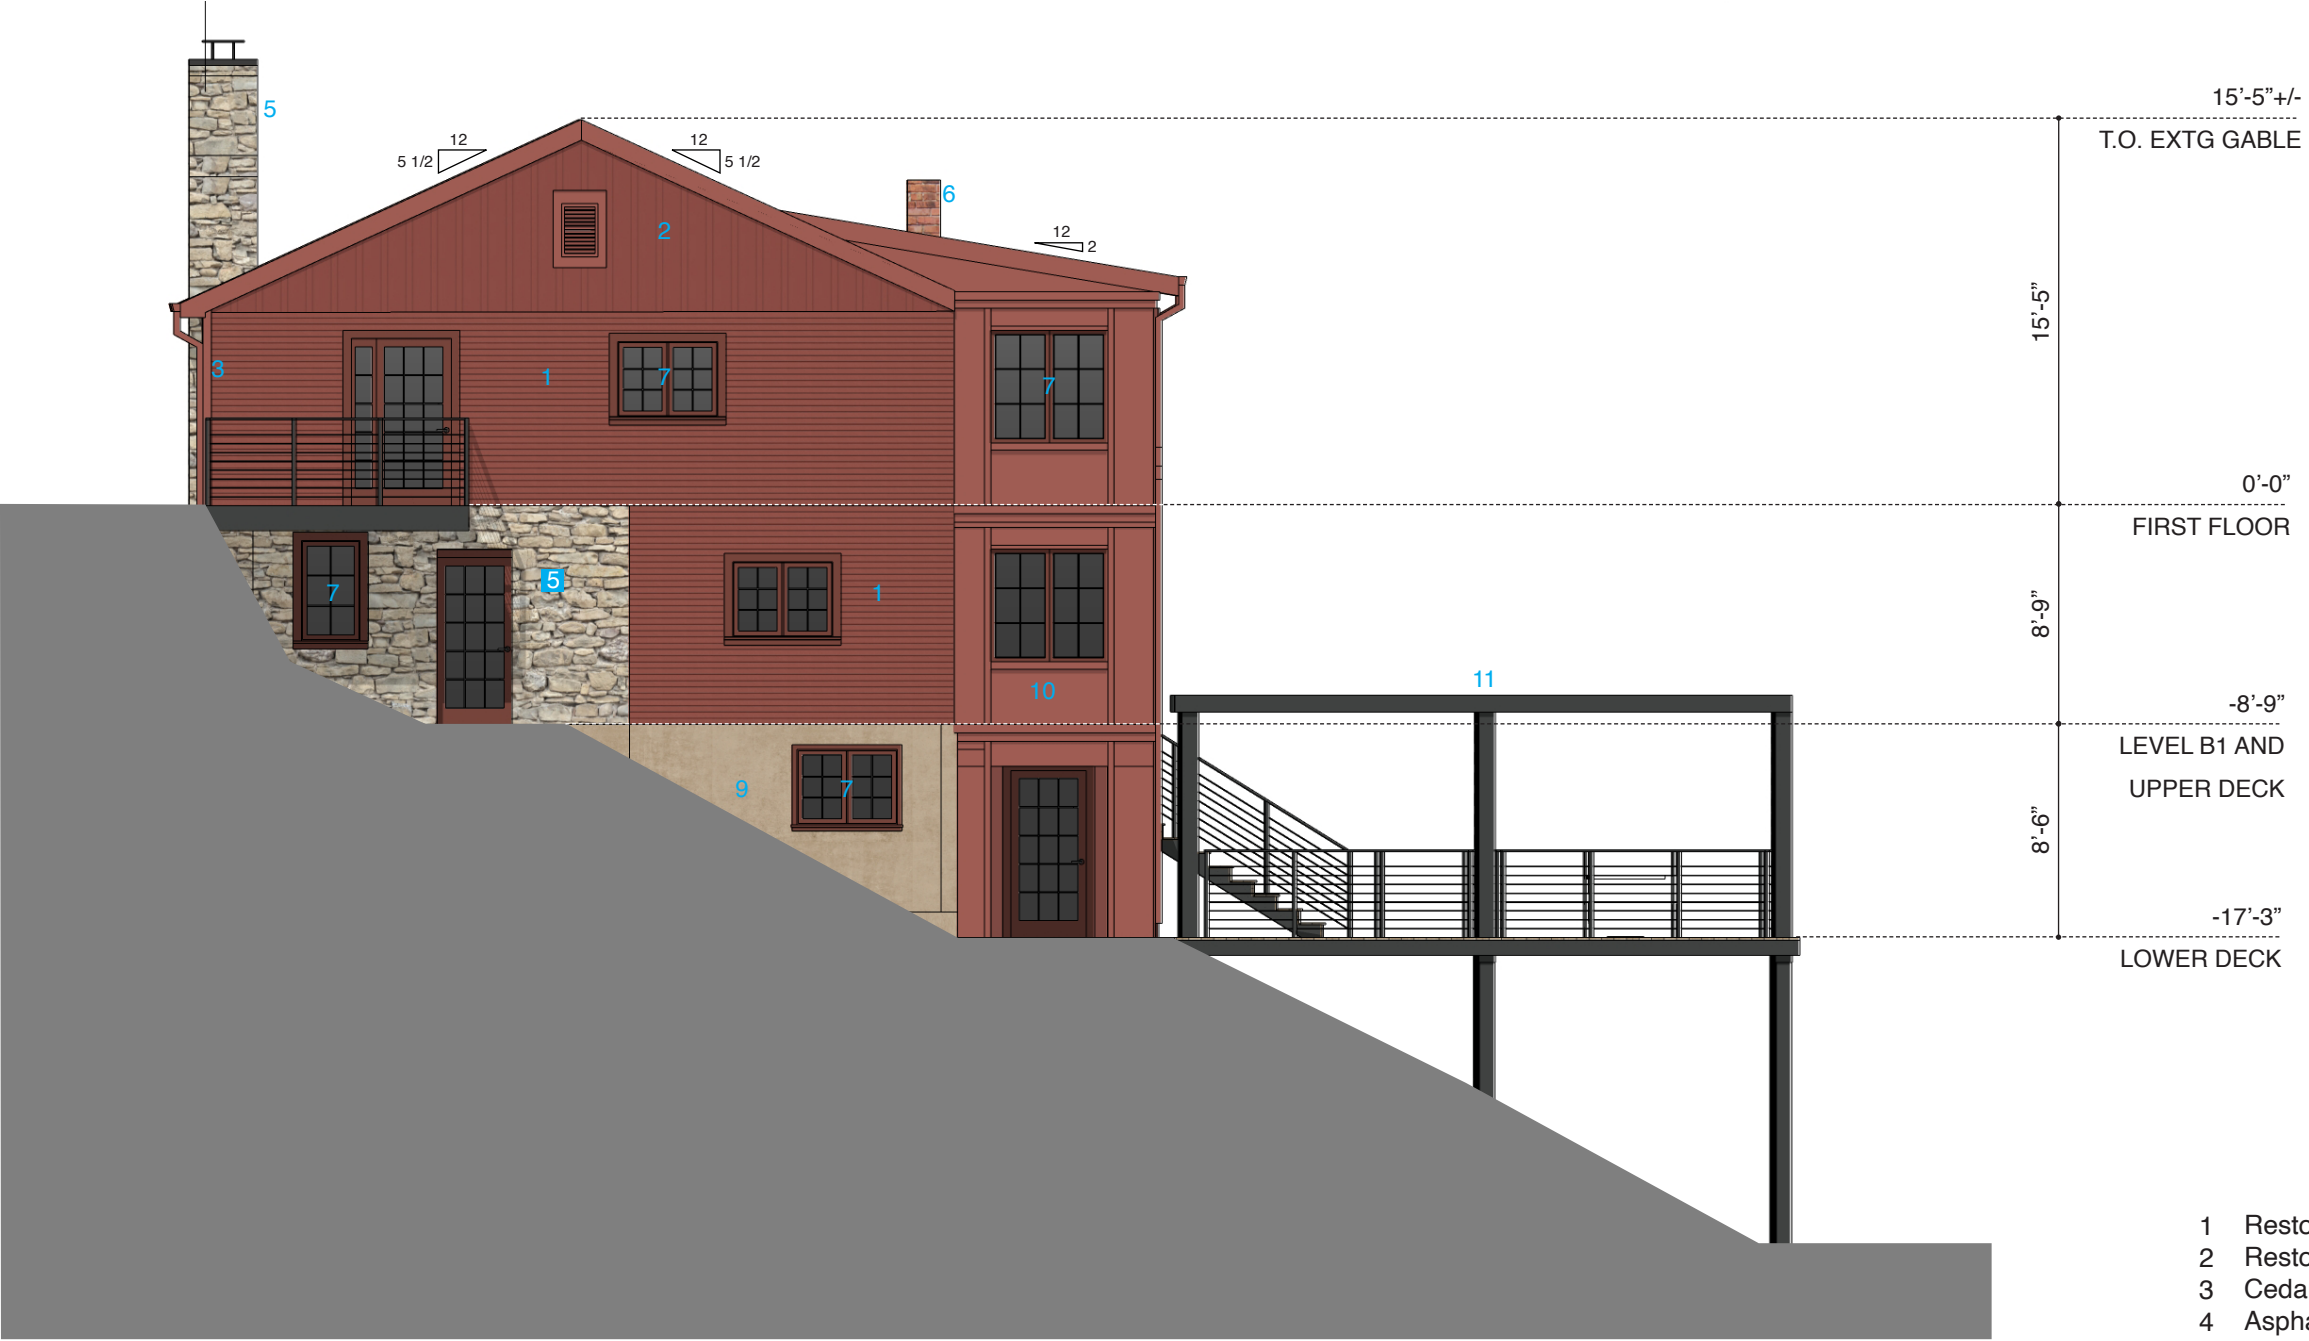
- 1 Restored 3" Horizontal Cedar Siding
- 2 Restored Cedar Board and Batten Siding
- 3 Cedar Trim
- 4 Asphalt shingle roof
- 5 Existing Stacked Stone
- 6 Existing Brick
- 7 Casement 6-lite Windows with Wood Casing
- 8 Fixed 15-lite Window with Wood Casing
- 9 Existing Concrete Foundation
- 10 Fiber Cement Board
- 11 Steel Structure

South Elevation  
 scale : 1/8" = 1'-0"  
 0' 2' 4' 8' 16'
