# MEMO

Date: November 11, 2019

Re: Review for COHATCH new construction at 25 North Street

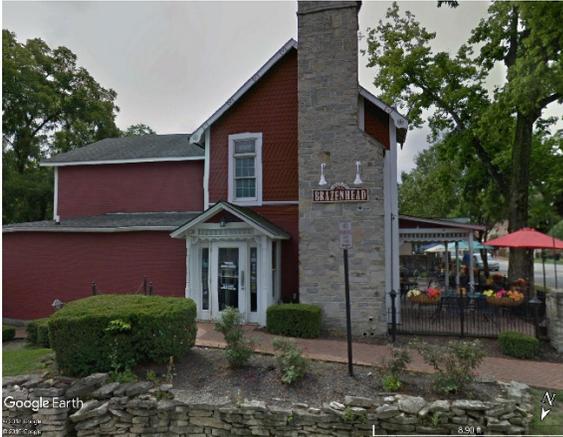
**1. 56 N. High Street. The wood-frame building was originally a dwelling dating to ca. 1890. The building is on the National Register as part of the Washington Township MRA. It is also recommended contributing to the City of Dublin's Historic District and the Dublin High Street Historic District National Register boundary increase. New construction in the area should match the scale, massing, and proportions of existing historic structures such as this.**

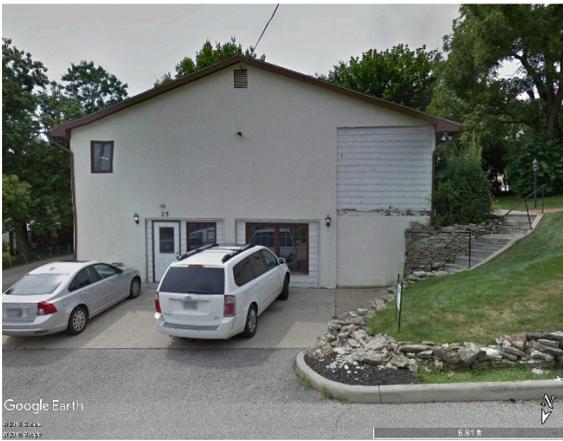
**3. 25 North Street. The ca. 1960 commercial building will be demolished and replaced with new construction.**

The applicant proposes to demolish the existing ca. 1960 commercial building at 25 North Street and replace it with a 10,000 SF co-work and event space. The existing structure consists of a gable-roof two-story rectangular structure built into a hillside and clad in stucco and wood shingles. To the west of the structure lies a stone retaining wall as well as ca. 1890 Queen-Anne style house at 56 N. High Street. The property at 25 North Street has little integrity of design, materials, workmanship, feeling, and association. It was surveyed as part of the 2017 City of Dublin Historical and Cultural Assessment and recommended non-contributing to the local district and non-contributing to the recommended Dublin High Street Historic District boundary increase. This reviewer agrees with that recommendation and demolition maybe a suitable option for the non-contributing structure at 25 North Street.

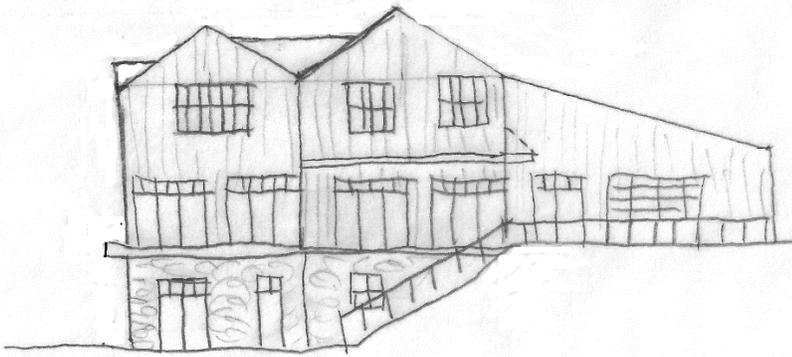
8. Sketch of the front (north) elevation on North Street. The overhang and thin metal columns have been removed and replaced with a canopy covering the entry doors. The windows now relate to one another and have divided lights and mullions to reflect neighboring residential structures. The gables roofs now have the same slope and are centered over the mass of that portion of the building.

#### NORTH STREET (North) Elevation

- The stone foundation of the lower level looks good. I would suggest using a variety of siding types on the upper floors to help reduce the mass. And while board-and-batten siding is very popular now, it may look dated in years to come. I would suggest using a combination of horizontal and vertical boards to clad the building much like in some of the early inspiration images.

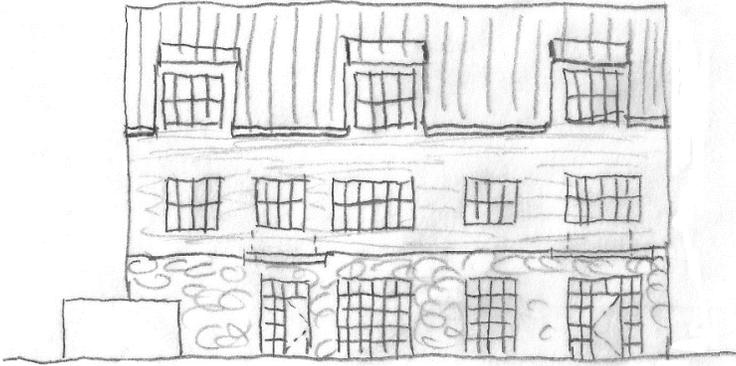
8. Sketch of the rear (east) elevation on Blacksmith Lane. The overhang has been removed and the windows now relate to one another. The windows now have divided lights and mullions to reflect neighboring residential structures.

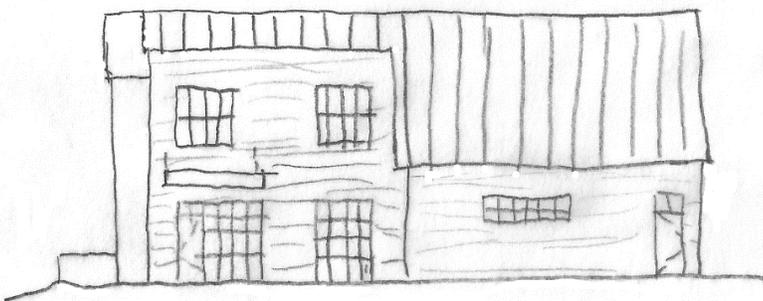
9. Sketch of the west elevation facing the historic building at 56 N. High Street. The windows have been modified with mullions and divided lights.

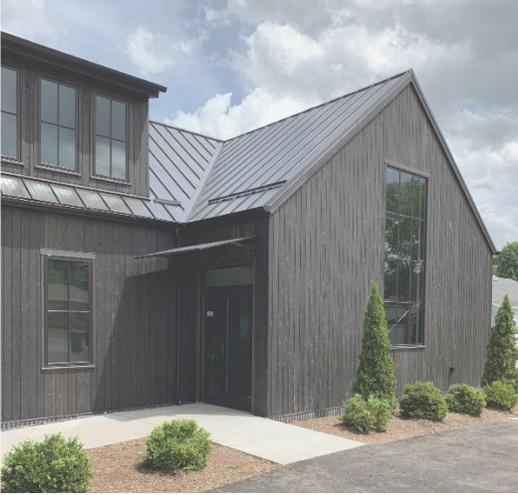
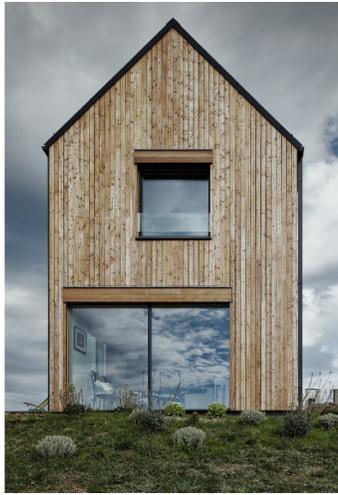
10. Design inspiration from the 08-27-2019 submittal. Both buildings use traditional, vernacular materials but are clearly modern. The windows in the building on the left are residential in style with divided lights and read as a cohesive whole. The large window to the right has divided lights and is centered under the gable. The building on the left also has a symmetrical gable with the window centered under it.

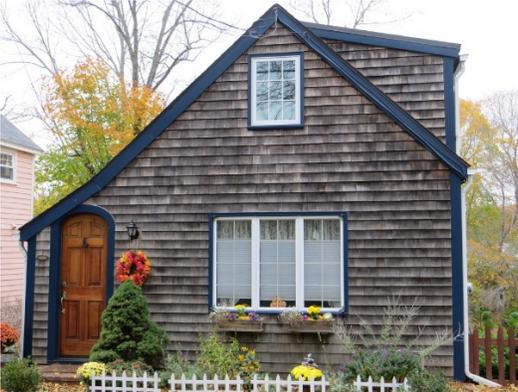
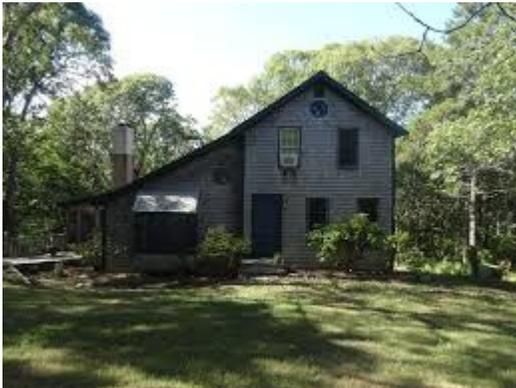
11. Traditional saltbox-style buildings with symmetrical gables and windows centered in the gables.

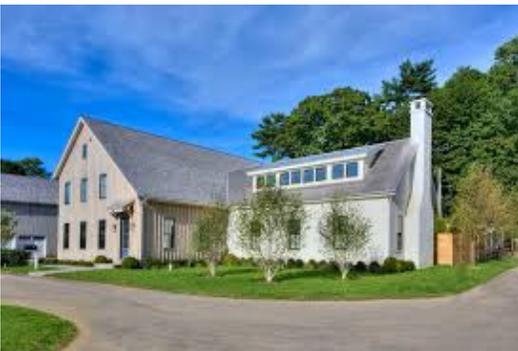
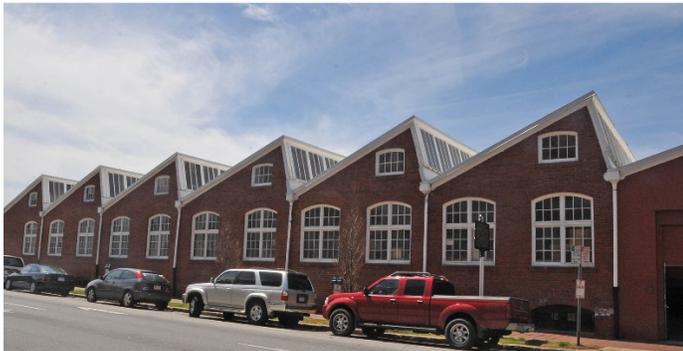
12. A modern saltbox-style dwelling to the left. Again, the gable is symmetrical and the windows are spaced evenly under the gable to read as a cohesive whole. The right, the sawtooth roof of a former Shamrock Mill building in Winston-Salem, NC. (Photo by Jerrye & Roy Klotz). The pattern of the gables is repeated through the building and the windows are arranged symmetrically under the gable to create a balanced composition.
