# MEMO

Re: 83 S High Street; Informal Review of October Submittal, Preservation  
POV

## INTRODUCTION

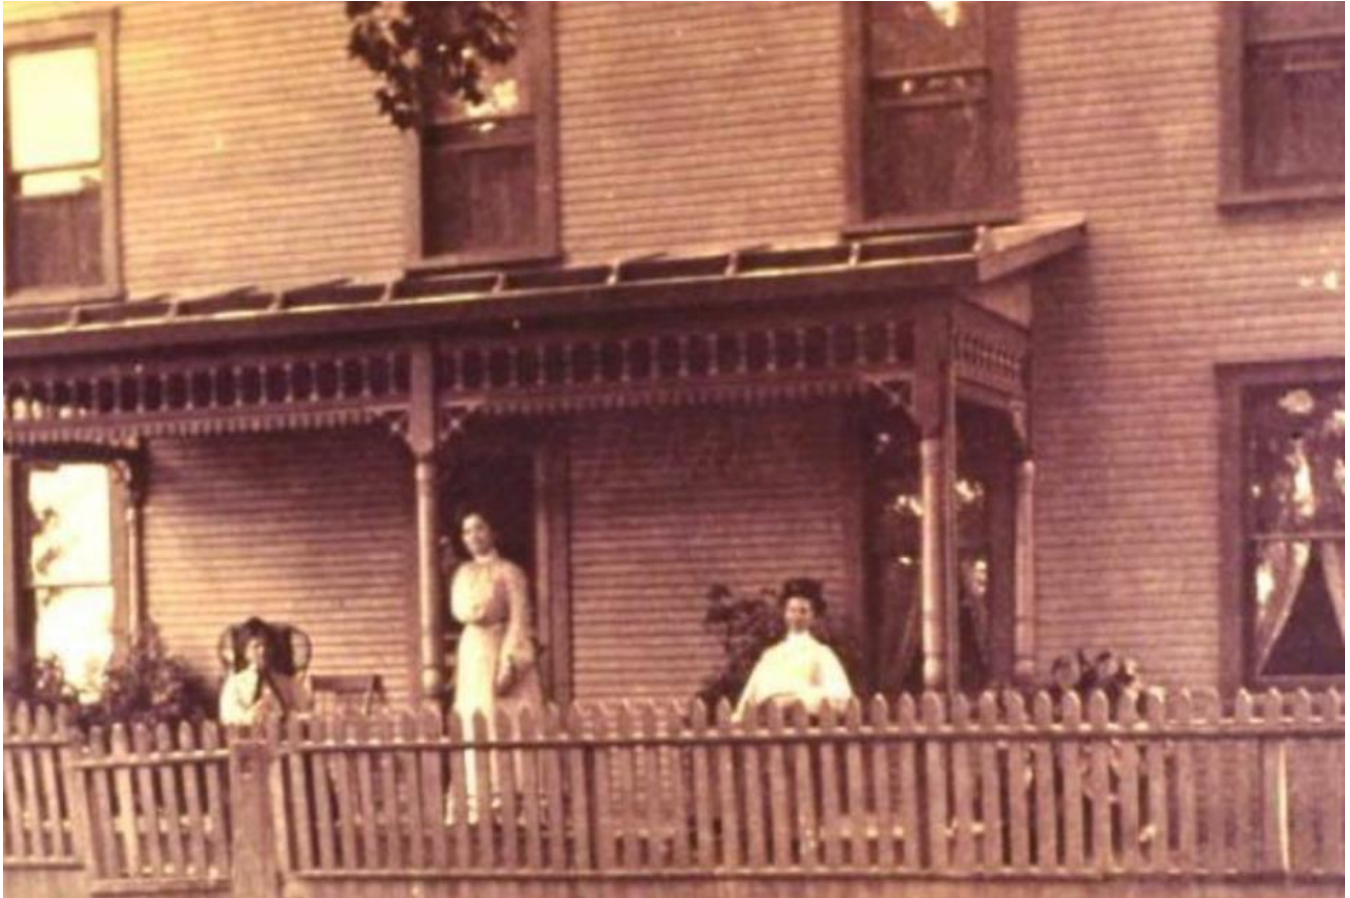
1. Historic Photo taken of the front of 83 S High, circa 1900 (Photo downloaded from the Movoto website, accessed October 28, 2022 at [https://www.movoto.com/dublin-oh/83-s-high-st-dublin-oh-43017/pid\\_o41bdc5skh/#propertyPop](https://www.movoto.com/dublin-oh/83-s-high-st-dublin-oh-43017/pid_o41bdc5skh/#propertyPop))

windows and the door surround; and non-operable shutters, nine-over-nine double hung windows and a federal-style door entry surround were added. The current owner referenced a historic photograph dating to the late 19<sup>th</sup> to early 20<sup>th</sup> century and removed these “fake” Federal-style elements sometime between 2012 and 2013. This also returned the building to its vernacular appearance, although with a wider clapboard than was shown in the historical photograph. The wooden recreation of the front porch was added to a pre-existing concrete slab around 2015-2016, based on Google Maps’ Street View Timeline (see “83 South High Street, Dublin OH: Street View Timeline...”, attached) and the Franklin County Auditor’s photos [<link>](#).

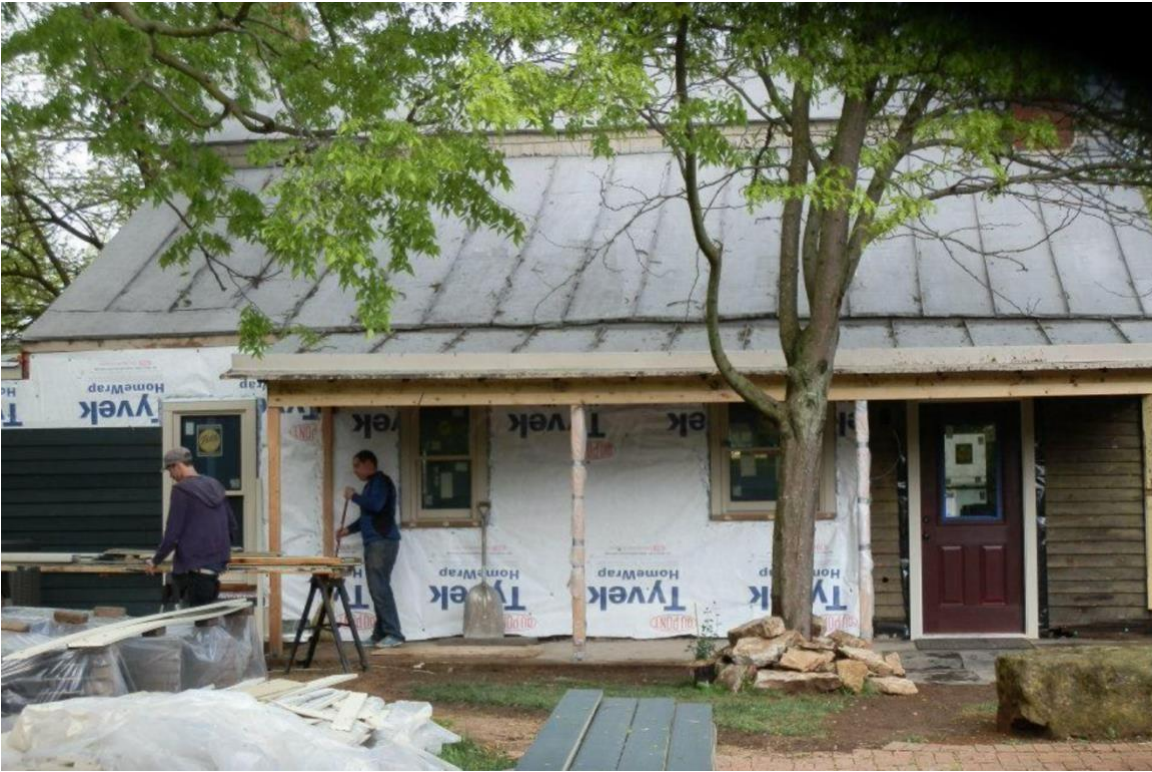
2. Construction photo of West Elevation, showing the rear porch, taken some time between 2012 and 2013. (Photo downloaded from Movoto website, accessed October 28, 2022, at [https://www.movoto.com/dublin-oh/83-s-high-st-dublin-oh43017/pid\\_o41bdc5skh/#propertyPop](https://www.movoto.com/dublin-oh/83-s-high-st-dublin-oh43017/pid_o41bdc5skh/#propertyPop))

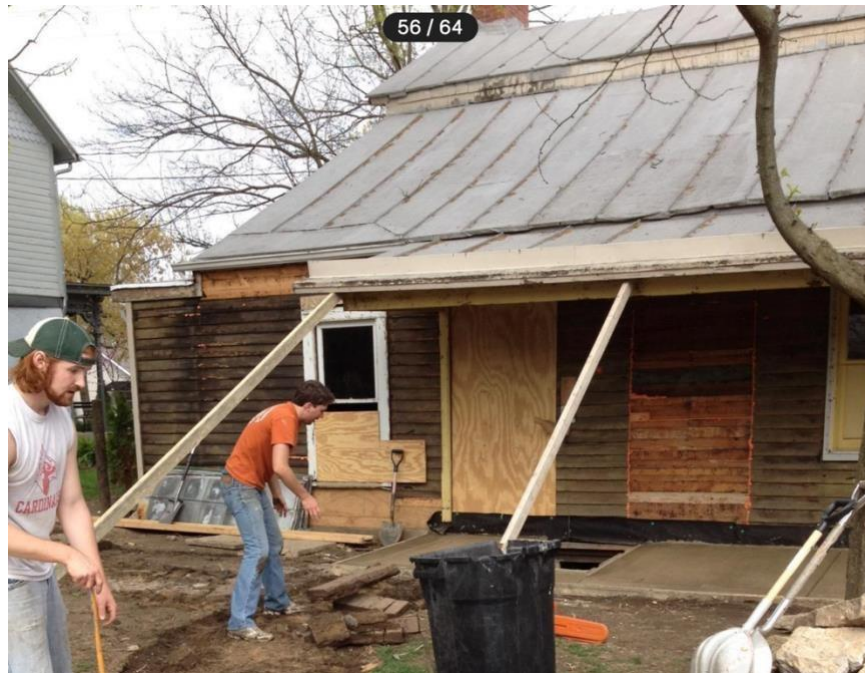
3. Construction photo taken of the rear of the lean-to, looking northeast, taken between 2012 and 2013 (Photo downloaded from Movoto website, accessed October 28, 2022, at [https://www.movoto.com/dublin-oh/83-s-high-st-dublin-oh43017/pid\\_o41bdc5skh/#propertyPop](https://www.movoto.com/dublin-oh/83-s-high-st-dublin-oh43017/pid_o41bdc5skh/#propertyPop))

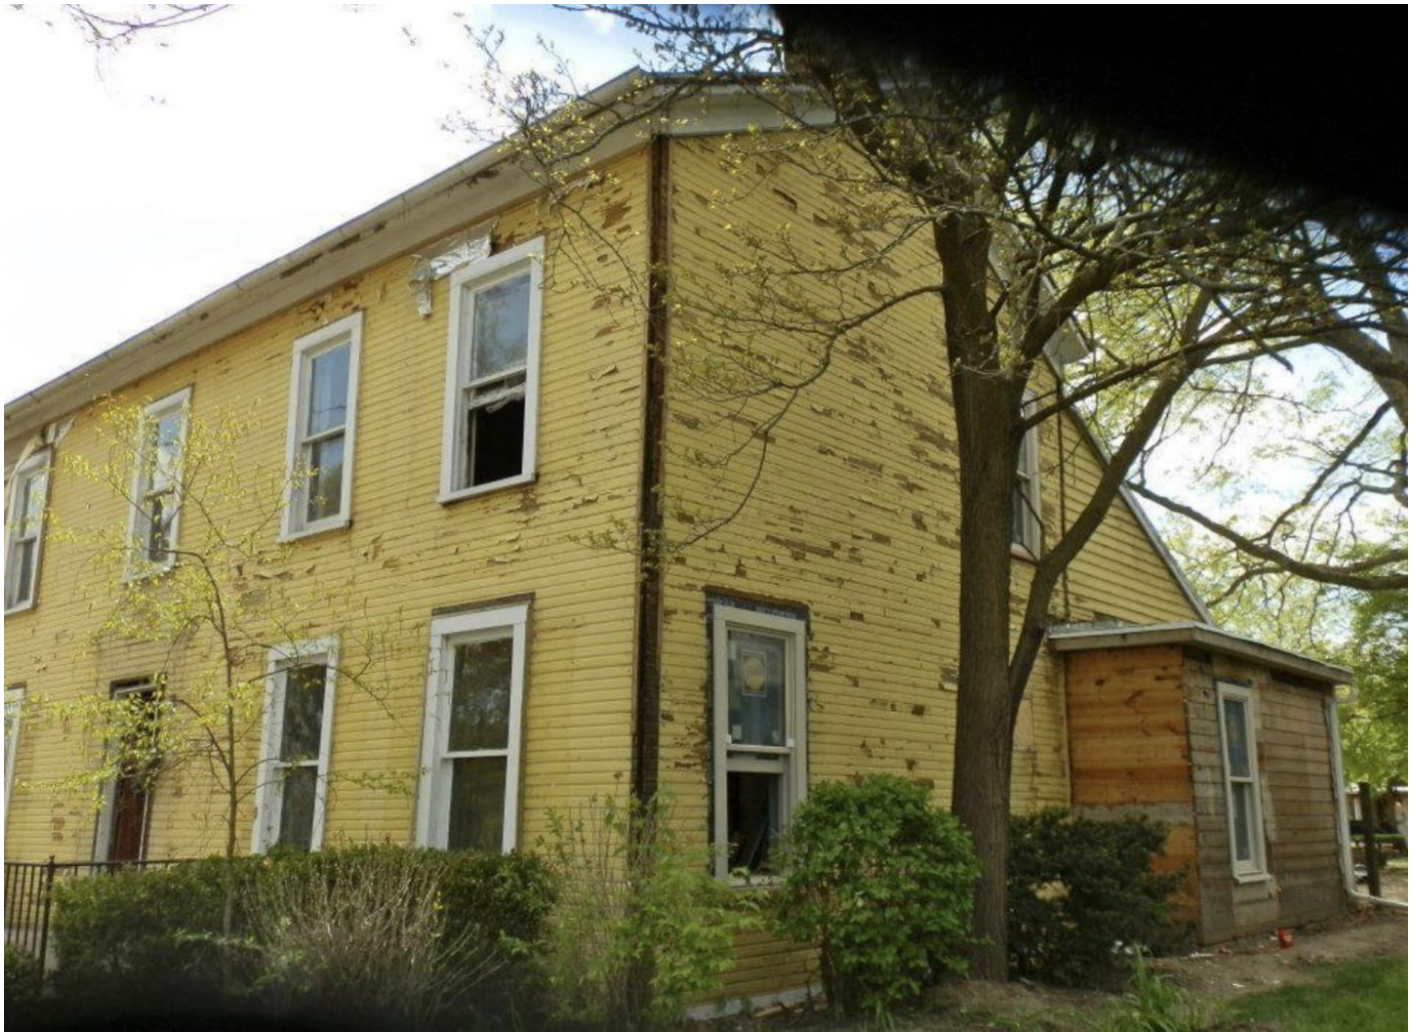
4. Construction photo of the front and north elevations, taken between 2012 and 2013, showing the lack of paint where corner boards were placed, as well as the boxed cornice. (Photo downloaded from Movoto website, accessed October 28, 2022 at [https://www.movoto.com/dublin-oh/83-s-high-st-dublin-oh-43017/pid\\_o41bdc5skh/#propertyPop](https://www.movoto.com/dublin-oh/83-s-high-st-dublin-oh-43017/pid_o41bdc5skh/#propertyPop))

The original I-House and the lean-to addition both have a gray metal-seamed roof, noted as tin in the “Self-Guided Walking Tour of the Dublin Historic District”. The I-House portion has a slightly more ornamentation with a plain board boxed cornice under the eaves and along its side-gabled roof, as well as its restored porch with turned columns and spindle-work. The rear historic lean-to addition has a high sloped roofline that extends to just below the I-House’s roof to create the salt-box appearance. A rectangular porch, with less ornamentation, takes up approximately three-quarters of the rear addition’s west elevation. There is also a small bump out on the addition’s north elevation; this mini-structure has a low-sloped roof, appearing to be almost level.
