FOR YOUR CONSIDERATION

To: City of Dublin
Architectural Review Board

Re: Application # 16-049, 73. S. Riverview St.

EXHIBIT A

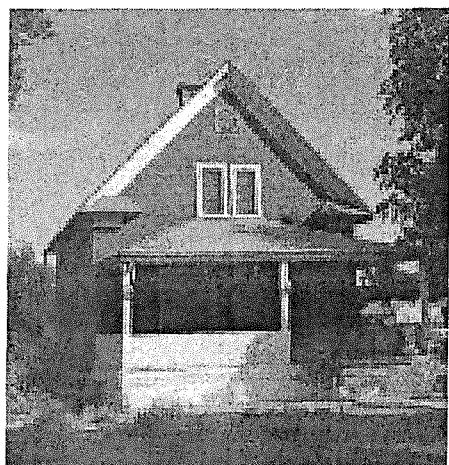
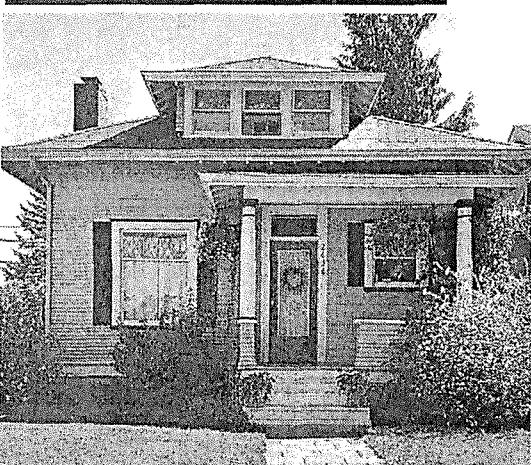
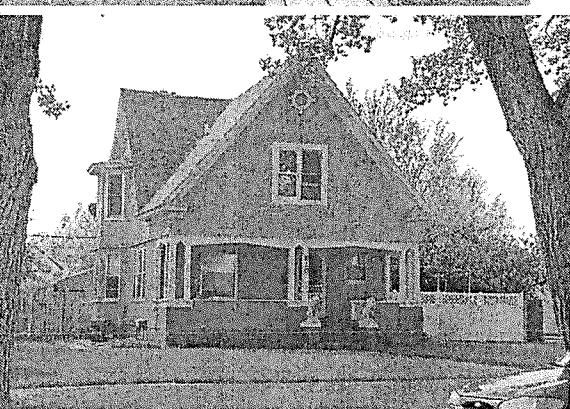
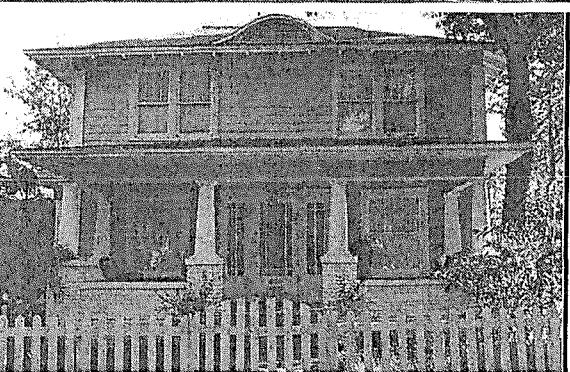
'AMERICAN FOURSQUARE' STYLE

This structure is most closely associated with the American Foursquare style. It is a branch of the so-called ‘bungalow’ period of architecture popularized in the U.S. by the Craftsman/Prairie schools of thought. A period of architecture from the mid 1890’s through the late 1930’s. Although initially constructed in 1936, this home has experienced ill-advised exterior alterations and ad-hoc additions that have diminished the character of the original structure to such a degree that it is now inconsistent with the historic style of the surrounding area or the American Foursquare style (Exhibit A). The exterior alterations include vinyl siding, aluminum storm windows over the existing (non-compliant) historic windows, low-grade asphalt shingle roofing, and the enclosing of the front porch with non-historic jalousie windows. There is a flat roof bay window addition on the side of the building (not commensurate with the Foursquare 1930’s style) and two additions on the rear are of dubious construction quality and structural integrity.

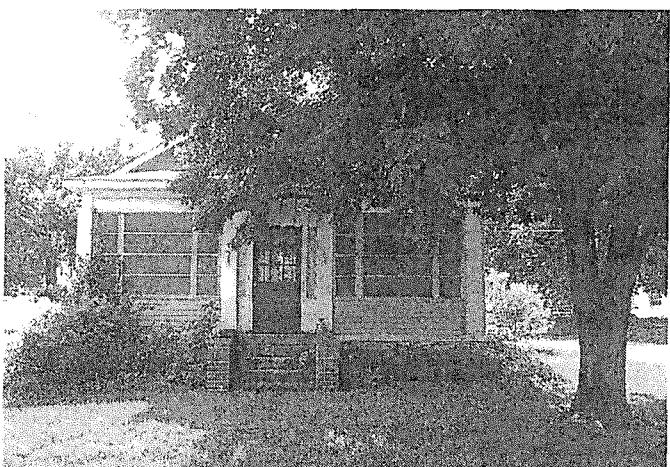
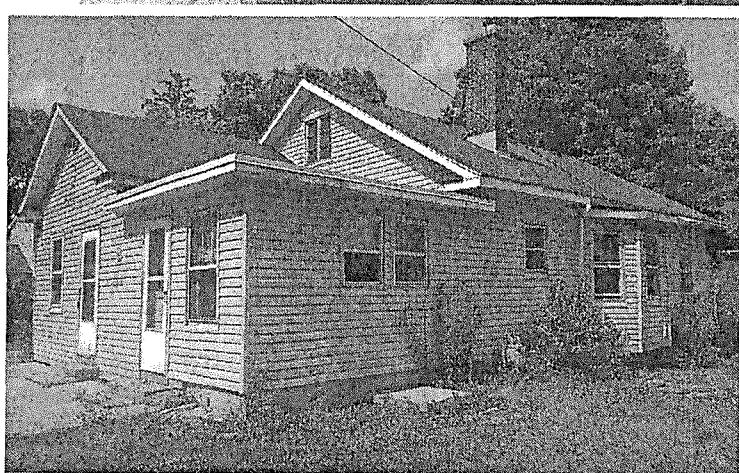
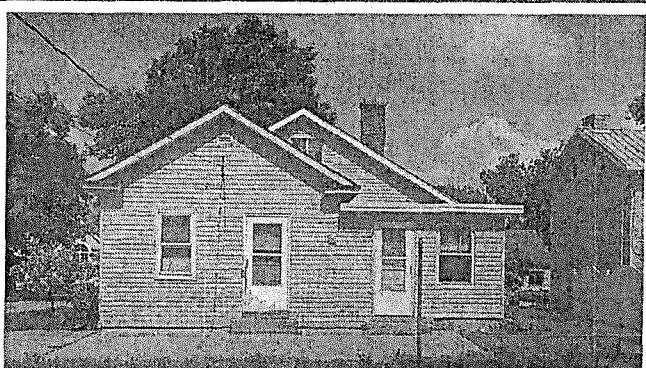
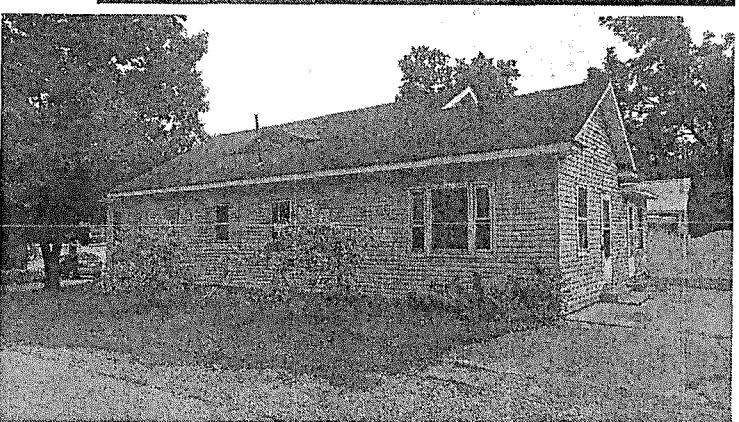
EXISTING AT 73 SOUTH RIVERVIEW

In response to the consultant's recommendation of reversing the exterior changes: the existing vinyl siding may be installed over water damaged or asbestos laden material, the windows will need to be replaced to meet current code energy standards (Exhibit B), and the columns/structure for the front porch be re-built as they are rotted at the base. Although this structure may have been a 1930's American Foursquare, the subsequent additions and alterations have stripped it of its architectural integrity. In conclusion, any original detailing that may have indicated the honest style and architectural intent of this house has been lost or would require complete replacement/reconstruction. It is unfortunate that this building has been disrespected by time, but as it stands today, this structure does not retain any architectural or historic significance to the area other than its age and scale.
