Project: Historic Retaining Wall Rehabilitation  
**Minor Project Review**  
Address: 36-38, 40 North High Street, Dublin OH 43017  
Owner: Bob Lombardi & James Lapierre, DDS  
Applicant: Wes Davis, P.E. – Osborn Engineering

Re: Historic Retaining Wall Rehabilitation – Minor Project Review

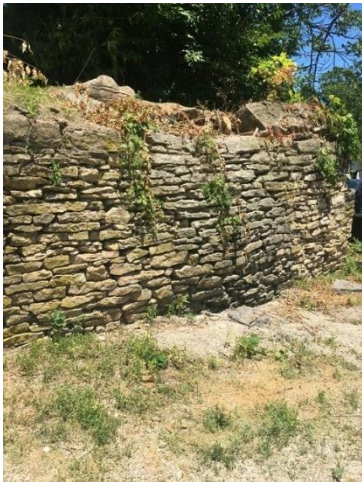
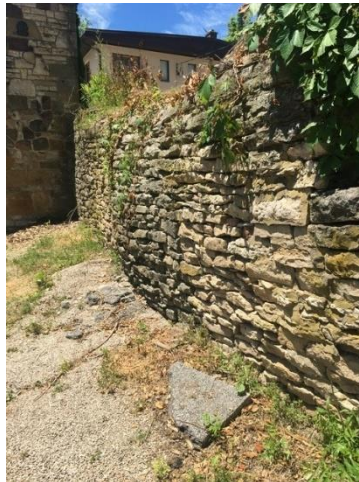
Retaining Wall Buldge at Mid-Height

The proposed work includes disassembling the existing wall and reconstruction back to the original style to the maximum extent practicable. Vic Art Masonry has experience with restoration of historic walls and is on the team for this preservation effort. Their recommendations for the strategic demolition and replacement of the historic wall has been included in the Minor Project Review package for the boards review. The area behind the wall on 40 North High Street will be excavated to allow for the removal of the compromised wall, as well as to install underdrain to improve the drainage. Currently the wall has experienced much deterioration from stormwater runoff to drain through the existing structure. Re-grading and the installation of a two-tiered underdrain system will alleviate this current drainage issue. Currently most of the parking lot on 40 N. High drains to the southeast corner of the property, towards the existing compromised wall. The installation of the french drain 10' north of the existing wall will now allow for that water to be captured and to remove the current condition where stormwater is allowed to drain towards and through the wall. Due to the nature of the wall there's no other remedies to alleviate the current state of the structure. The Osborn structural team has analyzed the wall and have concluded the only solution is to rebuild the wall as described above. Construction fencing has been proposed adjacent to the existing wall and privy to protect these important historical structures in the district.

The Board also indicated that the preferred reconstruction method would include using historic materials and techniques. The approach to repair the wall is consistent with this request as the wall is proposed to be removed in the deteriorated area, with stones to be re-laid in a dry stack method. The non-historic wall adjacent to the existing building on 36-38 N High, which has very similar stones, and is proposed to be demolished with the redevelopment, will be utilized to re-build the wall if needed. Mortar will be used on the wall sparingly but was agreed that it could be used on the wall re-construction to improve integrity as long as the mortar is not seen. Modern methods will be used to alleviate drainage issues along this section of the wall. An underdrain is proposed along the re-built section of the wall to discourage sheet flow through the wall. Current sheet flow through this section of the wall is the primary cause for it's deterioration. Also, gravel will be installed behind the wall during the reconstruction that will reduce the load the wall is now experiencing.

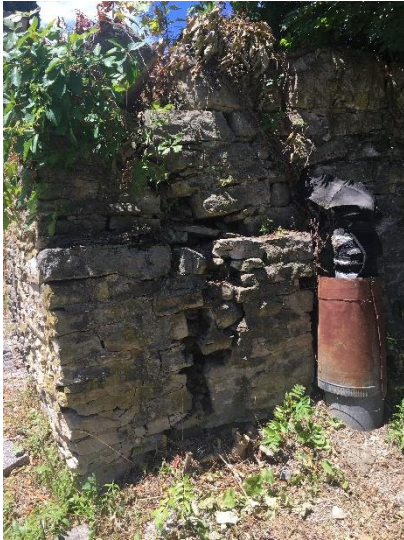
Disenlodgement at Southeast Corner
