APPENDIX A – Historical and Cultural Assessments

Parcel 273-000032 **Address** 27 N Riverview St **OHI** FRA-8834-1

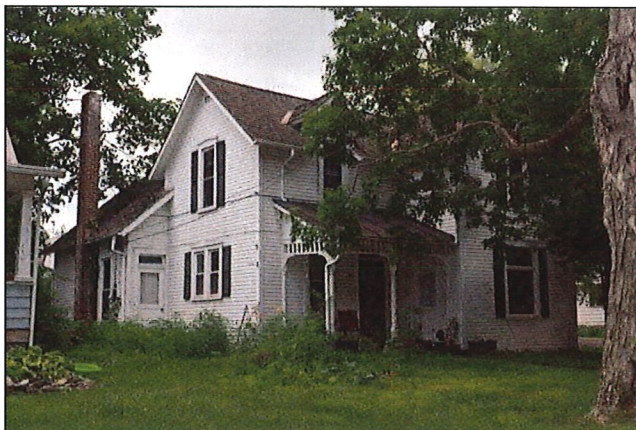
Description: The two-story Gabled-ell house has an irregular footprint, resting on a stone foundation. The cross-gable roof is sheathed in asphalt shingles and features a gable wall dormer on the façade ell. The exterior walls are clad in shiplap siding. The front door is sheltered by a shed-roof porch on the façade ell, which is supported by turned posts and features ornamental brackets and a spindle frieze. Windows are one-over-one replacements flanked by fixed shutters, and set into modest pedimented surrounds. A large carriage barn is west of the house.

Condition: Good

Integrity Notes: The building has good integrity, diminished some by replacement materials.

27 N Riverview St, looking northwest

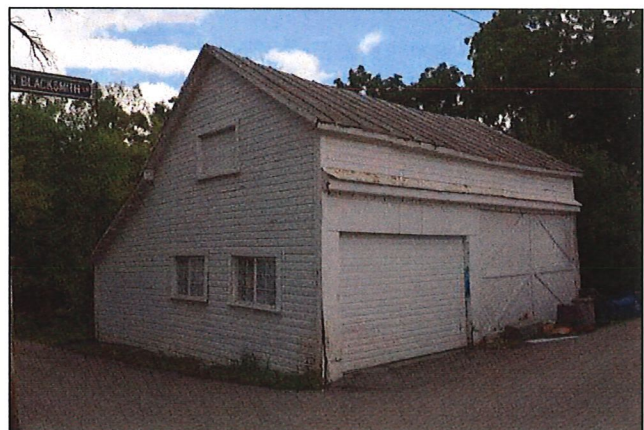
27 N Riverview St, carriage barn, looking southeast
