HAAS RESIDENCE
POOL DESIGN

JOHN HAAS
7099 OLD PROSE CT
DUBLIN, OH 43017

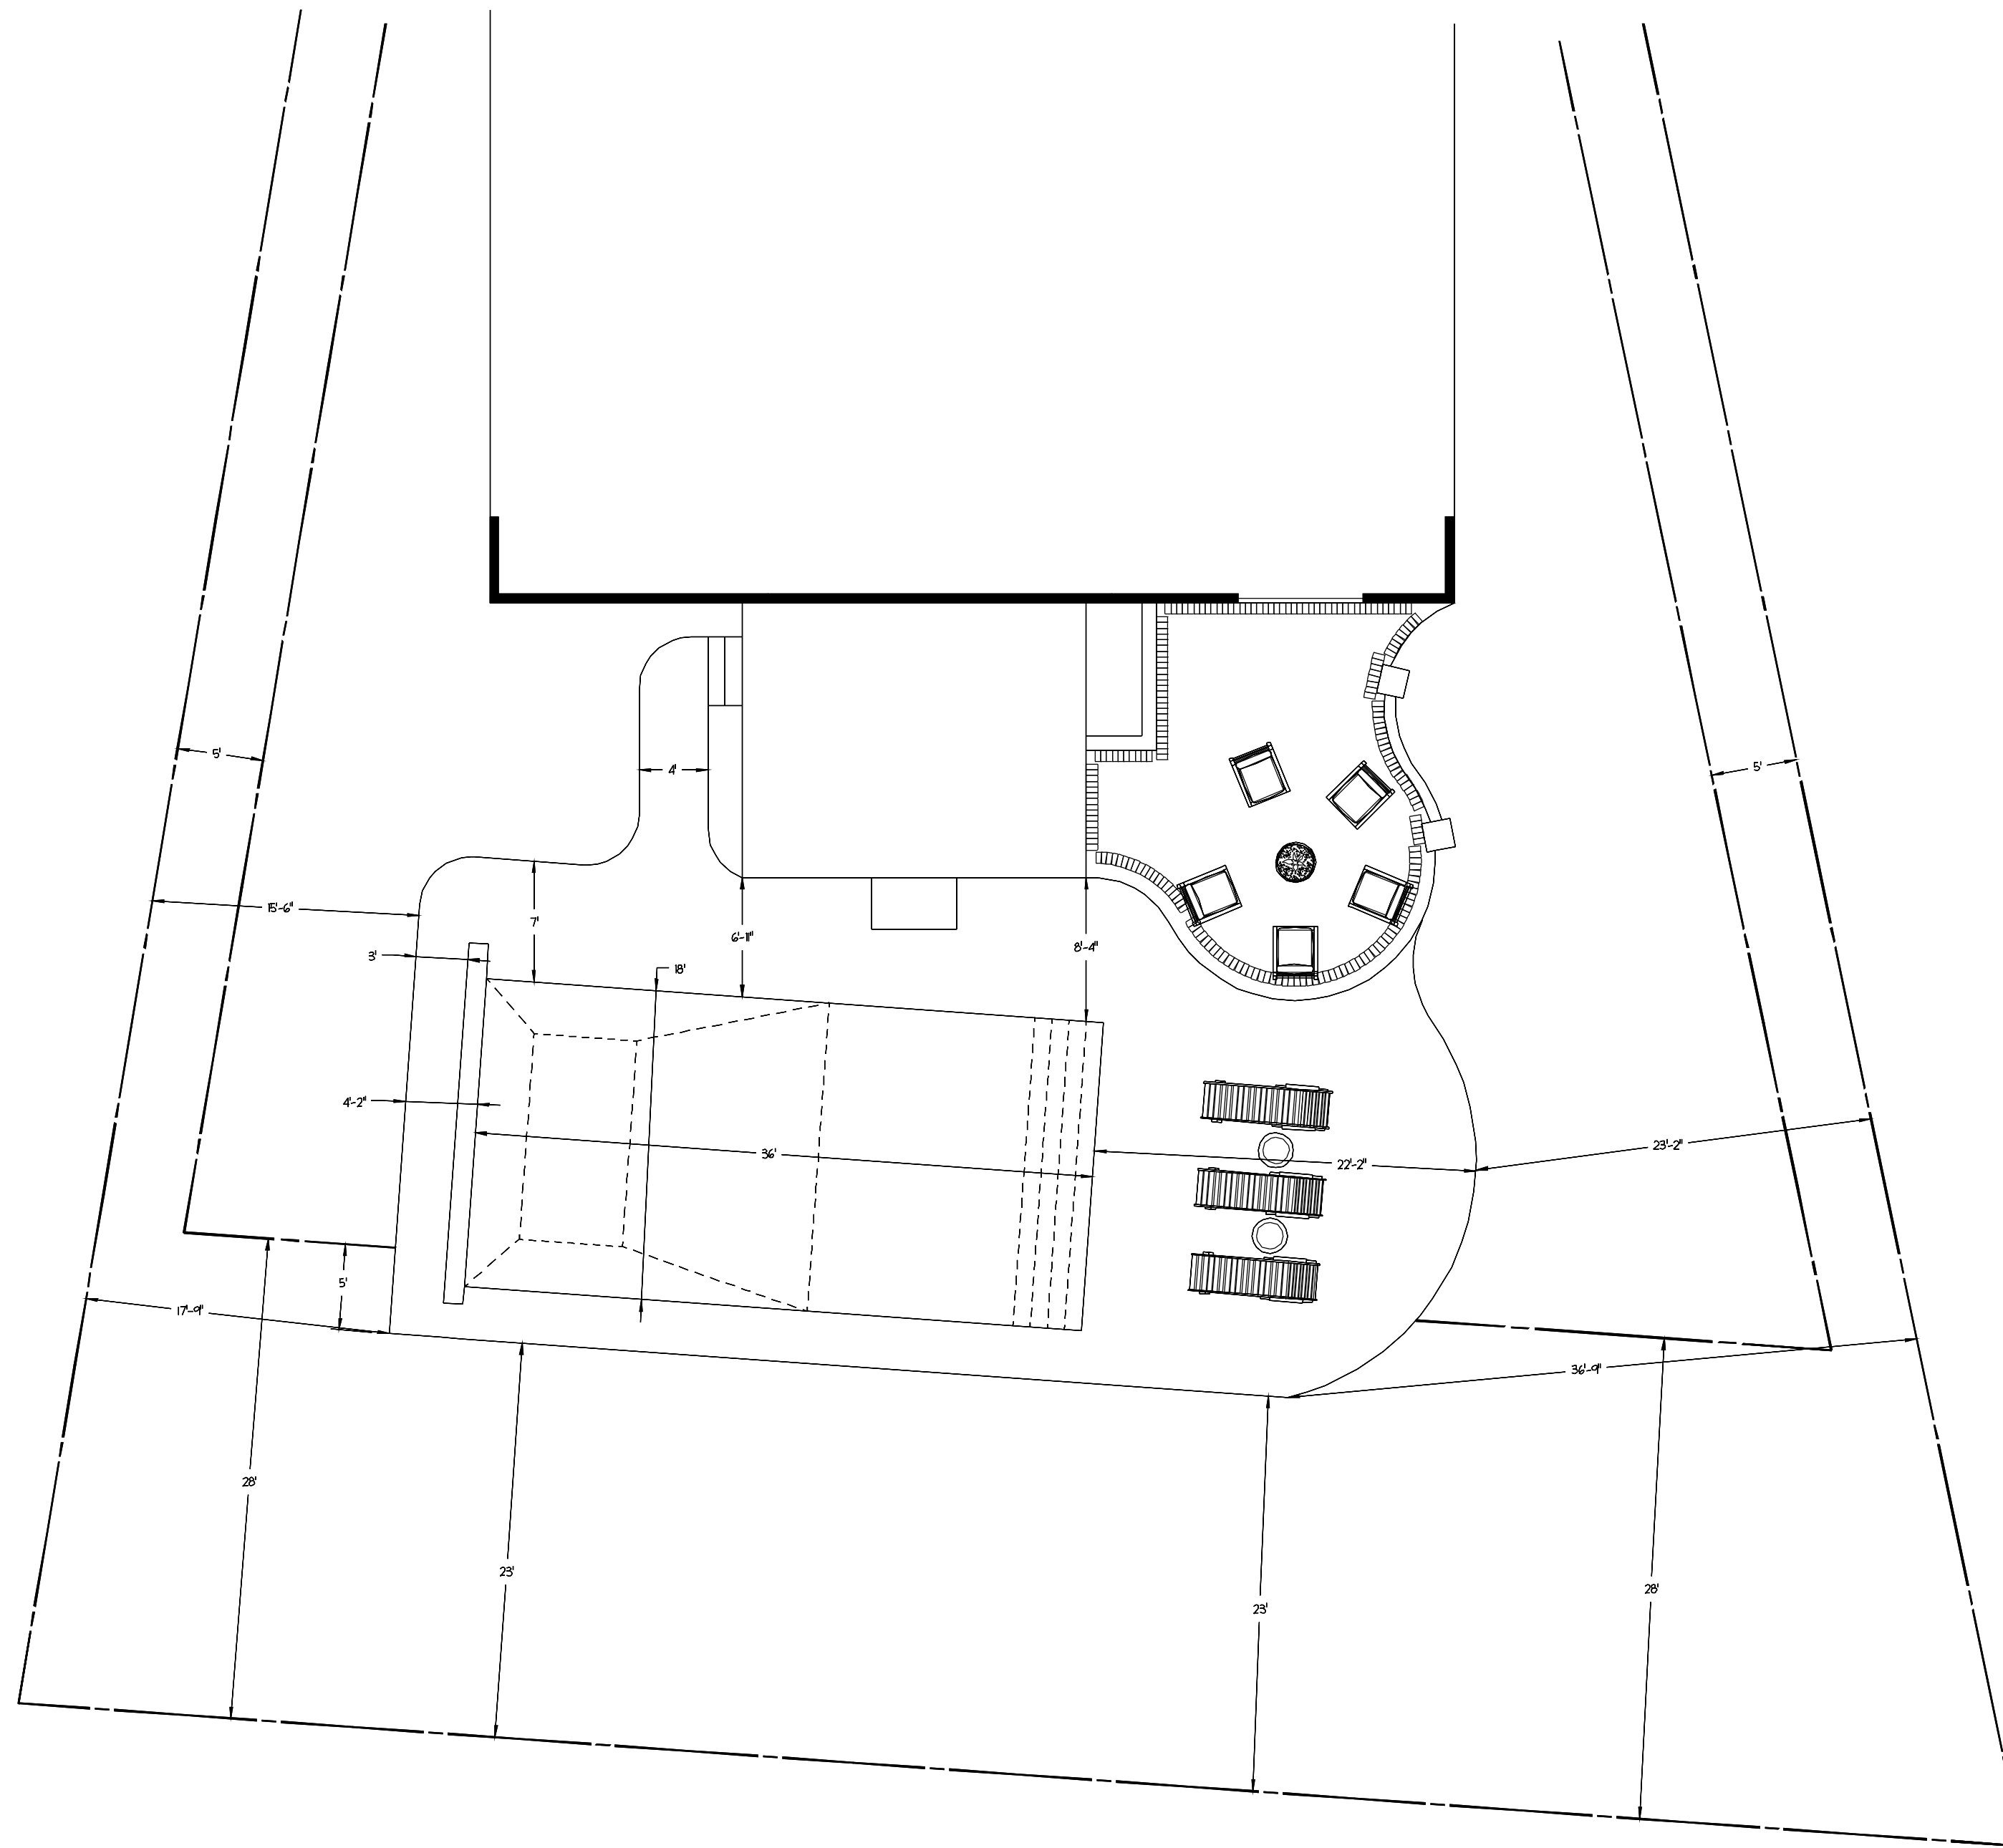
Minimum Side Yard Setback = 5-feet

Total Side Yard Setback (sum of two side yard setbacks) = 15-feet

Rear Yard Setback = 20 of lot depth = 28-feet (found by averaging lot lengths and taking 20)

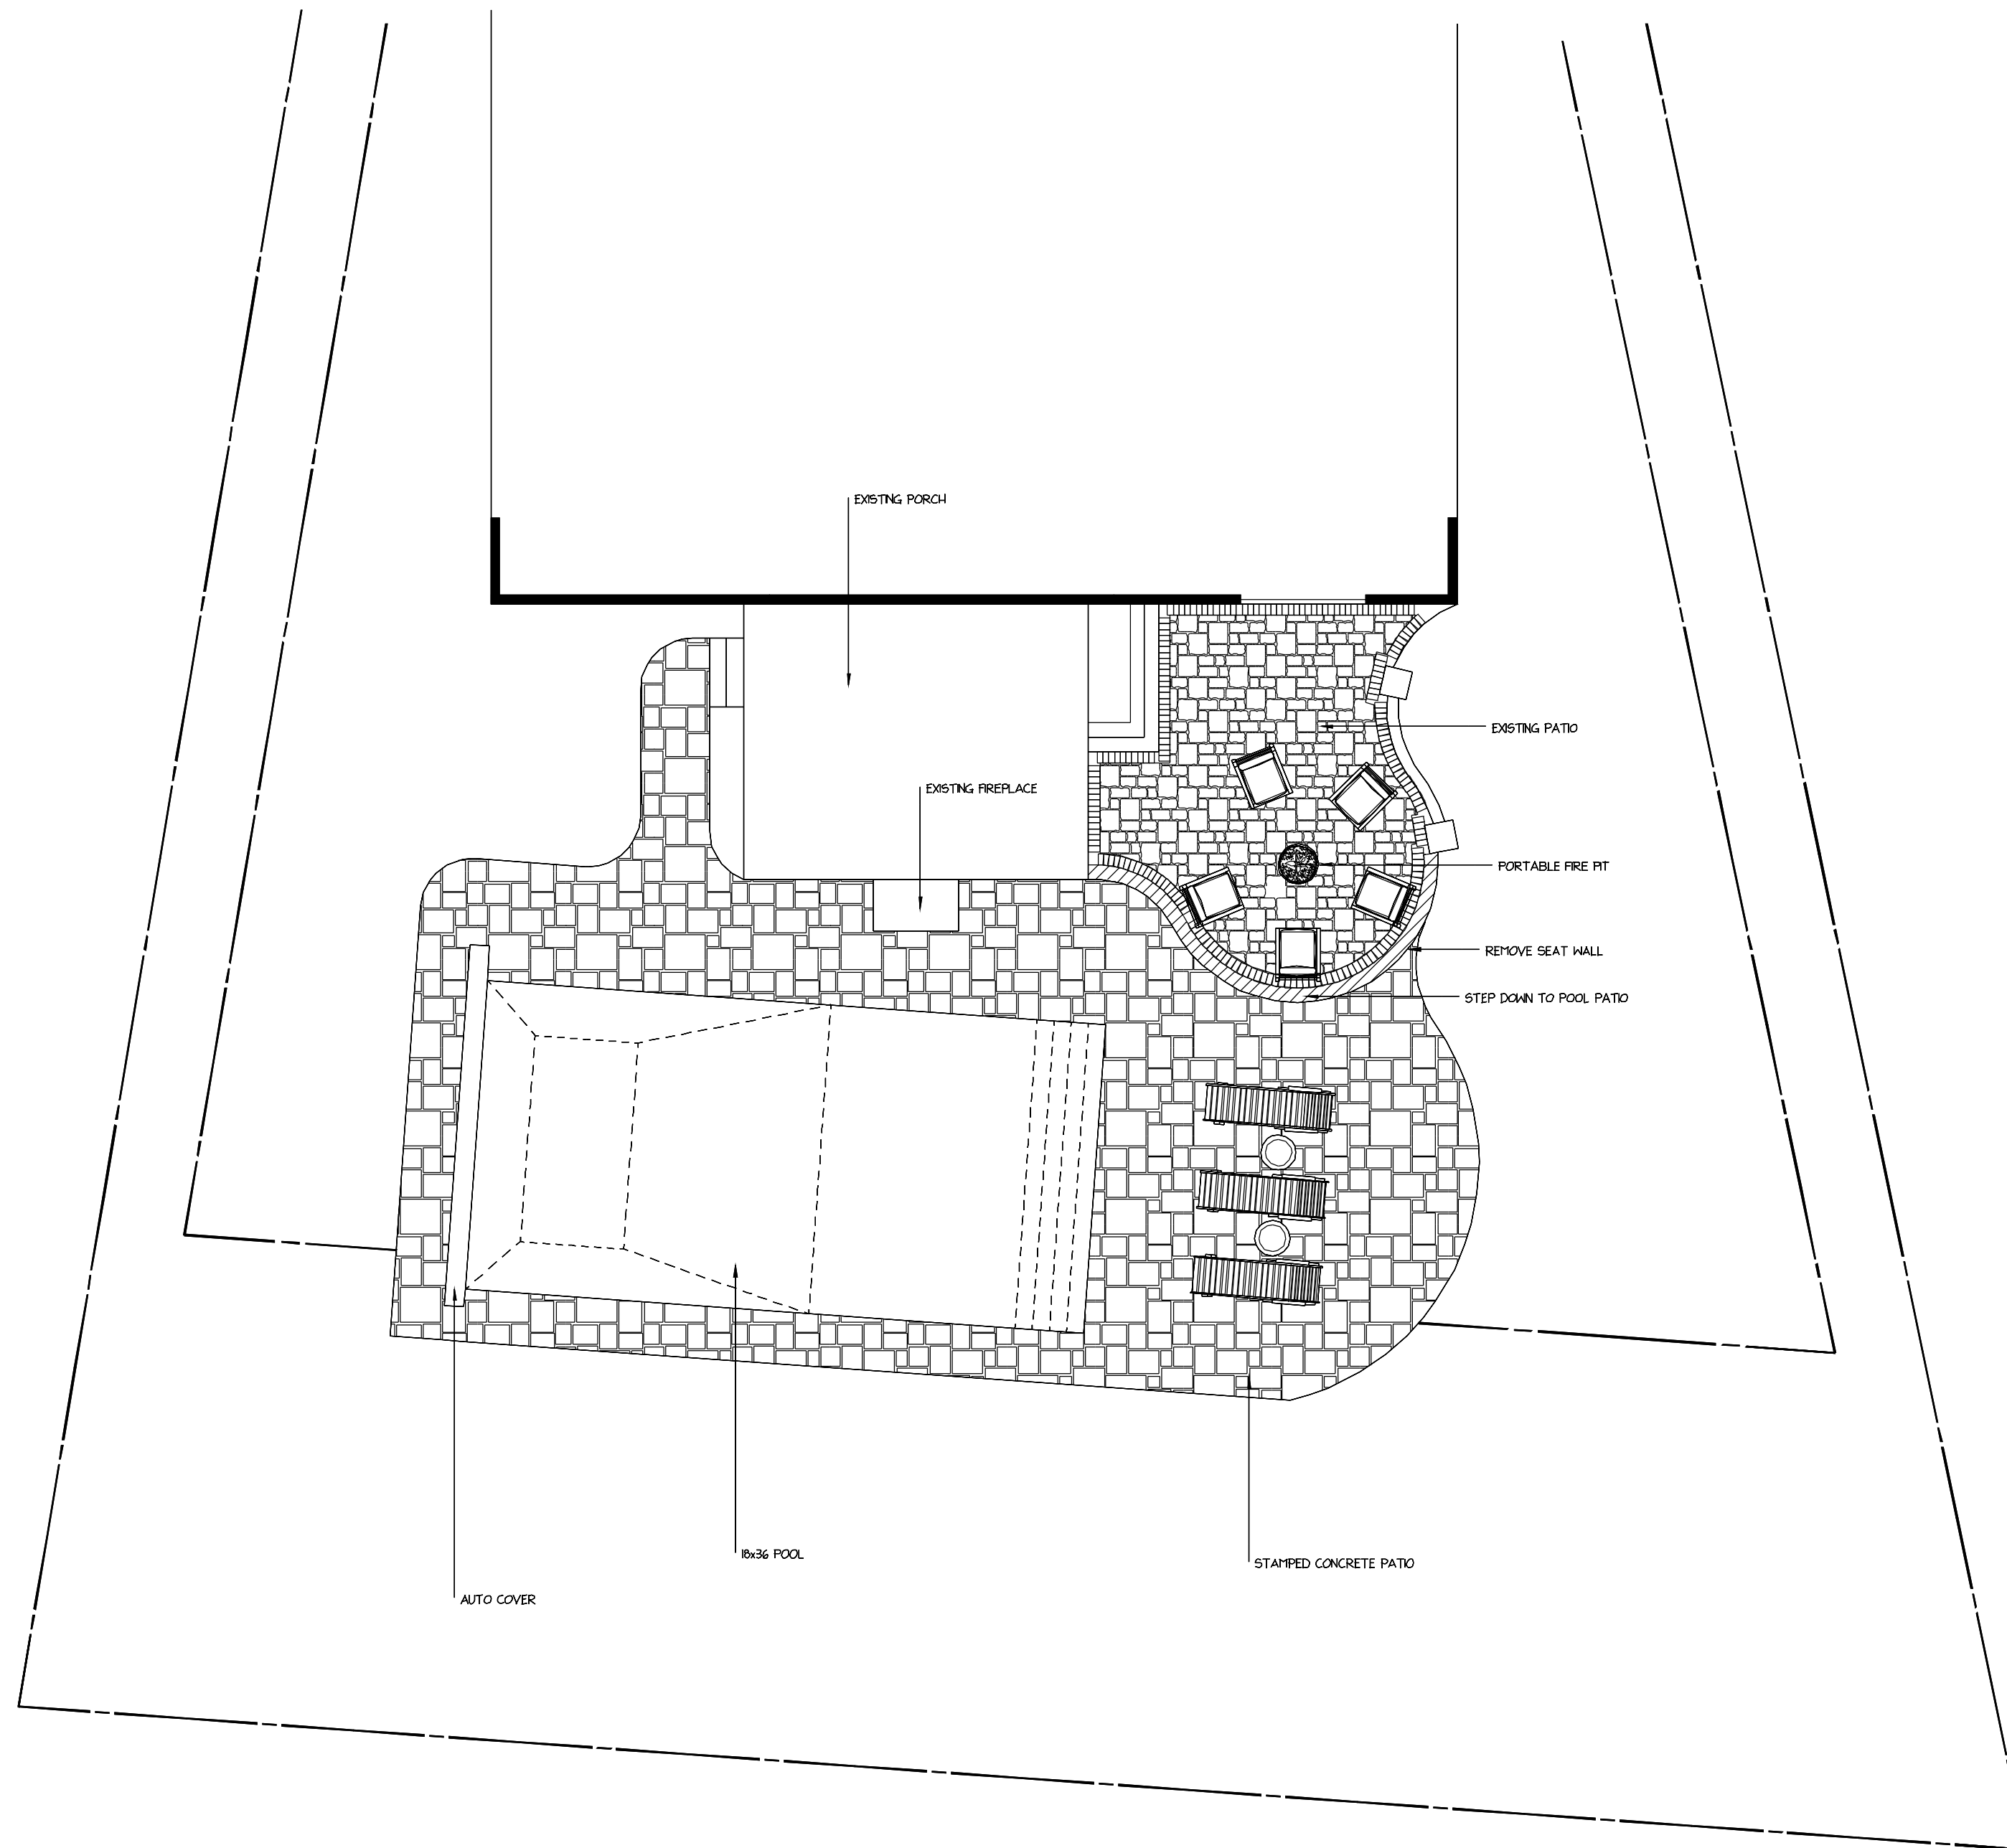
Minimum Side Yard Setback = 5-feet

Total Side Yard Setback (sum of two side yard setbacks) = 15-feet

Rear Yard Setback = 20 of lot depth = 28-feet (found by averaging lot lengths and taking 20)
